## Special session on the 2004 Niigata-ken Chuetsu earthquake Séance spéciale sur le tremblement de terre de Chuetsu, Niigata, en 2004

F. Tatsuoka  
*Tokyo University of Science, Japan*  
 K. Konagai  
*Institute of Industrial Science, University of Tokyo, Japan*  
 T. Kokusho  
*Chuo University, Japan*  
 J. Koseki  
*Institute of Industrial Science, University of Tokyo, Japan*  
 M. Miyajima  
*Kanazawa University, Japan*

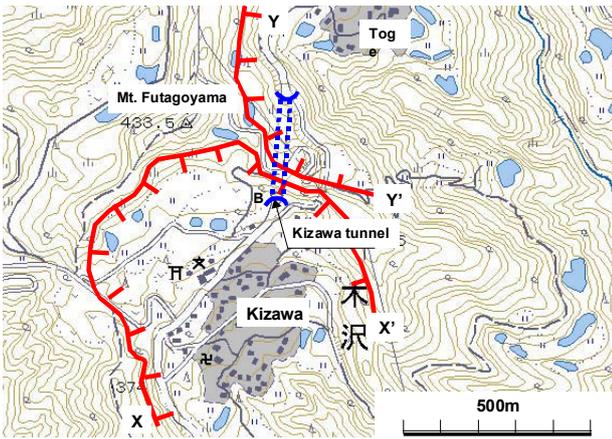
**Kizawa Tunnel:** The Kizawa tunnel skims the NW-SE trending branch of Futagoyama mountain ridge (Fig. 3). The area is covered with a thick Ushigakubi formation of Pliocene age. The surface configuration, shown in Fig. 3, indicates that Kizawa locality, about 300 to 800 m south of Mt. Futagoyama, lies on an old landslide mass with its escarpment, shown by line XX'. The south end of the tunnel is located a little below this escarpment. A depressed configuration is also found east to northeastern side along the Futagoyama ridge, suggesting the presence of another landslide escarpment (line YY'). The north end of the tunnel is closer to this configuration.

Fig. 3. Surface configuration in the vicinity of Kizawa tunnel.

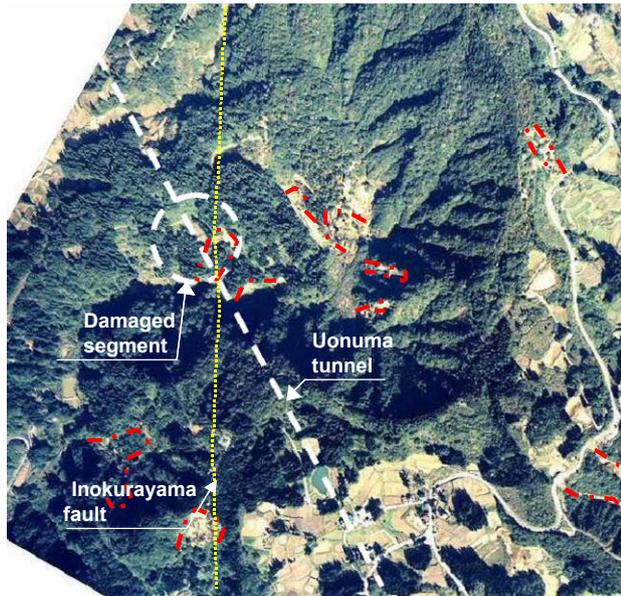
JR Shinkansen Uonuma Tunnel: The Uonuma tunnel, a 8,625 meter long concrete tunnel, crosses the inferred the Inokurayama fault (see Fig. 7), which is located just above the epicenter and the damage to the Uonuma tunnel may hint a re-activation of a small segment of this inferred fault. The Inokurayama fault stretches approximately 4 km in the SSE/NNW direction from its southern end, just east of Kawaguchi town, to the Konpira mountains in north with its west side as a hanging wall. of Uonuma tunnel (Konagai et al. 2005b).

Fig. 7 Aerial photograph of the area above the damaged segment

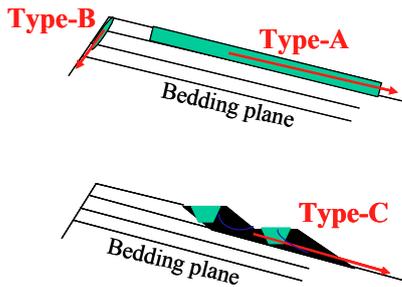
Fig. 1 Three types of slope failures; A, B and C, during the Niigataken Chuetsu earthquake.

The slope failures are classified into 3 types (Fig. 1):

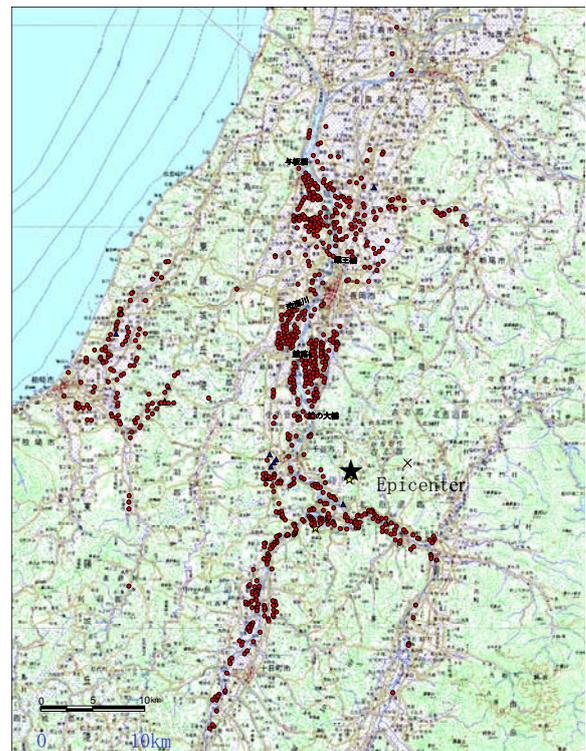
Fig. 1 shows soil liquefaction sites that were found by field investigation and aerial photographs (Wakamatsu et al. 2005), Photo. 1 shows a typical aerial photograph taken immediately after the earthquake. Light portions seen in the paddy fields in the photograph indicate sand volcanoes caused by soil liquefaction in the ground. According to Fig. 1, soil liquefaction mostly occurred along the riverside of Shinano River and its branches between Yoita Town and Tokamachi City. A distance from the epicenter of the main shock to the liquefied sites was within 30 km.

Fig. 1. Soil liquefaction sites (dark dot) found by field investigation and aerial photograph in the 2004 Niigata-ken Chuetsu Earthquake (Wakamatsu et al. 2005).

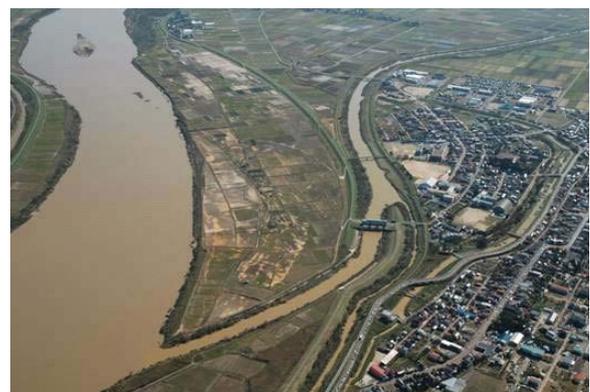
Photo. 1. Aerial photograph of Yoita Town taken immediately after the earthquake (taken 24 Oct. 2004, by the courtesy of Asahi Kogyo Co. Ltd.).

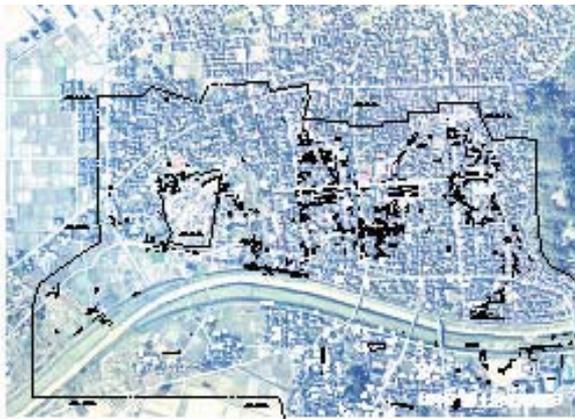
Soil liquefaction occurred in Mitsuke City is explained herein as a typical case. Photo. 2a shows soil liquefaction sites on an aerial photograph of Mitsuke City. Black dots indicate sand volcanoes caused by soil liquefaction. Black dots shown in Photo. 2b indicate wooden houses damaged at roofing tiles. Photo. 3a indicates an aerial photograph of Mitsuke City in 1984. Kariyata River was winding and black dots indicating soil liquefaction spots coincide with the old river bed at that time. On the other hand, black dots in Photo. 3b indicate damage to

Photo. 2 a) Sand volcanoes (white dots); and b) wooded houses damaged at roofing tiles (white dots) on an aerial photograph in these days (Bando et al. 2005).

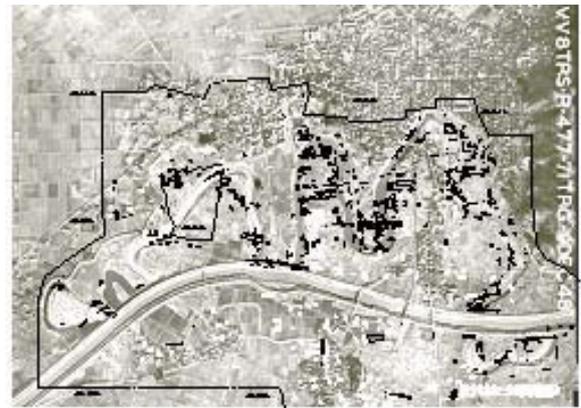
roofing tiles. The area of these black dots in Photo. 3b does not coincide with that of the black dots in Photo. 3a; that is, damage to roofing tiles did not occur at the liquefied sites. This fact seems to be related to a difference in the predominant frequency between the liquefied ground and these wooden houses with roofing tiles.

Photo. 3 a) Sand volcanoes (white dots); and b) wooded houses damaged at roofing tiles (white dots) on an aerial photograph in 1948 (Bando et al. 2005).
