Failure analysis of an 80m high geogrid reinforced wall in Taiwan

R.D.Holtz & S.L.Kramer – *University of Washington, Seattle, U.S.A*
C.W.Hsieh – *National Pingtung University of Science and Technology, Taiwan, R.O.C.*
A.B.Huang – *National Chiao-Tung University, Hsiuchu, Taiwan, R.O.C.*
W.F.Lee – *Taiwan Construction Research Institute, HsinTien, Taiwan, R.O.C.*

ABSTRACT: During the magnitude 7.3 Chi-Chi earthquake that occurred in Taiwan on September 21st 1999, an 80 m high geogrid reinforced wall failed. The failure site is located about 20 km from the epicenter, and peak ground acceleration at the site is believed to have been in excess of 0.5g during the earthquake. The GRS wall used geogrids as reinforcement and the backfill was an on-site lateritic soil. Because geosynthetic reinforced soil (GRS) structures have generally performed well under seismic conditions, this failure offered a rare opportunity to investigate the ultimate seismic behavior of a full-scale GRS structure. A series of field observations and measurements were made in an attempt to establish the possible failure mechanisms of the wall. Laboratory experiments were conducted on the soils and geosynthetics t

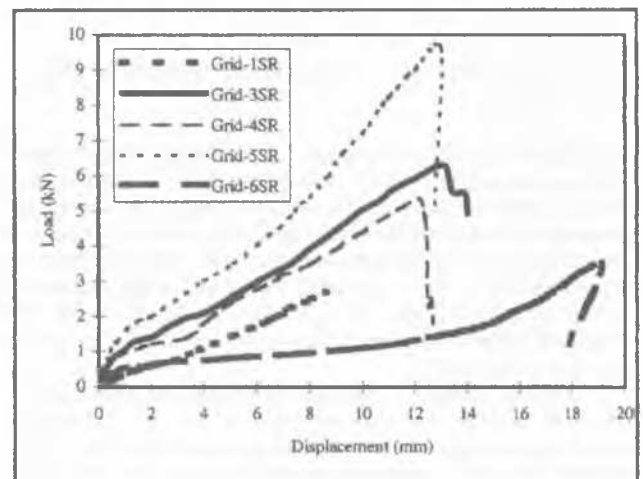
All five types of grids were made of polyester with a polymeric protection coating. Single rib strength tests (GRI:GG1), wide width tensile strength tests (ASTM 4595), and junction strength tests (GRI:GG2) were performed on the sampled geogrids in an effort to identify the strength properties of the reinforcement material. Table 2 shows the results of these tests. Figure 4 depicts typical load-displacement curves from the single rib tests. Some slow strain rate (5 mm/min) were also applied on single ribs to investigate the influence of the strain rate on the strength properties of the geogrids. It was found that the differences caused by the change of strain rates (50 mm/min versus 5 mm/min) were negligible.

Figure 4. Load-displacement curves from the single rib strength tests.

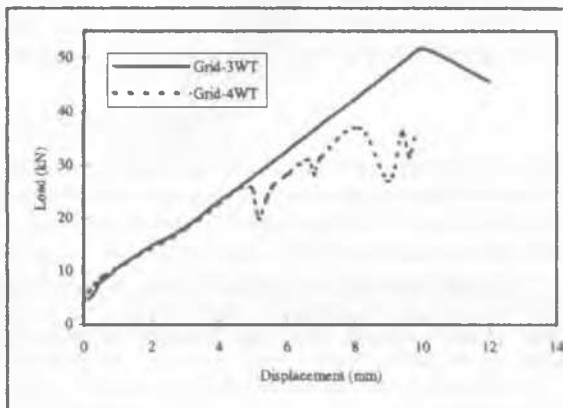
Table 3 shows the results from wide width tensile strength and junction strength tests. Figure 5 shows typical load-displacement curves from the wide width tensile strength tests. These tests were not performed on samples of Grid 1 and Grid 6 because of the limited amount of grids retrieved from the site. As shown in Table 3, the ultimate strength obtained from wide width tensile strength tests are in a range of 81% (high strength material) to 87% (medium strength material) of those from the single rib tests.

Figure 5. Typical load-displacement curves from the wide width tensile strength tests.

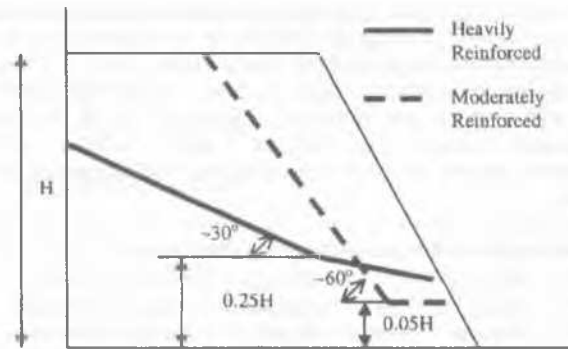
Results of shaking table tests performed at the University of Washington have indicated that the failure modes of model geosynthetic reinforced steep slopes under seismic loading involve bilinear failure surfaces such as those shown in Figure 10 (McElroy, 1997; Perez, 1999). Slopes designed with longer reinforcements and smaller vertical spacings ("heavily reinforced") have a failure surface that is generally flatter and extends more into the backfill than slopes designed with shorter reinforcement lengths and larger vertical spacings ("moderately reinforced"). These observations are consistent with the performance of the GRS wall at NCNU.

The mode of failure observed in the NCNU wall is similar in concept to those observed in model tests of steep GRS slopes conducted on the shaking table.

Figure 10. Failure modes for steep GRS slope under seismic loading conditions.
