# Strengthening and underpinning of stone foundations of St. John Church in Gdańsk

M.Topolnicki – *Technical University of Gdansk*

**ABSTRACT:** The St. John church in Gdańsk, almost 600 hundred years old, has been constructed on weak organic soils. Available records describe numerous attempts to improve the foundations and to stop the observed settlements. In the framework of a recent restoration programme it was decided to conduct underpinning and strengthening of the stone foundations at the eastern part of the church, where significant settlements and horizontal displacements occurred. For technical and economical reasons jet grouting technique was applied. Presented are design considerations, execution of the work and control measurements, with special emphasis on heavily loaded pillar foundations.

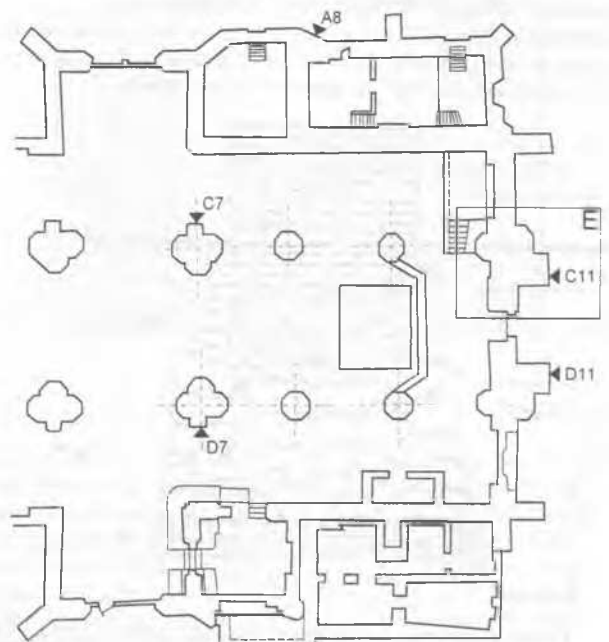
Fig. 2 Layout of the eastern part of the St. John church.

The jet grouting underpinning works were conducted under 4 smaller pillars close to the altar and two main pillars C7 and D7, as well as under the adjacent outer walls (see Fig. 2).
