Deterioration of flood protection dikes due to shrinkage cracking Pathologie des diques à cause de fissures de retrait

I. Lazányi & G. Horváth - Technical University of Budapest, Geotechnical Department, Hungary

ABSTRACT: An exceptionally long spell of drought in the Tisza valley, Hungary, has led to massive cracking due to shrinkage on several hundred kilometres of flood protection dikes built of rich swelling clay. An extensive research program was launched aimed at revealing the mechanism of cracking and finding effective remedial measures. Regional meteorological data and geological and soil survey data were conflicted with the occurrence and frequency of damage cases. Various geophysical methods were put on field trial in order to find the most suitable non-destructive method for the detection of cracks. Experimental evidence was found to confirm the general validity of a unique linear relationship between loss in moisture content and ensuing volume change, applicable also to the range of partially saturated soils. The mechanism of cracking and its effect on the serviceability of dikes was studied and concepts for remedial measures suggested. The paper reports on various tri

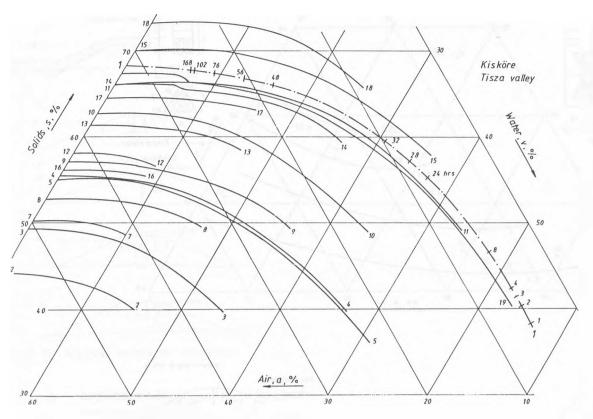
The process of desiccation can be best followed in a triangular diagram showing the changes in the "phase composition" of the sample. Results with the Kisköre clay are shown in Figure 7. The sides and base, respectively, of the triangle represent the "relative volume" of the component "phases": solids, s, water, v and air, a. (Note that s% +v%+a%=100%). Desiccation curves for samples with the same initial density (s) but increasing volumetric moisture contents (v) e.g. curves N° 1 to 4 show a similar trend: they run "parallel". (On Curve 1, the times elapsed, in hrs, during desiccation are also indicated). Curves 1 to 4 eventually all land at the s side of the triangle (i.e. at v=0 moisture content) but at different final densities (s_{max}) which latter depend on the initial state. The same statement applies to all curves. (The underlying measurements are summarised in Table 2.)

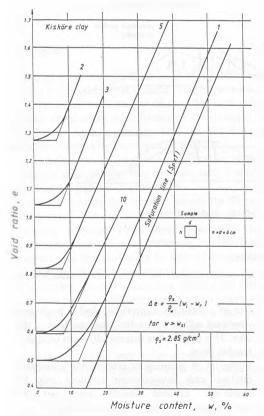
The results for the Kisköre clay are re-plotted in a more familiar form in Figure 8 which shows the relationship between void ratio and moisture content.

The important conclusion that can be drawn from the set of desiccation tests shown in Figure 8 is that the volume change diagrams (i.e. void ratio vs. moisture content lines) for partially saturated samples were invariably parallel to the "theoretical" line which latter assumes the prevalence of complete saturation (S_i=1) throughout the process of desiccation. This finding has led to the construction of a normalised graph (Figure 9) which suggests that irrespective of the fact whether the sample be completely or partially saturated the volume change behaviour due to desiccation is governed by a unique linear relationship

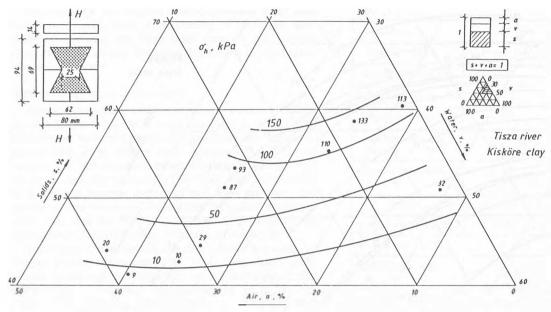
Figure 10.

Preliminary tests on briquette specimens suggest a relationship between the tensile strength and the phase composition (i.e. relative volumes of solids, moisture and air) of the soil (see the triangular chart in Figure 10). For convenience, the results are replotted in Figure 11 in a more familiar form as relationship
