Improvement/reinforcement of a ballasted track

Gerald P. Raymond – Civil Engineering, Queen's University, Kingston, Ont., Canada

ABSTRACT: The paper deals with the reconstructions that were undertaken to correct multiple ballasted track formation failures for a heavy gantry crane. Finally, in 1988 a satisfactory design was obtained that incorporated geosynthetics.

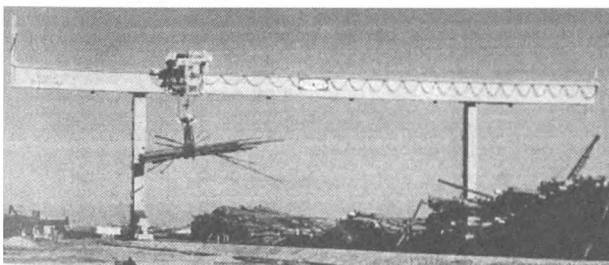
Figure 1. Gantry crane.

A ballasted track to support a heavy lumber yard gantry crane (Figure 1) was placed in service in January 1986. The yard is in Northern Alberta, Canada with an average annual temperature of 1.25 °C and an average and maximum freezing index of 1.706 °C-days and of 2,631 °C-days respectively.

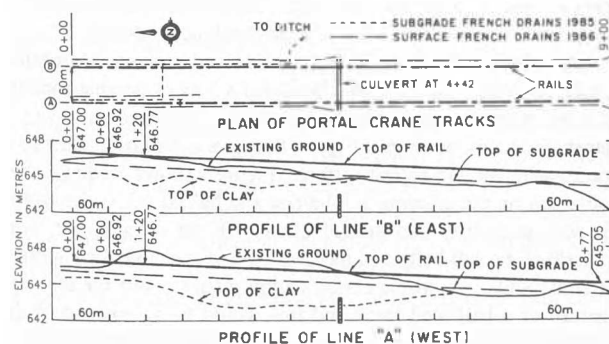
Figure 2. Track layout and longitudinal sections.

Figure 2 shows a plan of the tracks layout and longitudinal sections. Figure 3 shows a typical at grade cross sections for the 1985 build. The 1985 subdrains, placed at the North end only, were of the aggregate geotextile-wrapped type without pipes. The track subgrade drainage was 2% across the full track width.

Track reconstruction was planned in four nearly equal Sections; Section 1 (0+00 to 1+81); Section 2 (to 4+70); Section 3 (to 7+00); Section 4 (to 8+94). The original Mill feed-ins were located on this most northerly Section 1 (Figure 2). This was reconstructed first during the owners annual (summer) vacations along with the movement of logs from the next Section to be reconstructed (i.e. Section 4 the most southerly). Similarly when Section 4 was under construction logs, were moved to Sections 1 or 2.

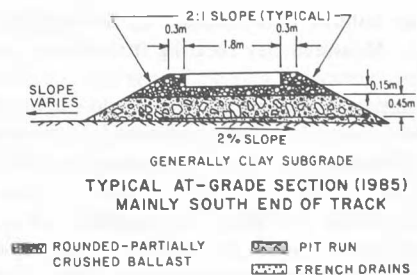
Figure 3. Cross sections of 1985 track construction.

At the North end the original soil at subgrade elevation was both compacted and uncompacted fill. The surficial clays of the area are all lacustrine and were used as required. Their properties

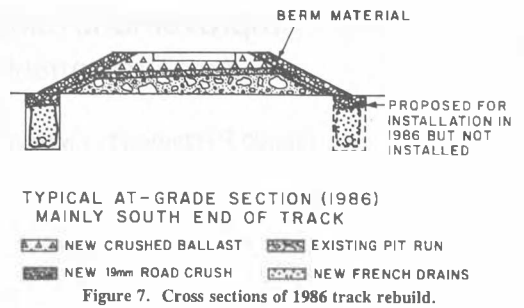
Figure 7. Cross sections of 1986 track rebuild.

In the summer 1986 the original designer made investigations and stated/recommendations given below that resulted in a rebuild of the tracks, illustrated by the at grade cross-section shown in Figure 7:

No subgrade failures were detected by borings through the existing track. Measured clay shearing strengths, c_u , were over 200 kPa.

Poor performance of the ballast was due to the ballast's low crushed surface area. Importation of quarried granite rock (at FOB Can.\$ 50.00 per ton) was recommended as replacement ballast.

The original design was based on maximum wheel loads of 285 kN (unspecified as static or dynamic). New calculations suggested use of a design value of 400 kN. This resulted two

recommendations: (a) the track be stripped to the sub-ballast elevation and a 0.15 m of crushed road gravel (maximum particle size of 19 mm) be added followed by new quarried rock ballast (0.15 m thickness below the ties) to the top of the cribs, and (b) the tie spacing be reduced to 0.45 m centre to centre.

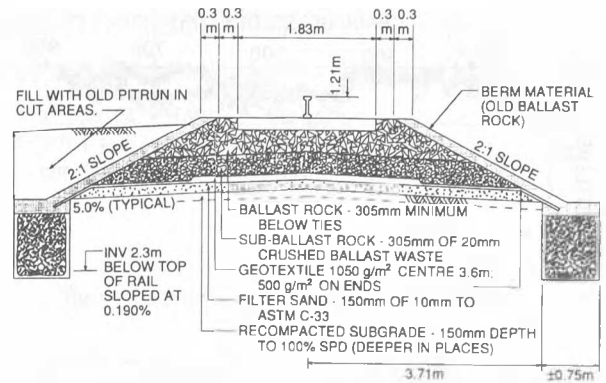
Figure 12. Reconstruction cross section adopted in 1988/9.

To prevent subgrade overstressing calculations as outlined by Raymond (1985) showed that a total depth of aggregate considerably greater than 0.75 m would be required. Unfortunately a bridge having about 25 mm clearance existed across the track limited the actual depth to 0.75 m unless heightened. This expense of increasing the clearance was unacceptable to the owner who agreed to take responsibility for any subgrade failure. The owner no doubt assumed that the existing subgrade was not in distress!

Subgrade protection from pumping was recommended as a 0.15 m layer of concrete sand (graded to the fine aggregate grading of ASTM C-33). The sand surface was to be sloped in accordance with the subgrade slope and covered with a track geotextile in accordance with the specification outlined by Raymond (1994). The geotextile was to be covered by 0.3 m of open graded sub-ballast obtained from the ballast waste (typically crushed 19 mm maximum size grading down to 9 mm minimum size particles) and then with a 0.3 m depth of ballast below base of the ties and in the tie cribs. The ballast was required to have 75 % of particles with three crushed faces, and 95 % with two crushed faces. To be accepted as a crushed face two specified requirements had to be achieved (CP Rail, 1987). The first required the crushed face to have a freshly crushed surface with a minimum width (measured across the crushed surface) greater than 25 % of that particle's maximum dimension (measured between any two of that particle's surface points). The second requirement was that the included angle formed by intersection of the average planes of adjoining fractured faces must be less than 135° for each to be considered as separate fractured faces. The contractor met the specification by crushing locally available 100 mm minimum sized rounded particles. The final cross section designed is shown in Figure 12.
