# Terzaghi oration: Geotechnical aspects of the 1995 Kobe earthquake

Kenji Ishihara – Science University of Tokyo, Japan

**ABSTRACT** The background information is given on the issues such as earthquake-generating plate tectonics in the Japanese archipelago, historical seismicity and development of fault rupture in the region of strong shaking during the Kobe earthquake. The geological setting and topography are described together with the expansion of land reclamation in the port area of Kobe. Characteristics of the ground motions recorded at various sites during the earthquake are also presented. Soil conditions investigated at two sites by way of undisturbed sampling using the ground freezing technique are described somewhat in details. The gravel-containing silty sand called Masado was identified to have developed liquefaction under intense shaking. The features of liquefaction and consequent lateral spreading which occurred in the reclaimed fills are presented in terms of attenuation characteristics of the lateral displacement of the ground diminishing with distance inland from the waterfront. As typical examples of the damage to foundations, results of in-site survey are pr

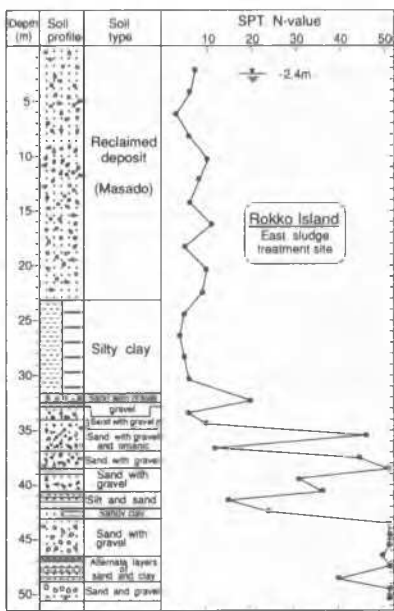
Fig.37 Soil profile at a site near the section R-2 and R-3 (Hanshin Highway Authority, 1993)

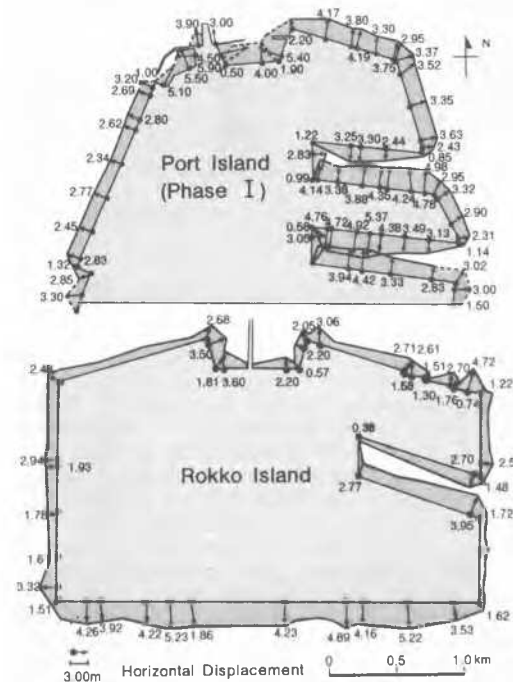
Fig.39 Lateral displacements of the quaywalls in Rokko Island and Port Island (Inagaki et al., 1996)

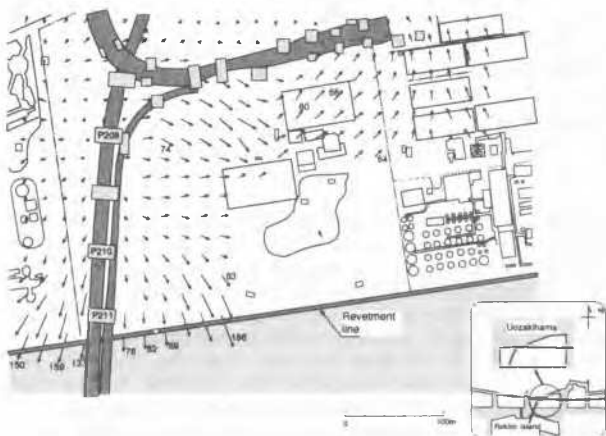
The ground displacements in some sections along the Bay Route No.5 were estimated by Hamada et al. (1996) over the widespread area by means of air-photograph interpretation. In this method, some target objects on the ground such as manholes or corners of drainage channels were pinpointed and designated on pairs of air-photographs taken before and after the earthquake and the displacements were obtained by taking the difference between the post-and pre-earthquake locations of these objects. The lateral displacements obtained in this way at specified points were used to obtain a picture of distribution of the horizontal displacements, based on a linear interpolation method using a finite element mesh. The picture of lateral displacements thus obtained for the southern part of Uozakihama is displayed in Fig.46, where it may be seen that in the area near the revetment line the lateral displacement is directed southwards to the waterfront with its maximum of 186cm. Note that the lateral displacement of the bridge pier, P211, closest to the revetment was 62cm a value which is significantly smaller than that of the surrounding ground.

Fig.46 Ground displacements in the south part of Uozakihama Island (Hanshin Highway Authority, 1996)

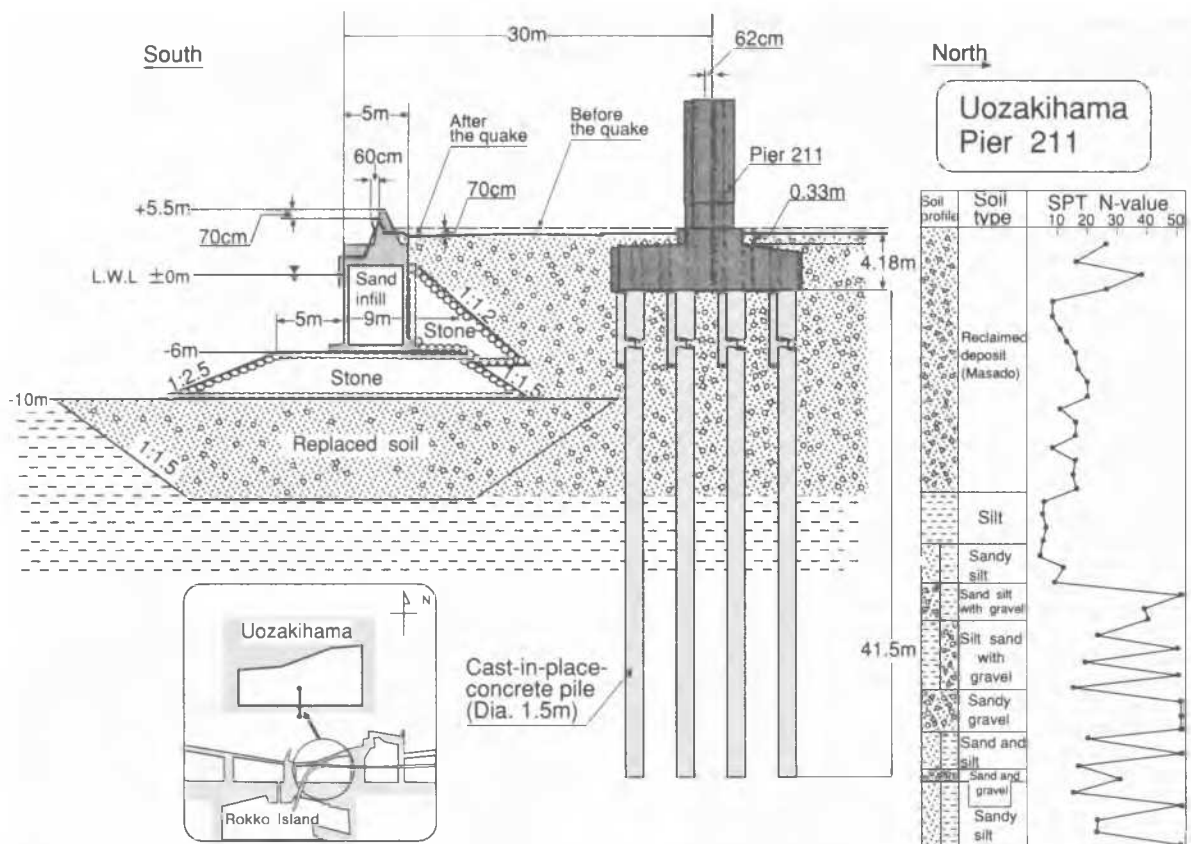
Fig.49 Quaywall, foundation and soil conditions at Pier 211 (Hanshin Highway Authority, 1996)

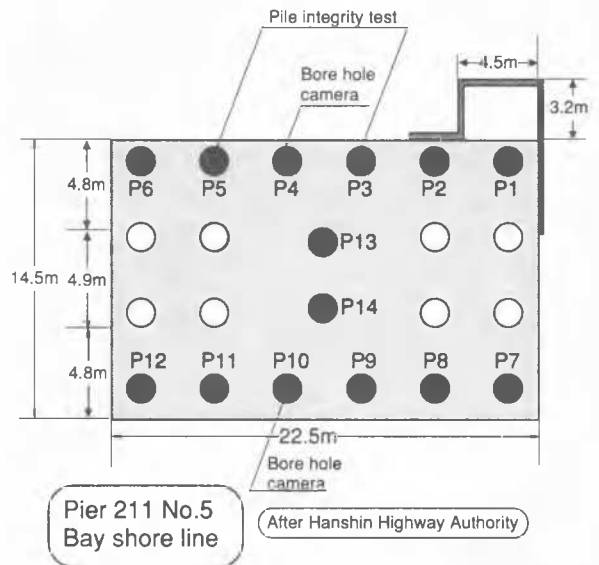
enlarged plan view of the foundation is shown in Fig.48 where it can be seen that two-column bents sit on a 22.5m long and 14.5m wide footing which is supported by 20 piles 1.5m in diameter. The piles were constructed of cast-in-place reinforced concrete. Side views of the Pier 211 are shown in Fig.48 where it is noted that the body of the footing is embedded to a depth of 4.18m. A cross sectional view of the foundation and the quaywall across the section A-A' in Fig.47 is displayed in Fig.49, together with a soil profile. Exact location of the soil profile investigation (RP4-1) behind the quaywall is shown in Fig.47. As a result of measurements by GPS, it was discovered that the Pier 211 had moved towards the sea by 62cm, as accordingly indicated in Fig.49. It is highly likely that liquefaction developed in the reclaimed fills in the backland leading to widespread occurrence of lateral spreading as demonstrated in Fig.46. The lateral displacement of the ground in close proximity to the Pier 211 but free from its influence, may be read off from Fig.46 as being of the order of 100cm.

Fig.50 Plan view of the foundation of Pier 211 (Hanshin Highway Authority, 1996)

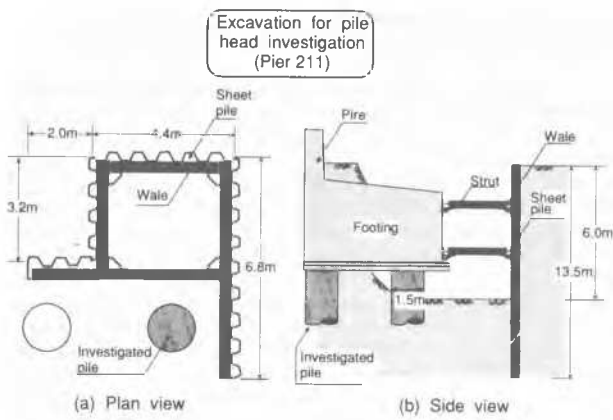
excavation to the level of the pile head below the bottom of footings; (2) picture-taking by means of video camera lowered to bored holes and (3) non-destructive method called "pile integrity test" using transmission of reflected waves. For the investigation of piles supporting Pier 211, excavation was executed to a depth of 6m at the northeast corner of the footing, as shown in Fig.50, by enclosing a 3.2m by 4.5m section using sheet piles. More detailed side and plan views are shown in Fig.51. Visual observation at the pile head disclosed several vertical and horizontal cracks a few millimeters wide as shown in a photograph in Fig.52. In the second method of in-situ investigation, a bore hole 7cm in diameter were drilled by the method of coring from the top surface through the footing slab down into the pile, as illustrated in Fig.53. If it happened to hit the reinforcement midway, another hole was drilled to reach a desired depth of 34m. A total of 2 holes were drilled to a depth of 34m for the inspection of damage in the foundation of Pier211. Exact locations of the holes are shown in Fig.48. A video camera was lowered into the holes to examine feature of cracking around the walls. Typical examples of video camera image at depth 0 -2.0m and 21.0 - 23.0m are displayed in Fig.54 where it is observed that several cracks developed down to a depth of 1.0m from the head of the pile P4 in Pier211. Cracks were also detected at various depths as represented by those at a depth of 22.0 - 23.0m shown in Fig.54. By and large, cracks were predominantly observed at depths corresponding to the boundary in soil deposits where liquefaction did and did not developed.

Fig.51 Details of the excavation work for investigating injury at pile head

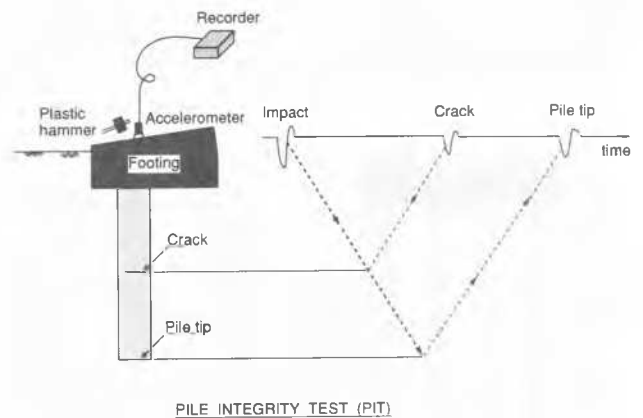
As a convenient technique of in-situ survey, the pile integrity tests were carried out at a number of piers along the No.5 Bay Route. The principle of this test is illustrated in Fig.55. Compressional waves produced by hammer hitting on the footing surface propagate downwards through the pile. Upon encountering an irregularity such as cracking, a reflected wave is generated coming back to the surface some instants afterwards. By detecting the length of time required for the reflected wave to reach the surface, it becomes

Fig.55 Illustration of pile integrity test (PIT)

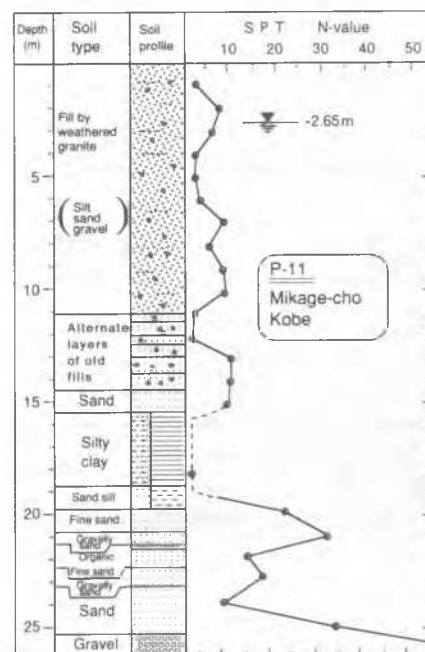
Site investigations including SPT and tube sampling were conducted before and after the earthquake at various locations in the premise. Fig.58 shows the places where boring were performed to identify soil profiles. One of the soil profiles at a place in the center of the LPG Tank101 is shown in Fig.60 where it may be seen that the man-made Masado deposit consisting of sand with silt and gravel exists down to a depth of about 15m. The soil materials were taken from the weathered granite deposits at the foothill of the Rokko Mountain behind the Kobe city area. Underneath the reclaimed deposit, a layer of silty clay exists which is the seabed deposit before the reclamation was made in 1960's. It appears likely that the gravel containing silty sand had developed liquefaction due to the intense shaking during the earthquake.

Fig.60 Soil profile in the center of Tank101

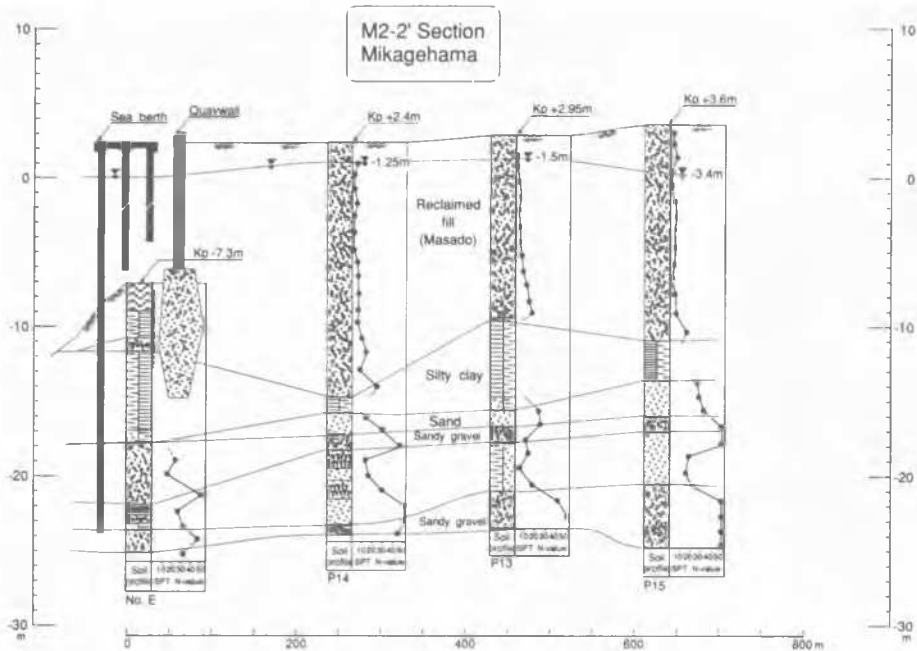
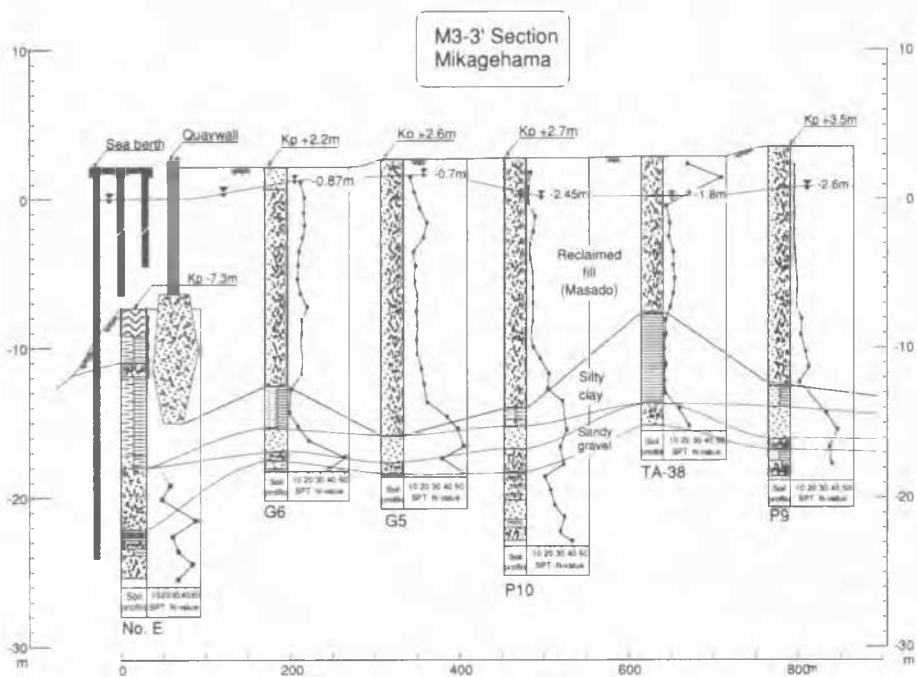
In order to visualize overall features of soil profile, pictures of soil stratification through some cross sections were drawn based on individual soil profile data at several points. A cross sectional view through the sections M2-M2' and M3-M3' are shown in Fig.61 where it may be seen that, while the depth is variable to some extent, the reclaimed fill composed of Masado prevails to a depth of approximately 15-20m all over the island. The SPT N-values are low on the order of 10 to 15 and as such the reclaimed soils were under conditions susceptible to liquefaction. Underneath the reclaimed fills there exist a silty clay deposit in original seabed.

Fig.61 Soil profile in the cross section M2-2' and M3-3'

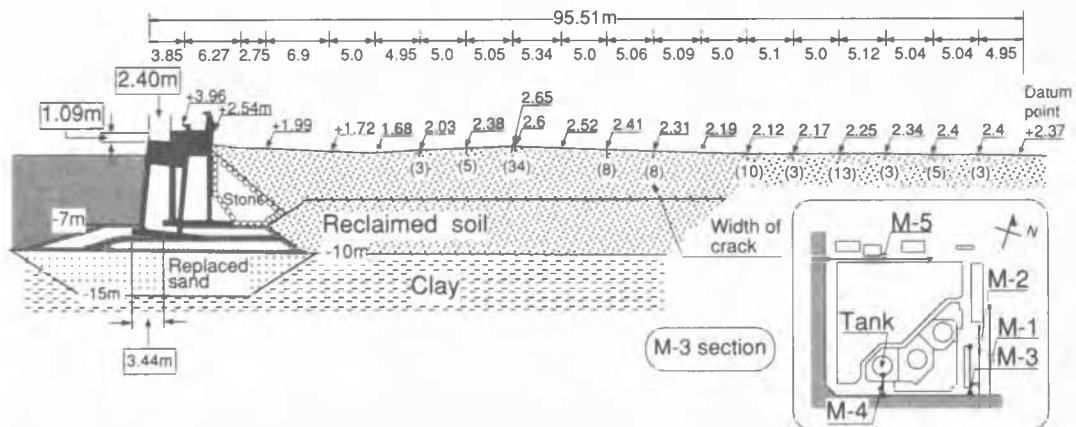
Lateral spreading of the terrain was investigated by the method of the ground surveying as described previously. Four alignments chosen for surveying are shown in the inset of Fig.62. The alignment M-1 was along the concrete fence separating the premise from the other storage yard on the east. Alignment M-4 was chosen in the premise due south of the LPG Tank101. Shown in Fig.62 are the features of ground distortion along the cross section M-3 where it may be seen that the lateral displacement at the ground surface occurred through a distance of 95m inland from the waterfront.

Fig.62 Ground distortion in section M-3 at Mikagehama Island as measured by the ground surveying

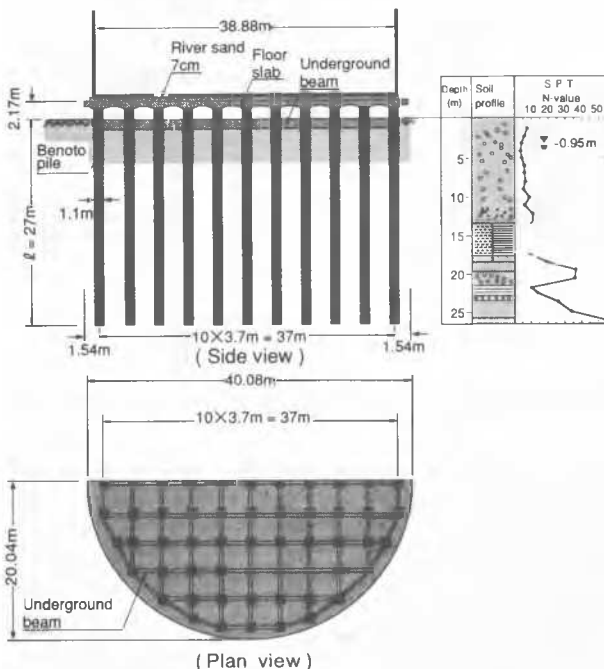
The foundation of the Tank101 consists of 97 cast-in-placed reinforced concrete piles installed by using Benoto excavation machine. The arrangements of the piles in plan and side views are shown in Fig.65. Each pile has a diameter of 1.1m and is embedded to a depth of 27m where a stiff deposit of gravel is encountered as shown in the soil profile of Fig. 65. Note that the soil profile shown was obtained at the center of the tank before the construction.

Fig. 65 Side and plan views of the foundation pile layout for the cylindrical Tank101

where the ground water table was encountered. No damage was whatsoever was discovered in the underground horizontal beams. Only small injury was horizontal cracks a few millimeters wide which had developed on the surface of several piles about 50cm below the tank slab. The surface concrete was scraped off to expose reinforcements inside, but no injury were identified further deep. To ensure sound functioning of the foundation, retrofit work was implemented to each pile. Reinforcement was conducted by enclosing each pile head by steel plates to a depth of 2m from the pile top.

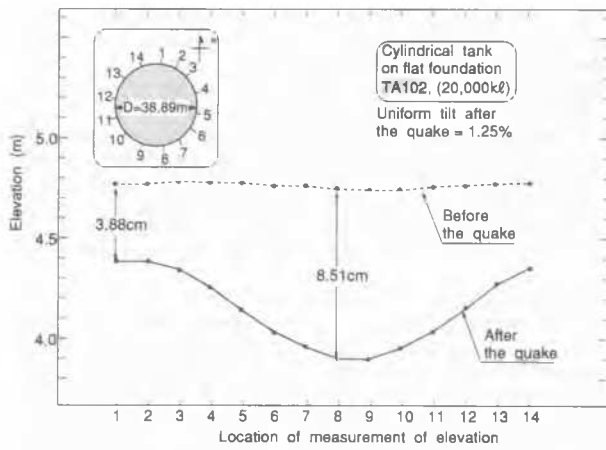
Fig.68 Measurements of elevation along the periphery of the Tank102

The elevation along the periphery of the tanks was measured prior to and after the earthquake as displayed in Fig.68 where the elevation at each point for the Tank 102 is plotted versus the location of measurements. Fig.68 shows that the maximum difference in elevation after the earthquake was 4.8cm for the Tank102, giving a value of tilt as being 1.25%. This value was in excess of 1.0% which is stipulated as an allowable limit in the government regulation. The tilt of the Tank103 was 0.34, a value within the allowable limit.

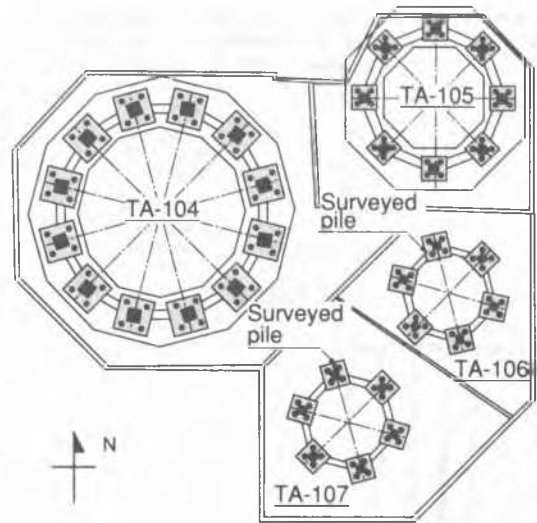
Four spherical tanks with a capacity of 100 to 1200kl located in the southeast part of the premise suffered damage involving mainly tilts due to lateral spreading of the ground. Plan view of four spherical tanks are shown in Fig.69. Plan view of the foundation for the tank TA106 with a storage capacity of 100ton is shown in Fig.70 where it can be seen that the footing of each column is supported by four reinforced concrete piles (RC-pile) 30cm in diameter. The details of the footing with connecting underground beams are shown in Fig.71. The piles were driven to a stiff soil stratum at a depth of 20m. The soil profile near these tanks is shown in Fig.72 which is the boring data at a site P14 in Fig.58. The elevation along the periphery of each spherical tank was measured in the same fashion as in the case of the cylindrical tanks. The results of measurements for the Tank106 and 107 are displayed in Figs.73 and 74, where it can be seen that the differential settlement of the order of 27cm did developed in the pile of Tank106 resulting in the tilt as much as 3.6% which is apparently beyond the acceptable limit. The tank TA107 also suffered a tilt of 1.25% which was beyond the allowable limit. The tank TA106 and 107 were retrofit by excavating the ground to a depth of existing footing and by installing additional piles outside the existing footing.

Fig. 69 Plan view of the foundations for the spherical tanks 104, 105, 106 and 107

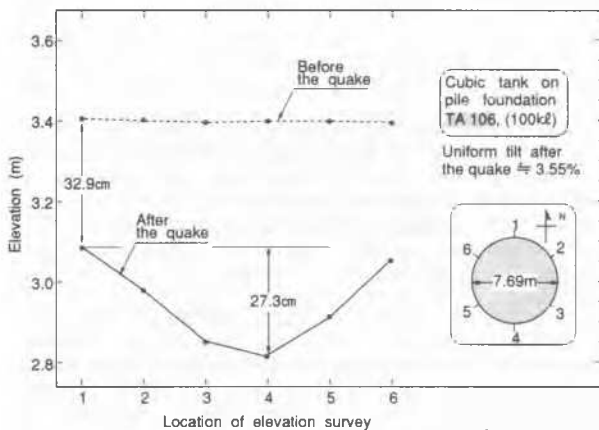
Fig. 73 Measurements of elevation along the periphery of the Tank 106

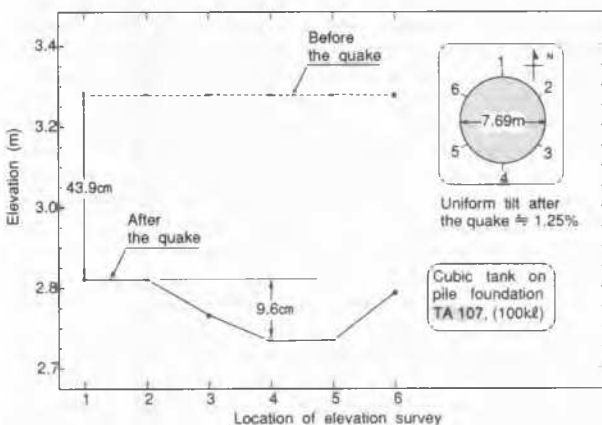
Fig. 74 Measurements of elevation along the periphery of the Tank 107

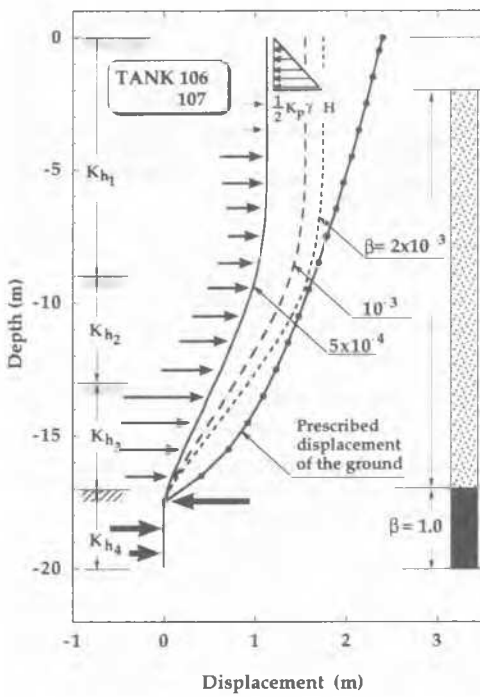
The outcome of the analysis is demonstrated in Fig.81 for variously assumed values of  $\beta$ . In view of the severe devastation near the ground surface observed at the time of the earthquake, it was considered appropriate to reduce the stiffness of the liquefied layer significantly. Thus, the value of  $\beta$  was changed in three steps from  $2 \times 10^{-3}$  to  $5 \times 10^{-4}$  as accordingly indicated in Fig.81.

Fig.81 Comparison of computed pile displacement with the assumed soil displacement for the piles of Tank106 and 107

the design code, the pile moves in unison with the movement of the surrounding soils and there is no relative displacement between the pile and the soil deposit. If a degradation of  $\beta = 2 \times 10^{-3}$  is introduced, the analysis result shows a pile movement of 1.75m on the surface as indicated in Fig.81. If the degradation of  $5 \times 10^{-4}$  is introduced for the stiffness in the liquefied stratum to a depth of 17m, the movement of 1.1m is obtained for the pile on the ground surface. The direction of the force acting on the pile body is indicated in Fig.81 with arrows where it can be seen that the moving soils in the liquefied layers is generating driving force in the direction of pile movement, whereas the underlying unliquefied soil deposit with  $\beta = 1.0$  is resisting the force acting in the opposite direction.

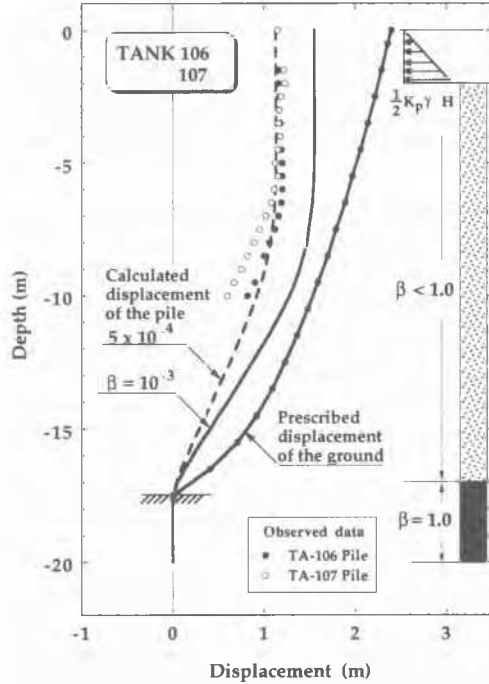
Fig.82 Comparison of calculated pile deformations with those measured by the inclinometer

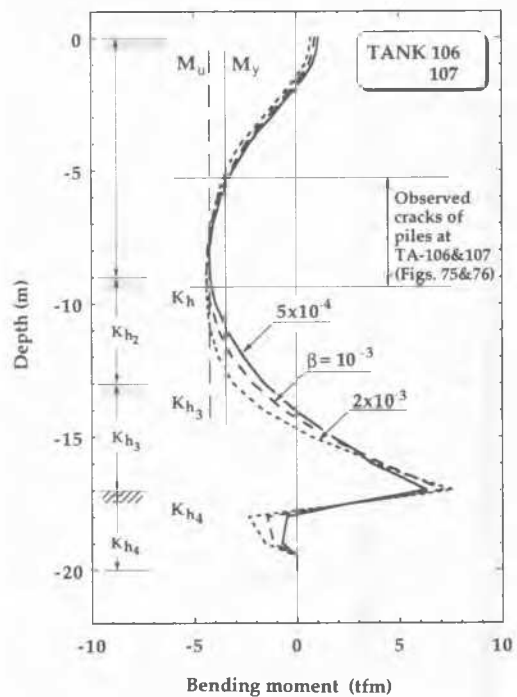
Fig.83 Calculated bending moment of the piles for the foundations of Tank106 and 107

When performing the analysis, the bending moment in the pile body was calculated in such a way that it satisfies the pile stiffness characteristics as shown in Fig.79. The moment distribution versus depth obtained from the analysis is demonstrated in Fig.83. It may be seen that the bending moment induced in the pile is approximately equal to the level of the moment

at which yielding starts to occur. Looking back at the features of crack development displayed in Figs.75 and 76, it may as well be mentioned that the depth of crack development roughly coincides with the depth range at which the bending moment becomes equal to its yield and failure value.

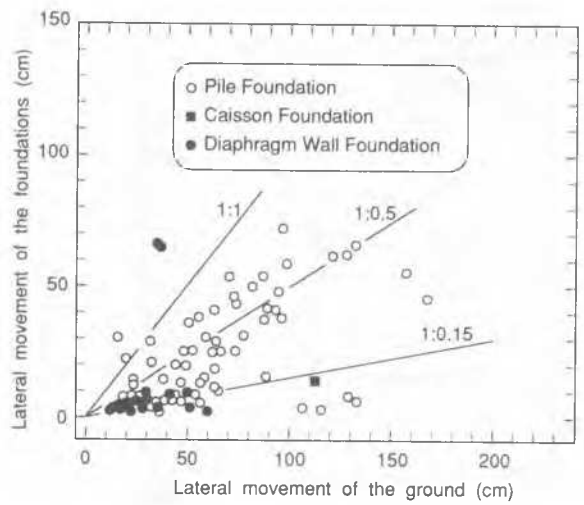
Fig.84 Relation between ground flow and foundation movement (Iwasaki, 1996)

For the case of the spherical tank foundation studied above, the first and second requirements seem to be satisfied roughly. In examining the third condition, it is necessary to know an absolute value of the pile head deflection resulting from the lateral flow, but unfortunately there is no available data to be referred to for the case of TA106 and 107 foundations. It would be of interest, however, to make proper reference to the compiled data regarding the movement of the ground and bridge piers obtained by the Hanshin Highway Authority. The lateral movements of the bridge piers along the No.5 Bay Route (see Fig.45) were monitored by virtue of GPS. The ground displacements in the vicinity were also measured by means of GPS or by using the airphoto interpretation technique. These two movements were plotted, as shown in Fig.84 for the data obtained from three types of foundations, that is, pile, caisson and diaphragm wall foundations (Iwasaki et al. 1996). It may be seen in Fig.84 that the lateral deformation of the pile-supported foundation was 50%, on the average, of the ground displacement in their neighbourhood, but this ratio could vary in the wide range between 15% and 80%.

The outcome of the case studies as above can provide a reasonable estimate of the range for the stiffness degradation parameter  $\beta$  that may be incorporated in the design practice. It is apparent that the parameter  $\beta$  is closely linked with the deflection of the pile head relative to the displacement of the surrounding ground. To examine this aspect, calculations were made for three values of  $\beta$  to obtain the deflection of the pile head,  $U_p$ , for an postulated value of  $U_G=2.4\text{m}$  in the case of the spherical tank foundations. The results of computation are plotted in Fig.85 in terms of the normalized relative displacement,  $(U_G - U_p)/U_G$  plotted versus the value of  $\beta$ . It may be seen that, if stiffness degradation parameter is larger than  $3 \times 10^{-2}$ , the relative displacement  $U_G - U_p$  becomes practically equal to zero, indicating concomitant movement of the pile and the surrounding ground. If the  $\beta$ -value is reduced to a value as small as  $5 \times 10^{-3}$  to  $5 \times 10^{-4}$ , relative displacement becomes 20% to 60% of the ground displacement, respectively. Though not conclusive yet, it may be mentioned that the stiffness of

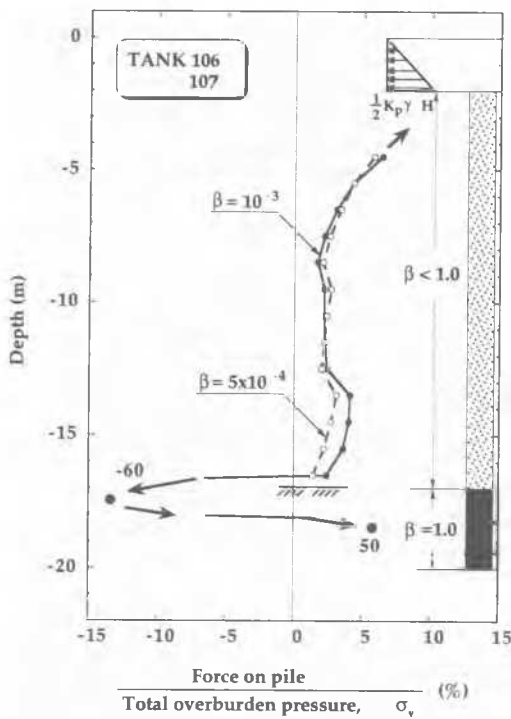
Fig.86 Computed lateral force acting on the piles from the soil deposit

was normalized to the overburden pressure  $\sigma_v$  and plotted versus the depth in Fig.86. It may be seen that the lateral force applied to the pile body was of the order of 3 to 7% of the overburden pressure.
