## A CASE STUDY OF ROCKFILL DAM: STABILITY EVALUATION AND REMEDIAL TREATMENT

**Hong Sung-Wan    Sohn Joon-Ik    Bae Gyu-Jin    Ahn Sang-Ro**  
**Um Yong-Sup    Park Eun-Young**

Geotechnical Engineering Division  
Korea Institute of Construction Technology (KICT), Korea

**SYNOPSIS:** Described in this paper are the stability evaluation and remedial treatments for an earth-core rockfill dam which experienced serious open cracks on the crest. Data obtained from the site investigation, the field instrumentation and the numerical simulation have been inclusively analysed to characterize the causes of the crack development. The effect of rapid drawdown of the water level has been evaluated as a possible cause to induce the differential settlement between the dam core and adjacent zones.

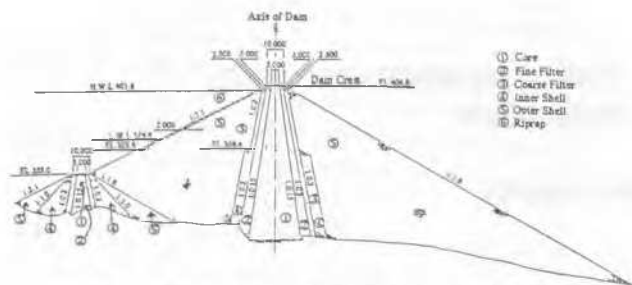
Fig. 1. Typical Cross Section of the Upper Dam

The dam is an earth core rockfill dam. The maximum height and length of the crest are 86 m and 269 m respectively. The typical cross section of the dam is shown in Fig. 1. The engineering properties of the dam construction materials are listed in Table 1. The engineering properties of the core were determined from laboratory tests and were obtained from the design reports.
