The closure of a leakage in the sealing system of a dyke

H.ARMBRUSTER, Federal Institute of Waterway Engineering (BAW), Karlsruhe, FRG

SYNOPSIS: The measurement of hydraulic, thermal and geoelectrical fields makes the detection of leakage points possible in embankments, i.e. their effects on the relevant area. The example given describes a case of damage, where the position on the leakage in an embankment on the water-side was known, but where the measurements were necessary to ascertain the length of the stretch requiring repairs and to establish the success of the measures taken. The repairs were carried out with the help of a hydro-cut diaphragm wall at a medium depth of 25 m.

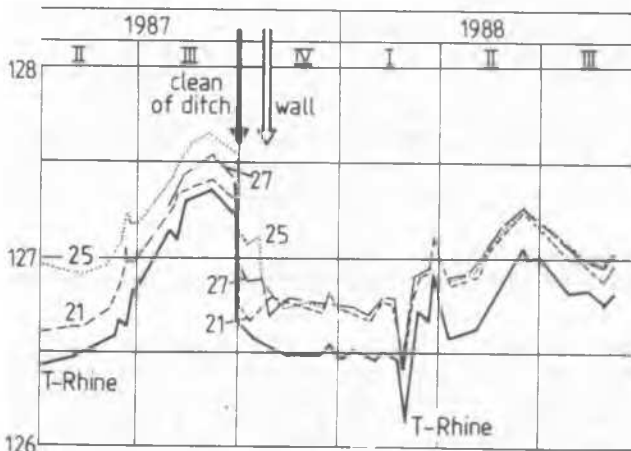
fig. 5. Water table progress lines

The measurements of the water table and the temperatures were continued on the extended system in order to determine the success of the sealing measures (fig. 4). The longitudinal section (compare before and after) shows that the phreatic line has dropped between pipes 23 and 33. However, the lowering of the water level at the end of September 1987 (fig. 5) is due to the fact that all vegetation had been cleared away from the lateral ditch and so the water level sank.

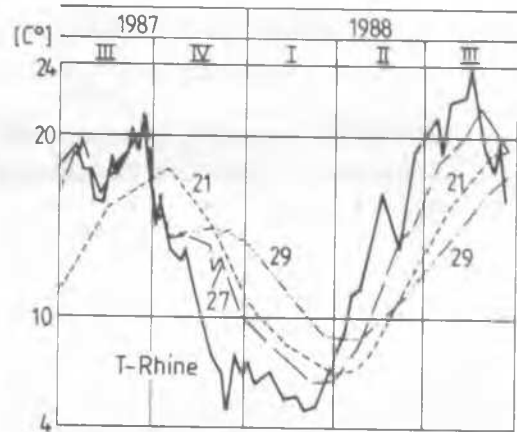
fig. 7. Temperature progress lines at a depth of 4 m along toe of the dam

There is also a change in the course of the temperature, which in the course of time (fig. 6) is clearer than in the longitudinal section. The temperatures at a depth of 4 m below the ground without any sealing are very strongly influenced by the temperature course of the Rhine (slight phase-shifting, a slight differences in the reduction in both amplitudes). After the construction of the wall a clear change in the temperature behaviour can be seen. The amplitudes in the measuring pipes become smaller, the extremes are shifted in phases by about one month (by the most at measuring tube 29 (fig. 7). The sinking of the water table in the lateral ditch resulted in a temperature jump in the measuring pipes. However, there are no typical tendencies after a repair (phase shifting, jump in amplitude).
