Prefabricated sand filter drains used at Tarbela Dam

HAQ IZHARUL, Dr. M.Sc., Pakistan
 ABDUL KHALIQ, M.Sc., Pakistan

SYNOPSIS The left bank rocks of Tarbela Dam are highly fractured and contain solution channels, fissured zones and erodible gouge material. Seepage through the bed rock was controlled by grout curtain and drainage system from the galleries. Problem arose when substantial amount of fines were passed by some of the drain holes. Different types of drains such as polymer bonded filters, epoxy bonded filters and sand filtered drains were tried and finally the latter were selected. The concept of the sand filtered drain consists of two concentric slotted PVC pipes prefabricated with filter sand in the annulus. The latest design has been the result of a thorough re-appraisal of the filtered drain concept. These drains have been successfully used at Tarbela Dam.

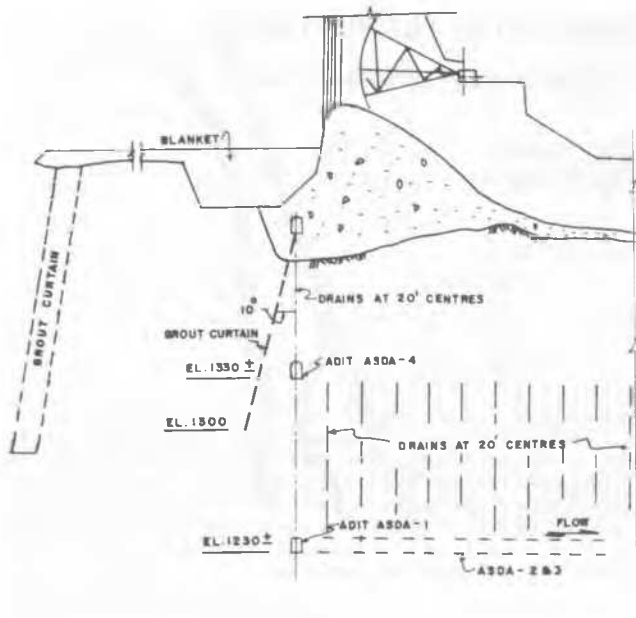
Fig.1 Drainage System For Auxiliary Spillway

Effective angle of shearing resistance of the gouge material was found as low as 18°. Stability analysis indicated that piezometric pressures especially under the auxiliary spillway must not be allowed to rise above specified limits. Fig. 1 shows schematic sketch of auxiliary spillway. Longitudinal drainage adits ASDA-2 and ASDA-3 are located in the left and right abutment rocks respectively. Both adits connect with the transverse Adit ASDA-1 under the headworks. During the initial impounding in 1974, the seepage into the drainage adits of left abutment reached 10 cusecs (0.283 cms) against the estimated value of 1.5 cusecs (0.042 cms). A number of drains discharged fines. The performance of drainage system of Auxiliary Spillway from 1975 to 78 was satisfactory. However during 1978 impounding deterioration was indicated with the discharge of significant amounts of fines from 10 drains under the headworks structure. These drains were plugged and replacement drains were installed by lowering a coaxial 50 and 75 mm diameter slotted PVC pipes down the holes from the drainage adits in 1.3 m segments. Sand filter was installed between the

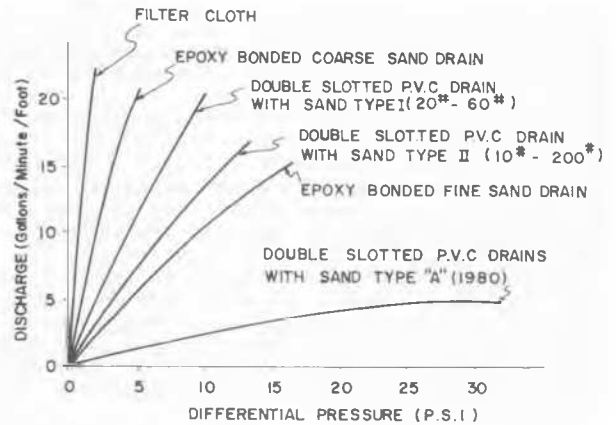
Fig.3 Flow Rates In Discharge Capacity Tests

To check the flow capacity, a series of laboratory tests were conducted on the sandwich filter drains. The flow through the drain was measured and loss of filter sand through the slots was also monitored. Another series of tests with weights applied to the PVC pipe were conducted. This series checked whether the accumulated weight of the sand filter may cause the slots in the PVC pipe to open thus increasing flows and loss of filter sand. The loss of fines was small amounting to .05% of the filter weight. There was negligible change in flows with added weight on the filter. A series of tests were conducted within a triaxial

cell allowing pressure to be applied from the outside of the drain such as occurs in the field. The effective permeability dropped to 0.00022 cm/sec. The drain capacity was found to be 0.049 L/Sec/m/m head.
