Mangla dam project – Behaviour of Siwalik clays/sandstones

G. S. BUTT, Pakistan
CH. ALTAF UR REHMAN, Pakistan

SYNOPSIS Mangla Dam Project structures have foundations/abutments of Siwalik formation of Plio-Pliostocene era. Since the completion of the Project in 1967, the foundation/dam have gone through 18 cycles of impoundments & drawdown. Residual shear strength parameter for clays was used for the long term satisfactory performance of slopes & foundation. The slips in the reservoir/one in tailrace of emergency spillway confirm the wisdom of using residual values. Bedrock sandstone is weakly cemented fine to medium grained. Boiling has been rampant d/s of Sukian Dam, a low dyke along a ridge. It is possible to control the boiling by vigilant observation and treatment with inverted filters. Clays/sandstones have performed satisfactory as fill materials for core/shoulders.

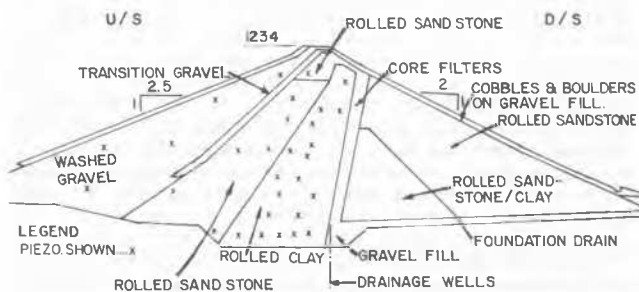
Fig.2 Mangla Main Dam

Mangla Main Dam has a rolled clay core, constructed of excavated Siwalik clays which was watered, broken & stockpiled. It was then laid at OMC (Optimum Moisture Content) to OMC+2 % in 0.3m layers. High construction pore-pressures upto 0.7 ru (Pore-Pressure ratio) developed. Over the last 17 years, pore-pressures have dissipated but no flownet seems to have developed, is apparent and would take much greater time (Fig-2, Fig-4).
