# Soil liquefaction problems in recent Japanese earthquakes

Y.YOSHIMI, Professor, Tokyo Institute of Technology, Tokyo, Japan

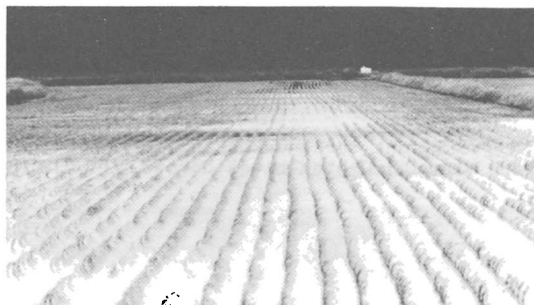
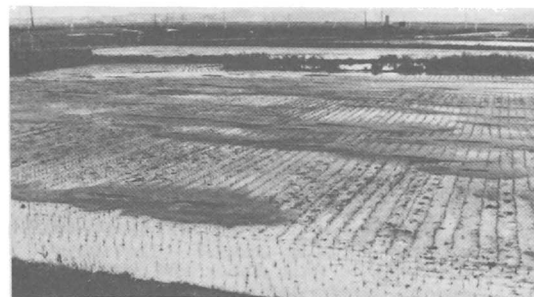
Fig. 3 Typical Rice Paddies

tion. As shown in Fig. 3 the rice paddies were ponded so that the groundwater table was as shallow as it could be; yet the rice seedlings were thin enough to provide a clear view of the ground surface. One will understand the significance of these circumstances if one imagines the opposite case in which the earthquake might have occurred at midnight in the middle of winter with the whole region covered by heavy snow.

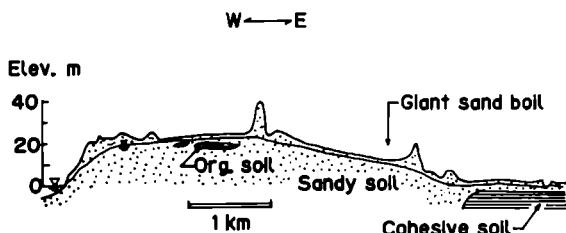
Fig. 9 Cross-Section Through Shariki Village (Courtesy of Dr. I. Tohno)

Fig. 8 shows one of the largest sand craters found after the 1983 quake, about 7 m across. The groundwater kept flowing for a few days. Fig. 9 shows a cross-section perpendicular to the coastline. Strong wind from the sea blew the dune sand to form so-called "blowout depressions" that were partly surrounded by parabolic dunes down wind (Kuwabara et al., 1985), as shown in Fig. 10. The blowout depressions became swampy, and then were filled by windblown dune sand in a very loose condition. That is where the giant sand boils were formed. Fig. 11 shows a cross-section of one of the giant sand boils.
