# The Teton Dam Failure — A Retrospective Review

H.B. SEED and  
J.M. DUNCAN

Professors of Civil Engineering, University of California, Berkeley, CA, USA

This paper reviews the events leading to the failure of Teton Dam in Idaho on June 5, 1976 and the investigations, conducted over a period of several years, to determine the cause of the failure. Conclusions are presented regarding the probable trigger mechanisms which initiated the failure, the mechanics of failure and the significant lessons concerning earth dam design and construction resulting from the investigations.

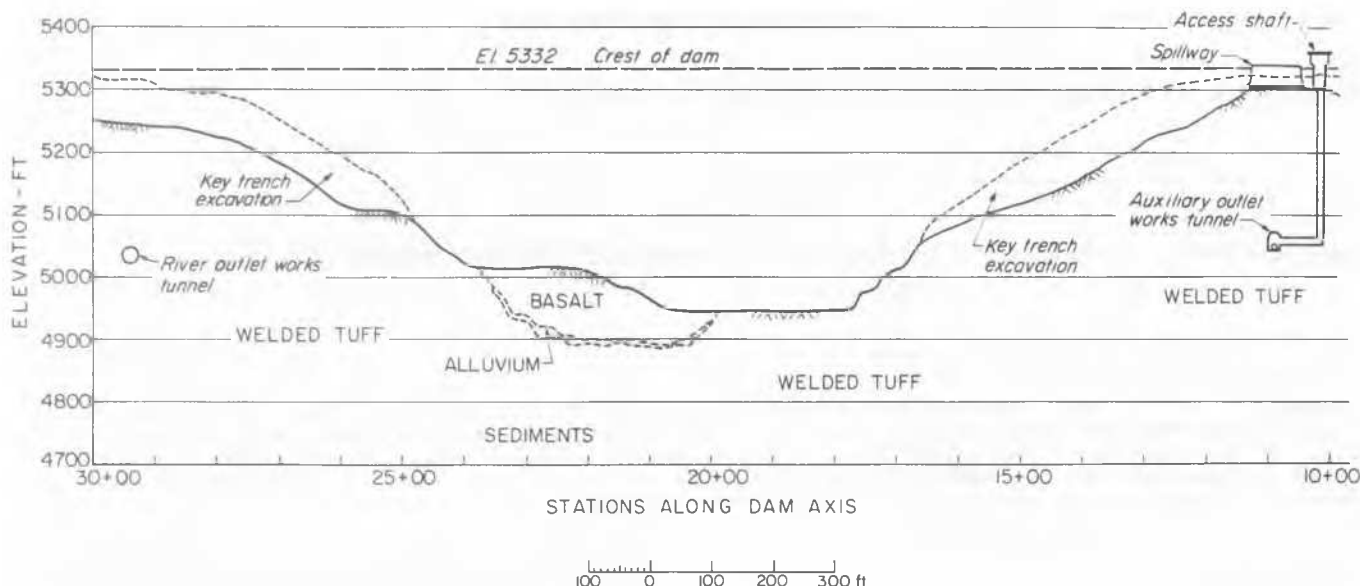
Fig. 1 Profile Along Axis of Dam

The Teton Dam was located in a steep-walled canyon cut by the Teton River into a volcanic plateau known as the Rexburg Bench. A cross-section of the canyon approximately along the axis of the dam is shown in Fig. 1. The walls of the canyon consist of later Tertiary rhyolite welded-tuff which is strongly jointed, with joint widths varying at different elevations typically between 1/4 to 3 inches but with occasional joints up to 12 inches wide. Alluvium has been deposited in the river channel to a depth of about 100 ft and the high lands near the ends of the dam are covered with an aeolian silt deposit up to about 30 ft thick. The primary features of the site are the extensive joint system in the rhyolite-tuff which makes it extremely permeable and the abundance of the wind-blown silt deposit which led the designers to use substantial quantities of this material in the dam cross-section.

Extensive site exploration work was performed prior to construction. Percolation tests in the rock showed it to be capable of transmitting volumes of water over 100 gallons/minute. Pump-in tests in five drill holes showed similar results. In one hole, 280 ft deep, pumping water at the rate of 440 gpm for a period of two weeks only raised the water level in the hole by 185 ft but the effects were observed in holes 1000 ft away. These investigations confirmed the presence of an extensive interconnecting system of joints which made the rock extremely permeable and indicated the need to seal the joints in order to reduce the leakage to acceptable quantities.

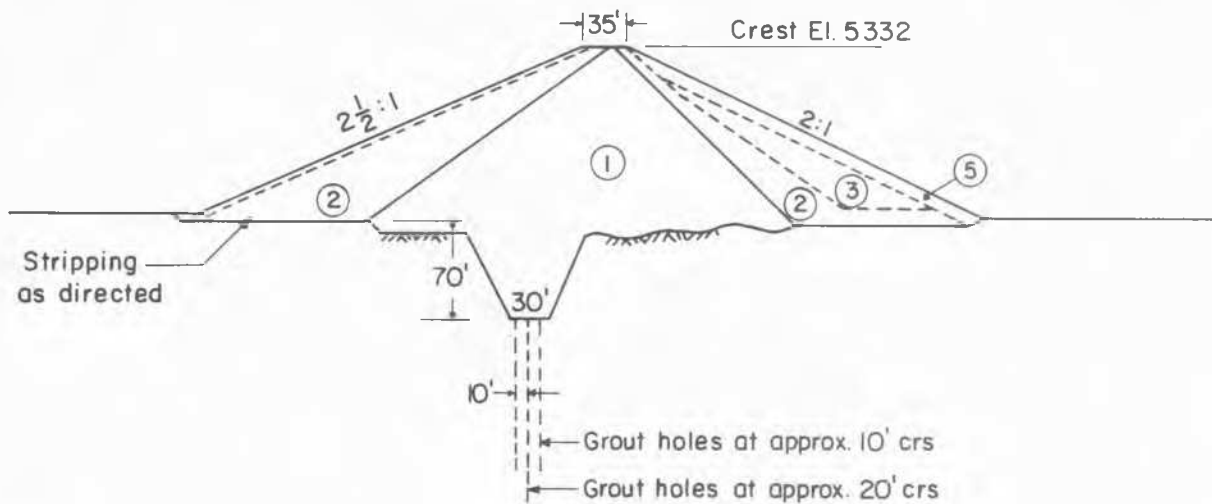
Fig. 3 Typical Cross-Section Over Abutment Sections Founded on Jointed Rhyolite

The possibility of arching over the key trench with a corresponding reduction in stress on the key trench fill is clearly evident from the geometry of the section shown in Fig. 3. A calculated stress distribution in the embankment and in the key trench at Station 15+00 before wetting of the fill is shown in Fig. 7. Vertical

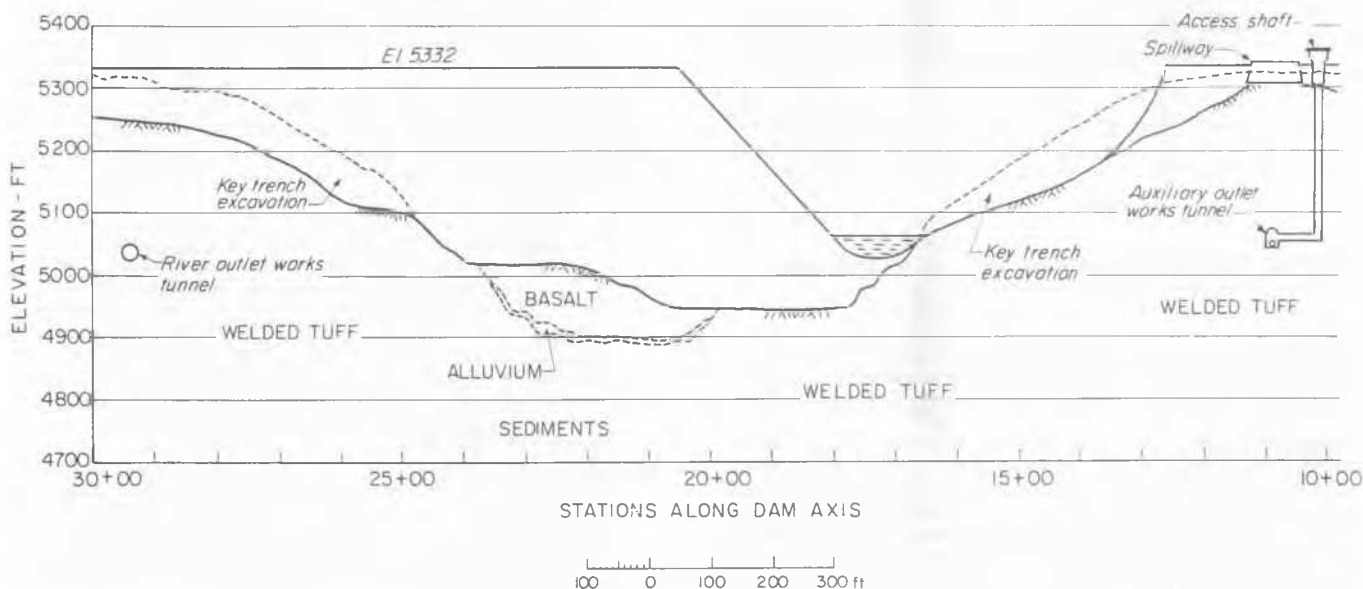
Fig. 5 Profile Along Axis of Dam After Failure

The flow of water through the gap in the embankment led to erosion of both the embankment and a portion of the underlying rock. A cross-section through the embankment showing the extent of erosion is shown in Fig. 5.

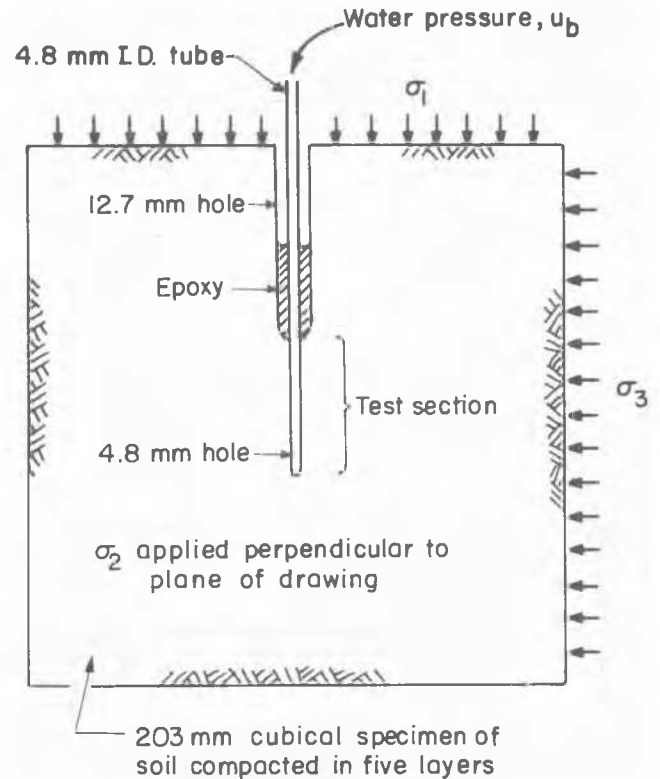
Fig. 12 Laboratory Test of Hydraulic Fracturing Around a Model Borehole

For this purpose, 20.3 cm cubical soil samples were placed in a cubical stress apparatus where three independent normal stresses could be applied to the faces as shown in Fig. 12. A 0.48 cm uncased borehole, 5.1 cm long, drilled in the center of the sample was sealed at the top with an epoxy plug and water pressure was then applied to the walls of the borehole through a steel tube cemented into the epoxy. Water dyed with rhodamine W.T. was used for the fracturing fluid so that the resulting stains in the soil could be used to determine the orientation and extent of the fracture plane following a test. A complete description of this equipment has been given by Jaworski (1979). Tests were performed on both undisturbed and recomacted samples with applied stresses simulating an in-situ stress condition. The results of a typical test are shown in Fig. 13. As the water pressure in the borehole was increased, the flow rate from the hole increased. As the fracturing pressure,  $u_f$ , was approached the flow rate increased very rapidly with little or no increase in pressure.

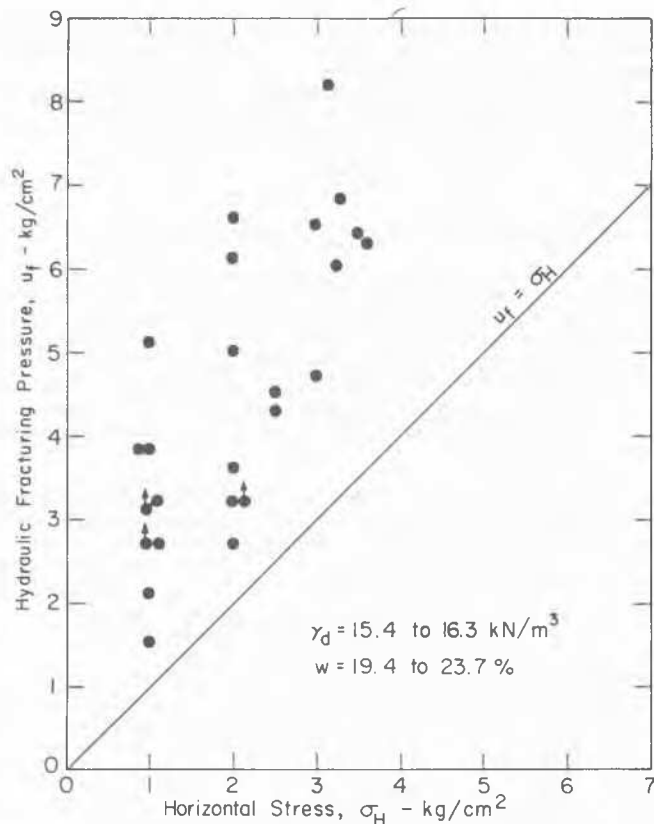
Fig. 14 Results of Hydraulic Fracturing Tests on Recompacted Samples of Teton Dam Zone I Fill

It was found that fracturing always occurred along vertical planes and that test results were very similar to those obtained in the field test program. Of particular interest was the wide scatter in the results of tests performed using the same procedure, compaction water content and density, as shown by the results in Fig. 14. It was found that small variations in soil composition had a far more important effect on hydraulic fracturing pressure than did variations in density or water content.

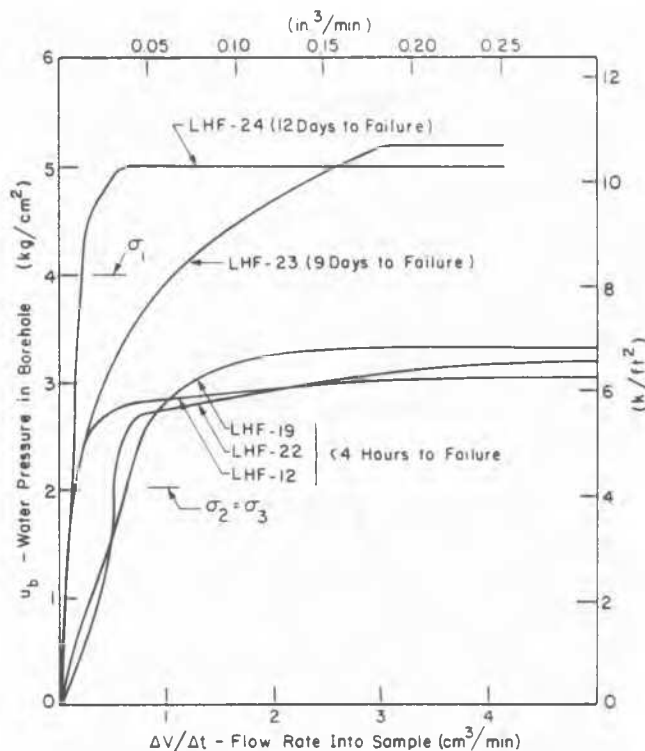
Fig. 15 Effect of Duration of Tests

Of particular interest are the results of two tests in which the borehole water pressure was increased slowly so that failure occurred after a period of days rather than hours. The results of these tests are shown in Fig. 15. It may be seen that the fracturing pressure in these tests, which lasted 9 days and 12 days, are substantially higher than those in similar tests lasting 3 to 4 hours. This effect is probably due to differences in the extent of the zone of seepage around the borehole. The comparative effect of rapid and slow filling of a borehole is shown in Fig. 16, and with a slow rate of wetting the effective water pressure tending to cause fracturing is substantially less than the hydrostatic water pressure in the borehole.

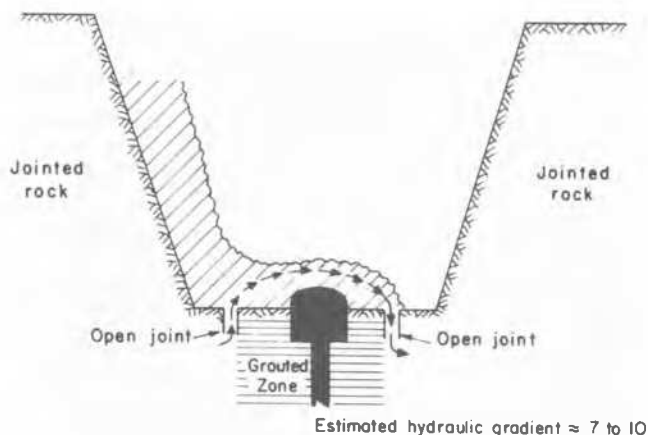
Fig. 21 Piping Due to Seepage Across Base of Key Trench

- (2) Seepage through the key trench fill, with accompanying erosion, from an open joint upstream, over the grout cap and into a downstream joint as shown in Fig. 21. At the time of failure, the hydraulic gradient along such a flow path was probably of the order of 7 to 10. This is higher than the hydraulic gradient which is known to have caused piping and a large cavity in the core of the East Branch Dam in 1957 as a result of seepage through a steep-walled key trench similar to that at Teton Dam (Fetzer, 1977).

All of the failure mechanisms postulated above could have been prevented if adequate protection of the Zone 1 fill against internal erosion had been provided in the original design. Such protection would have involved appropriate treatment of the rock to ensure that all joints in contact with the core material were sealed, together with the provision of a suitable filter system for the highly erodible fill. By these means erosion could have been prevented and failure could not have occurred. Thus while the new investigations indicate additional modes of failure to those proposed in 1976 and 1977 they do not change the basic conclusion of the report of the Independent Panel that:

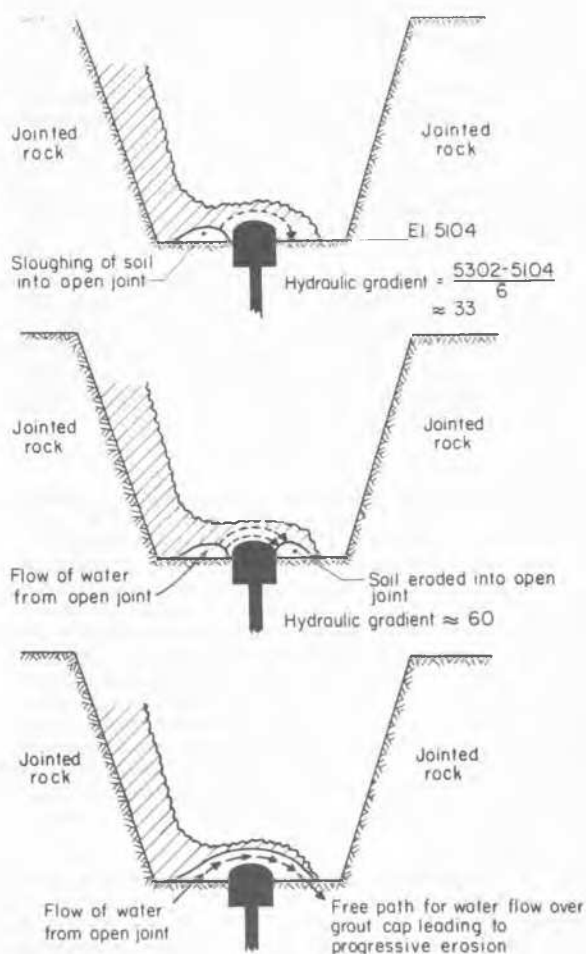
Fig. 22 Piping Due to Seepage and Sloughing Over Base of Key Trench

- (3) Seepage through the soil near the base of the key trench, facilitated by sloughing of wetted fill into open joints, thereby progressively increasing the hydraulic gradient as illustrated in Fig. 22.
