Failure of Waste Fill Buried within a Soft Clay

F.E.BARATA Prof., Eng. School, Federal Univ. of Rio de Janeiro, Soils and Foundation Consulting Engineer, Brazil

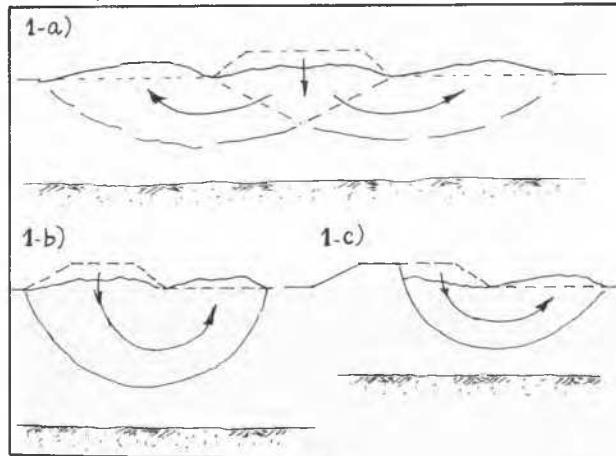
Fig. 1

Frequently the stability analysis of earth-fills built in swamp areas have been restricted to the classic case of a fill spread upon weak soil. The analysis is therefore performed under consideration of a superficial loading, susceptible of undergoing a general sinking (Fig. 1-a) or a lateral (rotational) sliding (Fig. 1-b and 1-c).
