SETTLEMENT DUE TO DEEP FOUNDATION CONSTRUCTION
TASSEMENT DU A LA CONSTRUCTION DES FONDATIONS PROFONDES
ОСАДКА В РЕЗУЛЬТАТЕ УСТРОЙСТВА ГЛУБОКИХ ОПОР

SWAN BENG TAN, Executive Engineer, Public Works Department (Singapore)

CITY HALL BUILDING

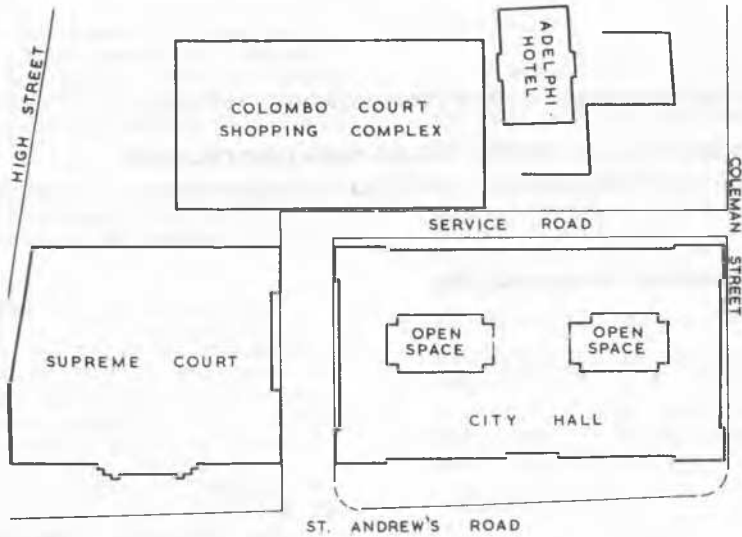
Figure 1 Site plan of City Hall Building

The 40 year old City Hall Building, 250 feet by 380 feet approximately, Fig. 1, is located at the junction of Coleman Street and St. Andrew's Road. To its left is the pile founded Supreme Court Building and to its north is the Adepfi Hotel whose foundation is unknown. The Colombo Court Shopping Complex lies to its northwest and is separated from the City Hall and Supreme Court by a 36 feet wide service road. The City Hall Building, Fig. 2, is made up of five 4-storied blocks, each block being independent of the other. Block B and E are similar and so are blocks A and C. The construction of the various blocks is generally of reinforced concrete with brick panel walls. The typical foundation, section AA in Fig. 2, consists of columns which are carried down through spread footings to a 9 inch thick reinforced concrete raft-founded on sand at 6 feet below the original ground level. The average dead and live load on the ground is about half ton per square feet.
