# DAMAGE TO STRUCTURES ON PRECONSOLIDATED CLAY

A. KOMORNIK, D.Sc., Senior Lecturer

J.G. ZEITLEN, M.Sc., Professor of Soil Engineering  
Israel Institute of Technology, Haifa, Israel

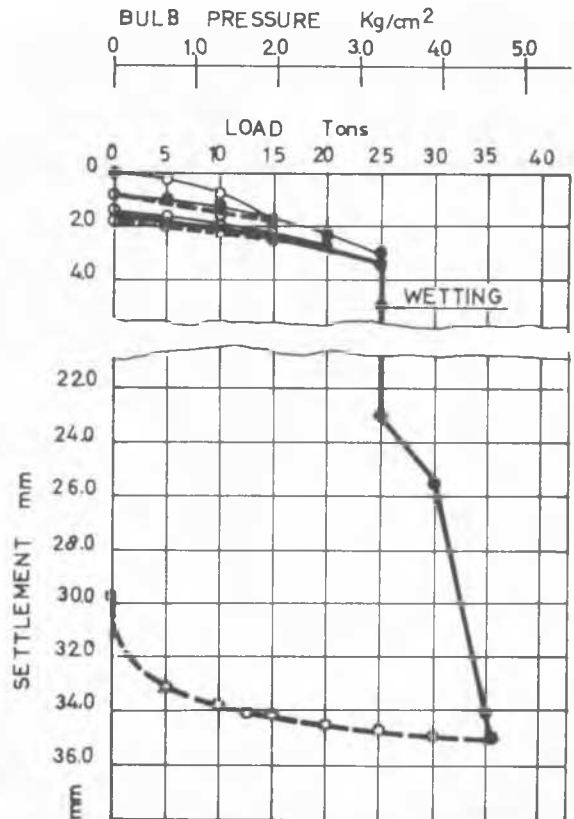
Fig. 4 Load Test Results (Site A')

During investigations at a site, A', adjacent to A, the influence of wetting was studied in the course of a loading test on a typical bored pile, 3 meters deep, with an underreamed bell diameter of 1 meter. The soil around the pile was wetted by saturation wells extending to 2 meters depth (Fig. 3). The total settlement increased from 5 mm to 23 mm during six days under a constant load of 25 tons (Fig. 4). Determination of the moisture content profile, before and after saturation, showed no change in the value of about 32 percent at the depths of the pile tip. The increased settlement was probably due partly to decreased resistance of the upper clay around the stem, as well as to decreased shear resistance of the pile end. The wetting action of the wells may have caused decreased suction in the pores of the lower bearing clay, not accompanied by a noticeable water content increase.
