LANDSLIDE IN LOESS ALONG THE BANK OF THE DANUBE

A. KEZDI, Prof. Dr. techn.
Technical University, Budapest.

SYNOPSIS Paper describes and analyses the sudden spreading of a loess plateau caused by the rise of the ground water table beneath a newly constructed industrial plant. After the outline of the geological conditions, physical characteristics of the soil and the results of stability analysis are given.

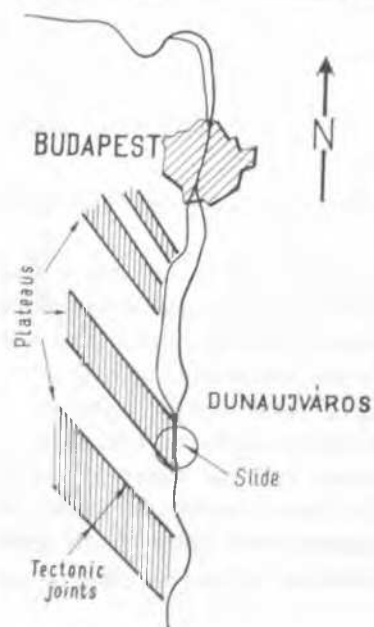
Fig. 3 Sketch of the plateaus along the western bank of the Danube after Schmidt-Eligius

The loess plateaus on the right bank on the Danube are dissected by NW-SE cracks, according to the regional tectonic structure of the country. (Fig. 3.) The joints are, in the opinion of Schmidt-Eligius (1966), dislocated and therefore open and waterbearing. The loess layers which cover the surface of the right-bank plateaus are of pleistocene origine, they are aeolian, wind-laid sedi-

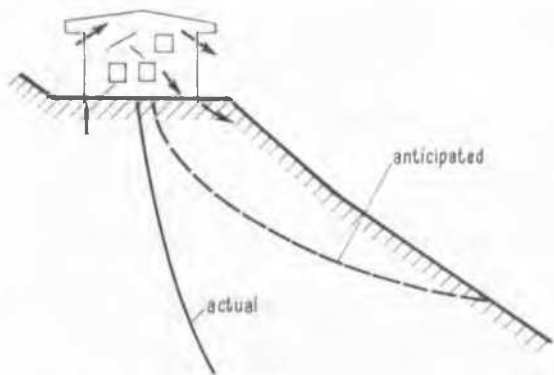
Fig. 6 Movement of a house on the rim of the loess plateau

While the construction of the plant and the city was going on, some signs showed a certain extent of movement right in the vicinity of the plant, where later the slide occurred. Just on the rim of the loess wall,

there was an old, abandoned house which showed cracks and fissures. So we decided to take measurements from time to time, and so, we could foretell the slide, because the reference points showed a movement of an increasing rate. However, the extent of the slide was many times greater than anticipated. The movement of an observed point up to the occurrence of the slide is given as an example on Fig. 6.

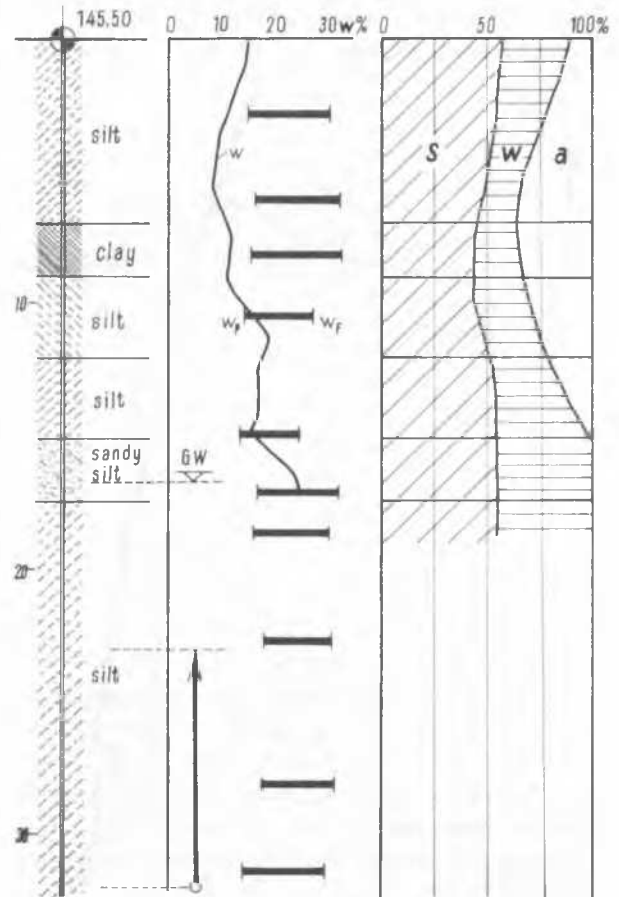
Fig.8 Index properties of soils from a drill hole in the area of the slide

A representative sample of the bore hole profiles obtained in the area is given on Fig. 8.; it does not need any further explanation. The collapse of structure, which is

characteristic for macroporous soils, could be experienced in all samples with three phases subjected to compression and inundation. However, saturated samples from beneath the water table, do not exhibit this property. As we shall see later, the "seat of the slide" was situated in the lower, saturated layers, so, the collapsing structure was not a decisive factor in the problem. On the other hand, strength characteristics play a very important part. Based on a great number of tests, the interesting diagram in Fig. 9. could be obtained. Triaxial tests furnished the important data in Fig. 10., showing the Coulomb-lines for different testing conditions. For the stability investigations, the "consolidated-undrained" strength parameters are competent; the consolidation pressure corresponded to the weight of the layer above the assumed sliding surface. No drainage was allowed, because the movement occurred very rapidly.

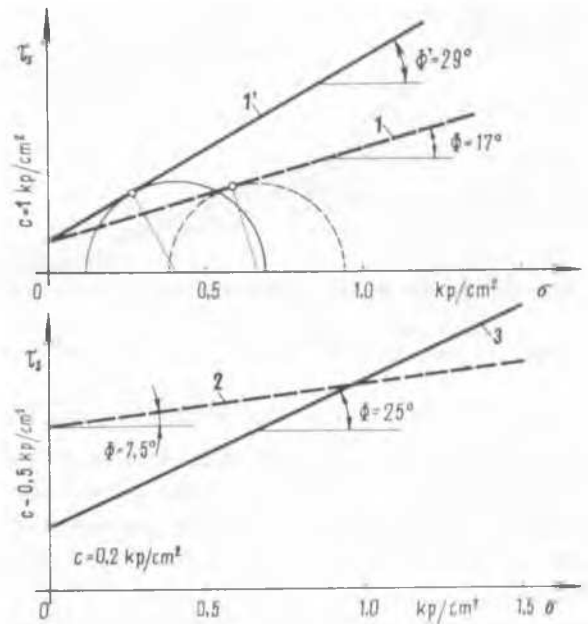
Fig. 10 Shear strength parameters. 1 - saturated; no volume change; 2 - saturated, unconsolidated; no volume change; 3 - saturated, consolidated

Permeability tests revealed the above mentioned anisotropy of the loess: the k -value in the vertical direction was more than hundred times greater than that in the horizontal direction. This fact was responsible for the rather steep phreatic line of the first groundwater level, which caused high seepage pressures.

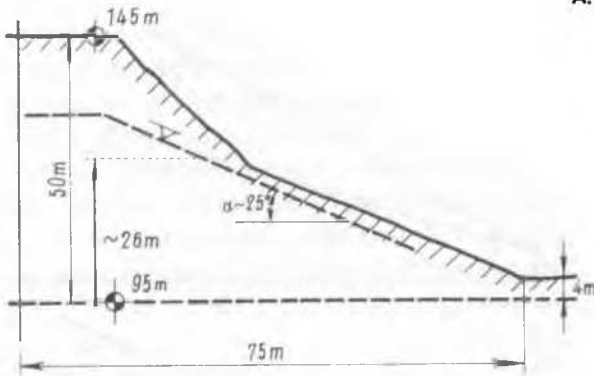
Fig. 11 Basic data for stability analysis

In the course of the investigations several types of stability analysis were applied. It was clear, right at the beginning, that the usual circular sliding surface must not be assumed here, the mechanism of the slide being completely different. First, we plotted several cross sections of the bank, in one single drawing, and selected the most dangerous one, accepting it for the purpose of stability analysis. It was, then, combined with the representative soil profile and physical - particularly strength - characteristics. The exploration of the hydrogeological conditions furnished the momentaneous height and the probable variations of the piezometric level of the second ground water level, so the basic data could be put together. These are given in Fig. 11. The upper ground water level which formed a depression line, was replaced, for simplicity, by two broken lines, one being horizontal, the other one making an angle α with the horizontal.

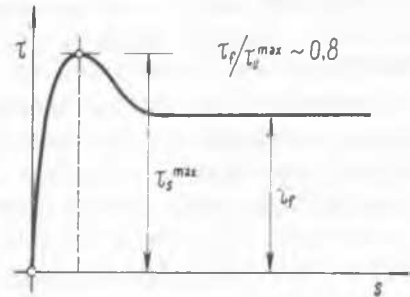
Fig. 12 Difference between maximum and final shear strength

Before entering into the numerical calculations, we have to form an idea on the mechanism of the slide. Previous experiences and observations during and after the slide, showed that the seat of the slide lay in a certain depth, where the shearing resistance was substantially weakened so that the pushing forces, the shearing stresses along the same plane, could overcome the total resistance. The latter was furnished by the shear strength and the passive earth pressure as well. When failure along the critical plane occurs, the shear strength drops (Fig. 12) and the movement spreads out. The incipient failure will be caused by the increase of the active forces: this was actually the main effect, since the rise of the water level increased both the active earth pressure and the seepage forces. An additional effect came into being due to the increase of the piezometric pressures (this was due to high Danube water, see the correlation in Fig. 7) which reduced the shearing strength:

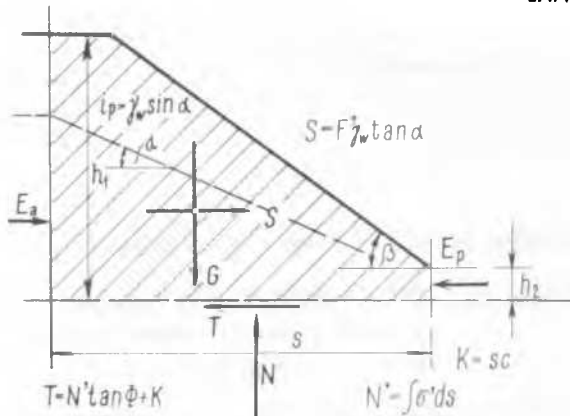
Fig. 14 Equilibrium of forces

So, the progression of the slide can be traced, in the writer's opinion, as given in Fig. 13. Herein, the increase of the seepage force a, of the piezometric stress b and the variations of the shearing and resisting forces c are plotted. The factor of safety drops to unity, when the sum of the driving forces becomes equal to the resisting forces. The factor of safety is therefore given by (see Fig. 14)

$$\gamma = \frac{T + E_p}{S + E_s}$$

$$T = N' \tan \phi + sc,$$

where N' denotes the effective normal force on the critical plane, due to the dead weight of the sliding block.

The height of the critical plane could be determined with a sufficient accuracy; also the extension and dimensions of the displaced block were known, so, the value of the piezometric stresses was the only uncertain quantity. Therefore, we calculated the safety factor assuming different values for the neutral stress acting in the critical plane; Fig. 15 presents the result of these calculations. We obtained $\nu = \text{unity}$ for a piezometric head 122 m above sea level. This value agrees very well with the observations before the slide, so it proved that the assumed mechanism of the slide cannot be far from reality. Since the original water levels - first and second ground water - were
