# Stability of Slopes in Earth Dams and Foundation Excavations

by Dr. K. L. RAO, M. Sc., Ph. D., M.I.C.E., M. I. Struct. E., M.I.E., Member (design and research) Central water and Power Commission, New Delhi

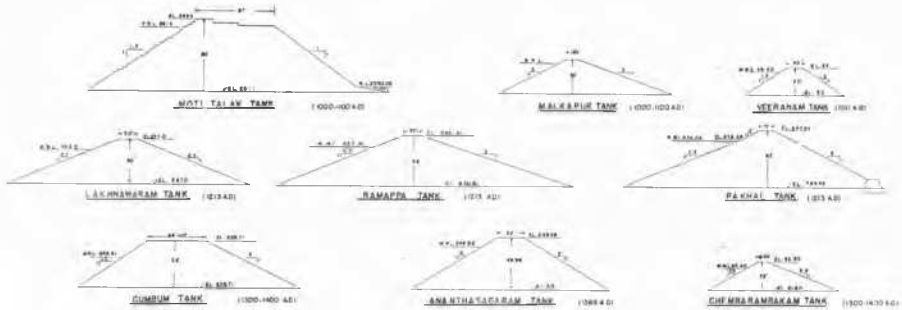
Fig. 1

Cross sections of some ancient earth dams still in service are shown in Figs. 1 and 2. These dams are located in South India. Pakhal Lake, Ramappa Lake and Lakshnawaram Lake embankments were constructed in the time of the kings of the Kakatiya dynasty in 1213 A.D. The reservoirs formed by these embankments have storage capacities of 3 400 m cft., 5 400 m cft. and 2 100 m cft. respectively and serve to irrigate thousands of acres. It is stated that in the 17th century when the Kakatiya kings failed to pay tribute and money to the then Delhi Emperor, Pakhal lake bank was breached by the

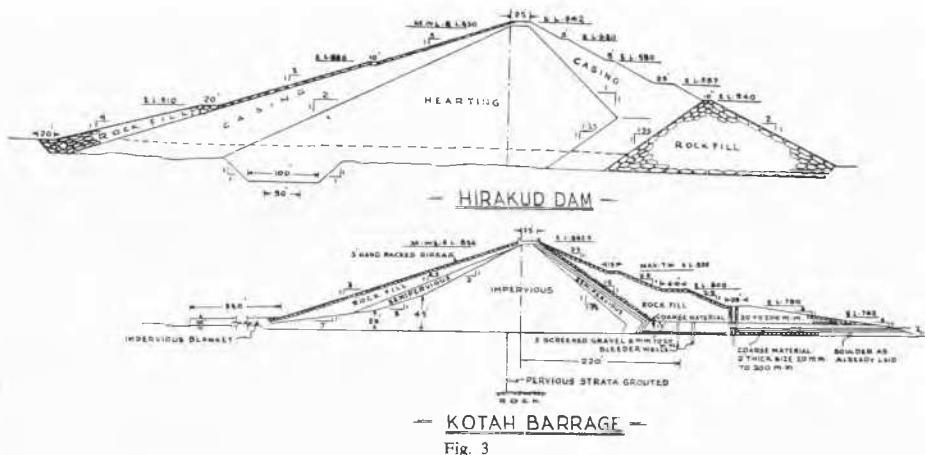
Fig. 3 shows sections of some recent earth dams built on modern concepts. The sections adopted are zonal. The top widths are small and the slopes generally vary from 2:1 to 4:1.
