# Present Soil Properties and Performance of the Arvo Dam During Twenty-five Years of Operation

by G. BARONCINI, Dr. Ing., Direttore delle Costruzioni della Società Meridionale di Elettricità, Naples, Italy  
and

A. CROCE, Prof. Ing., Incaricato presso l'Università di Napoli, Direttore del Centro Geotecnico della Fondazione Politecnica del Mezzogiorno, Naples, Italy

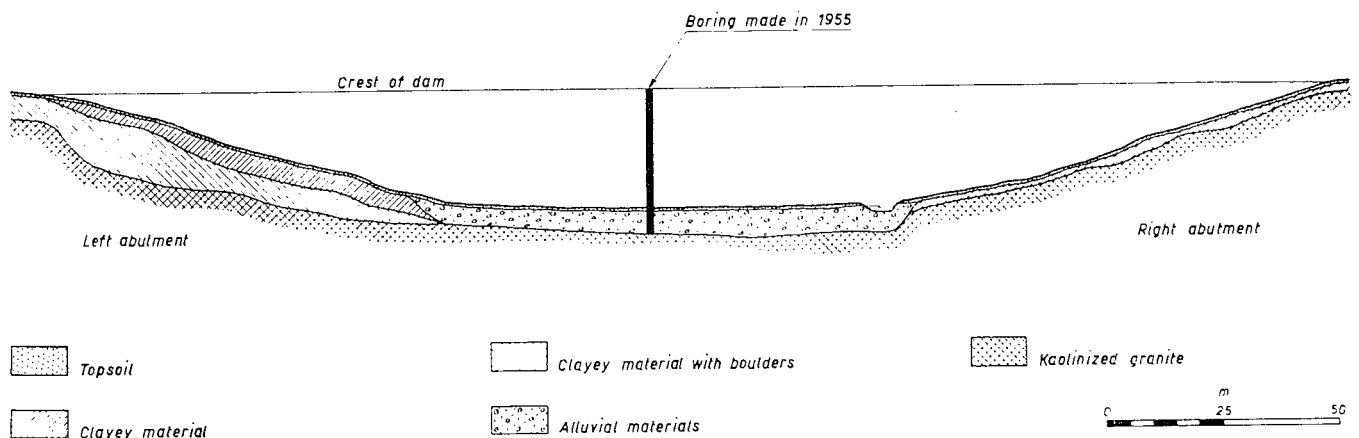
Fig. 1 Foundation materials. Profile on axis of dam  
Terrains de fondation. Coupe longitudinale

This is the general character of the high plain and it is typical of the site at which the dam was constructed (Fig. 1). The formation of decomposed granite was found to be very uniform; however, during the excavation of the cut-off trench, water came from the sides of the excavation in many places, but the total quantity was not large.

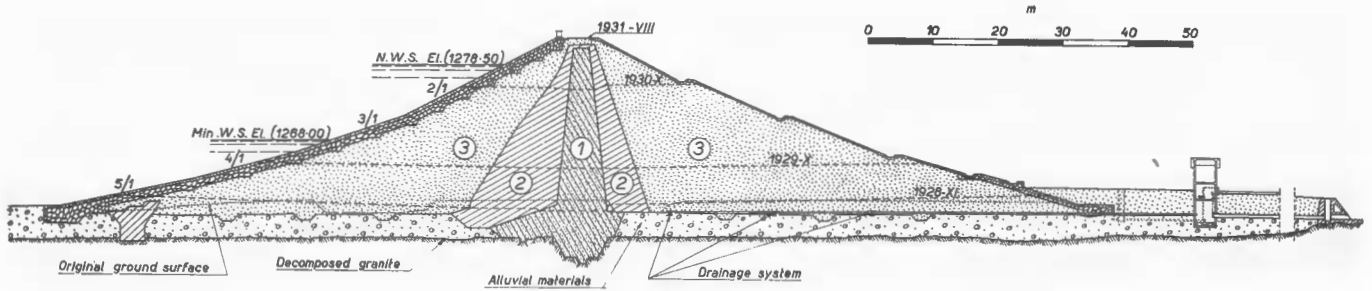
Fig. 2 Typical cross-section of dam  
Section type du barrage

The dam (Fig. 2) has a central core of clayey material of low permeability (Fig. 3, material 1). Coarse grained materials were used in the construction of the slopes (Fig. 3, material 3). Between the core and the external slopes two symmetrical zones were formed of materials having intermediate characteristics.

The strata *a* and *b* were in that part of the embankment constructed at the end of the construction season in 1929 and the stratum *c* was in the part of the embankment constructed at the end of the next season. Since the placement area was sloped downward towards the core (Fig. 2), during the two periods of inactivity water from rain and melting snows increased considerably the moisture contents of the surface stratum. When work was resumed in the spring, these wet

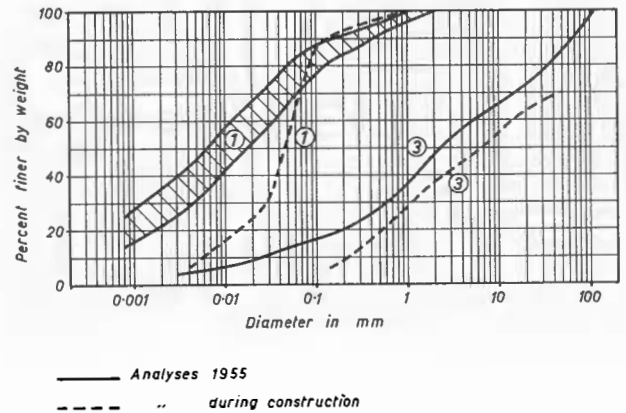
Fig. 3 Grain size distribution  
Courbes granulométriques

The grain size distribution of material 'B' is shown in Fig. 3. The average values of the Atterberg limits are  $PL = 0.25$ ;  $LL = 0.41$ ;  $PI = 0.16$ ; the values of  $LL$  range between 0.37 and 0.46. On the Plasticity Chart (A. Casagrande) the material 'B' is represented by a short and narrow band between the inorganic clays of medium plasticity and the inorganic silts of medium compressibility.

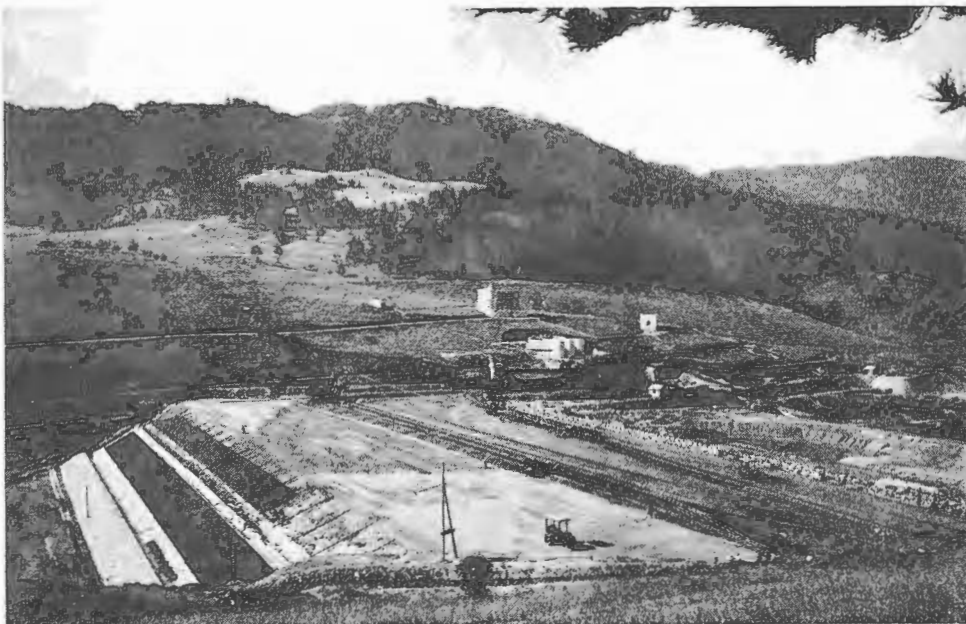
Fig. 4 The dam during construction, from the left abutment  
Le barrage pendant la construction; vue du côté gauche

in dump cars on an industrial railway (Fig. 4); they were spread by hand in layers 20 cm thick in the core and 30 cm in the remainder of the cross-section. Oversize stones were also removed by hand. Rolling and watering proceeded simultaneously; the water content used was that amount necessary to give the material a degree of consistency described as 'normal consistency'. This standard probably depended entirely on the judgment of the engineer.

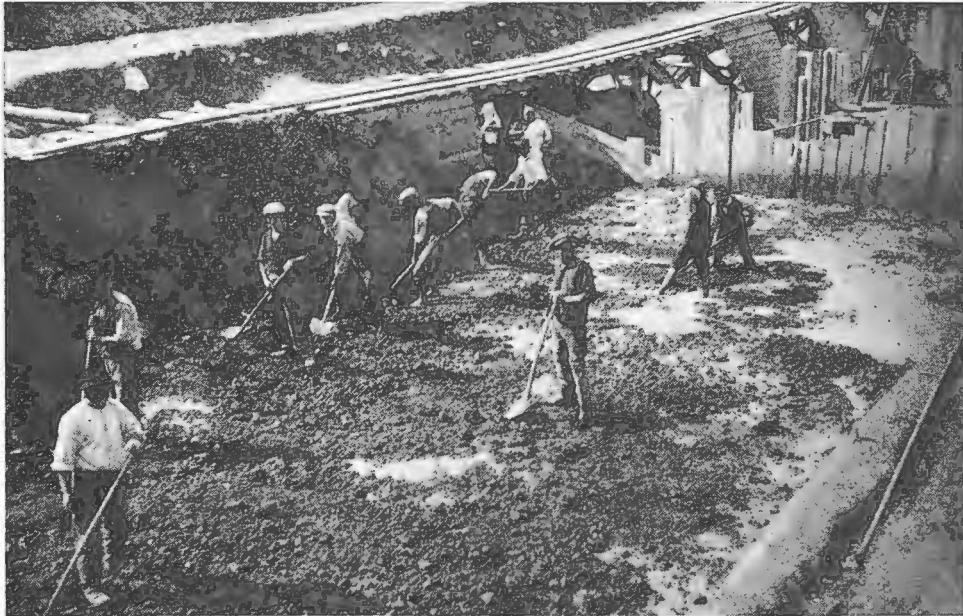
Fig. 5 Filling the cut-off trench  
Remblayage de la tranchée de parafouille

In filling the cut-off trench a different procedure was used. Because of the seepage mentioned previously it was not possible to use the rollers. The materials were distributed by the workers, mixed with the water and finally left undisturbed for some time (Fig. 5).
