Earth Movement Investigations in a Landslide Area on the Bosphorus

by H. PEYNIRCIOĞLU, Ord. Prof. Dr. Ing., Technical University of Istanbul, Turkey

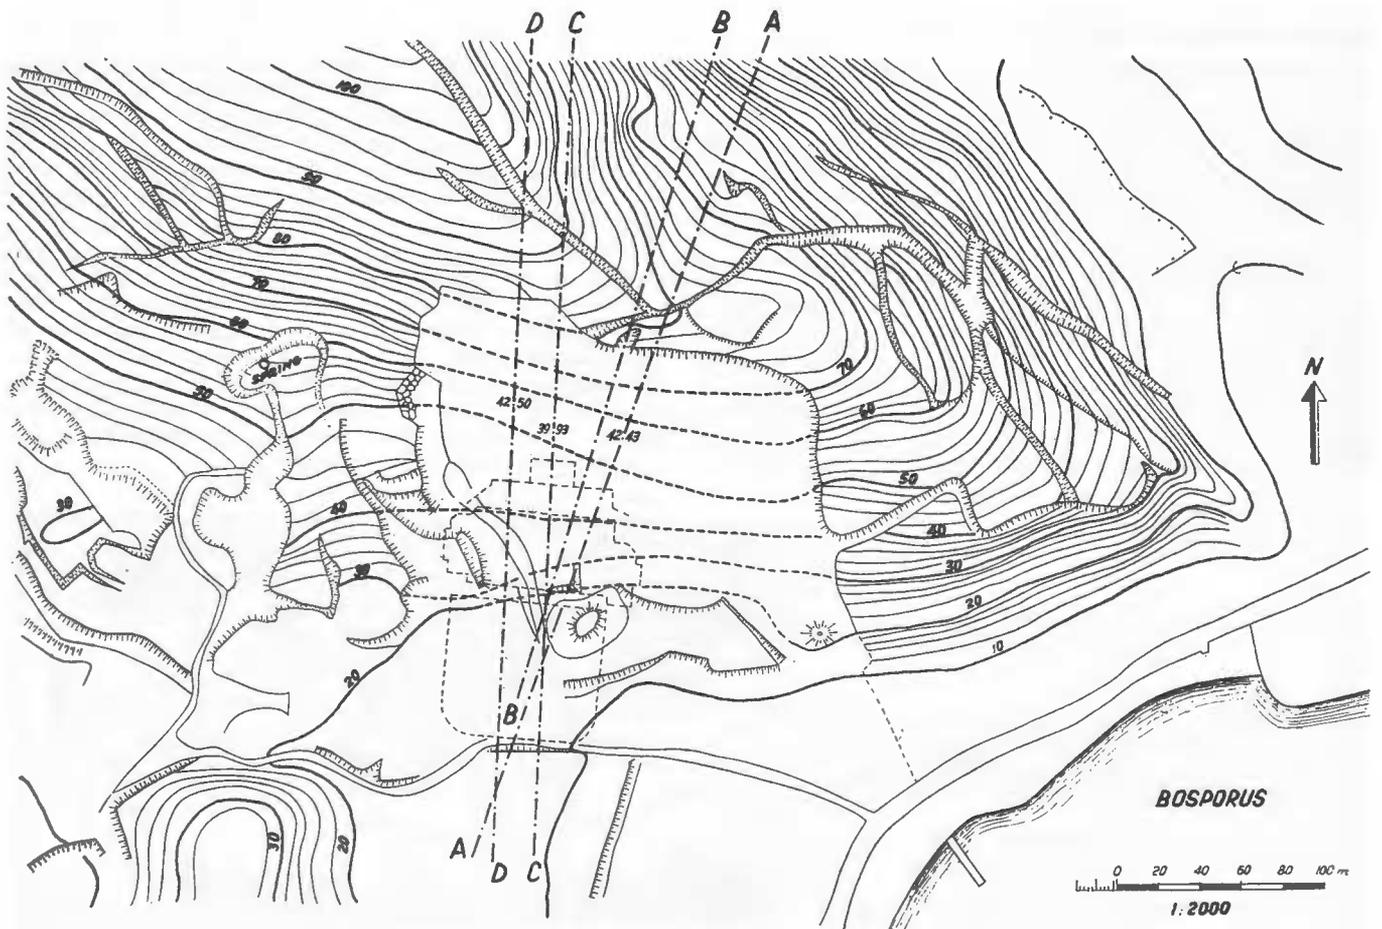
A great number of landslides occur in the area shown in Figs. 1 and 2. This area has been mined for clay for more than 50 years. In Fig. 2 a new system of landslide caused by recent excavations at the foot of the hill is marked by *B*. The site of the new brick and tile factory buildings is marked by *C*. This area had been excavated before as shown in an older map of the area, Fig. 3. The average depth of this first excavation at the site was about 20 m (Figs. 4 and 5).

Fig. 2 Landslide area seen from the place marked by *A* in Fig. 1
 Zone de glissement vue du point *A* de la Fig. 1
