Behaviour of Recent Earth Dams and Levees in India

by K. L. RAO, Dr, M.Sc., Ph.D., M.I.C.E. (London), M.I.Struct.E., M.I.E. (India), Member, Central Water and Power Commission, New Delhi, India

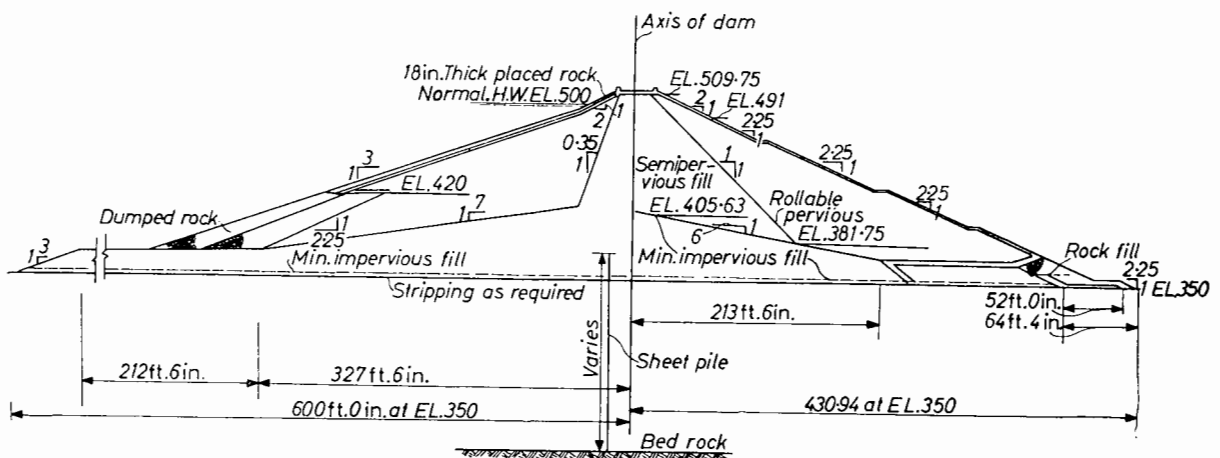
Fig. 1 Typical section—Maithon Earth Dam (DVC)
 Section typique du barrage en terre à Maithon

D.V.C. Dams—Panchet Hill on Damodar and Maithon on Barakar (Bihar) are 132 and 162 ft. high respectively. In both cases the river portions are closed by earth dams. The depth to rock in the river bed is 70 to 80 ft. and the intervening layers are pure sand. Prevention of seepage and piping were the major problems to be dealt with. The section adopted for Maithon and Panchet Hill Dams are shown in Figs. 1 and 2 respectively. After considerable controversy whether to adopt sheet pile cutoffs or upstream blankets, both were adopted.

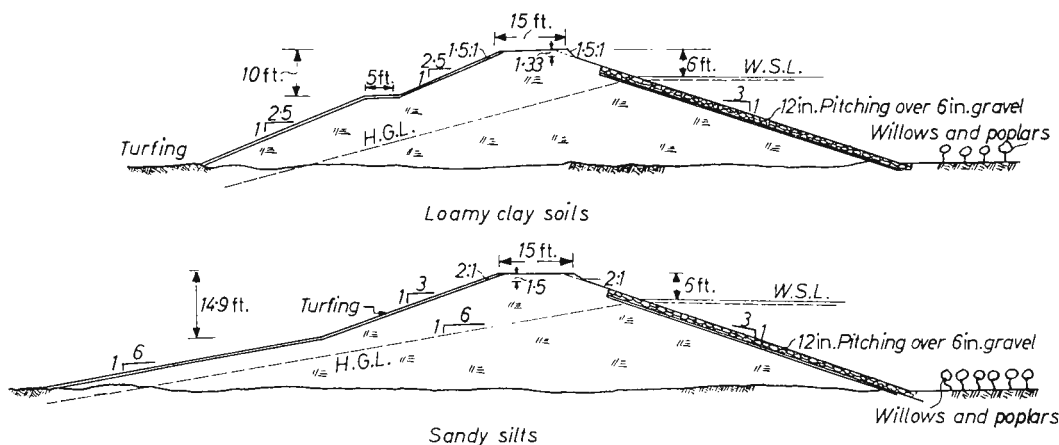
Fig. 7 Typical sections of flood embankments—Kosi River
 Sections typiques de digues contre les inondations—Kosi River

but also to confine its course, preventing its lateral movement. Kosi river is notorious for changes of its course, and during the last 100 years it has shifted nearly 75 miles to the west. There are various reasons for this which include steep gradients, excessive coarse silt, and lateral slopes, etc. The remedial measures undertaken consist of the construction of a barrage and 150 miles of embankment protected with spurs in reaches of excessive velocity. In most of the reaches of the river sand is the only material available for the construction of the banks. Clayey material has to be transported from long distances. Sections adopted are shown in Fig. 7. It is believed that unless the banks are attacked directly by the river causing erosion at the toe, they would be safe.
