CONSTRUCTION OF MUIRHEAD RESERVOIR, SCOTLAND

JAMES A. BANKS, O.B.E., M.I.C.E.

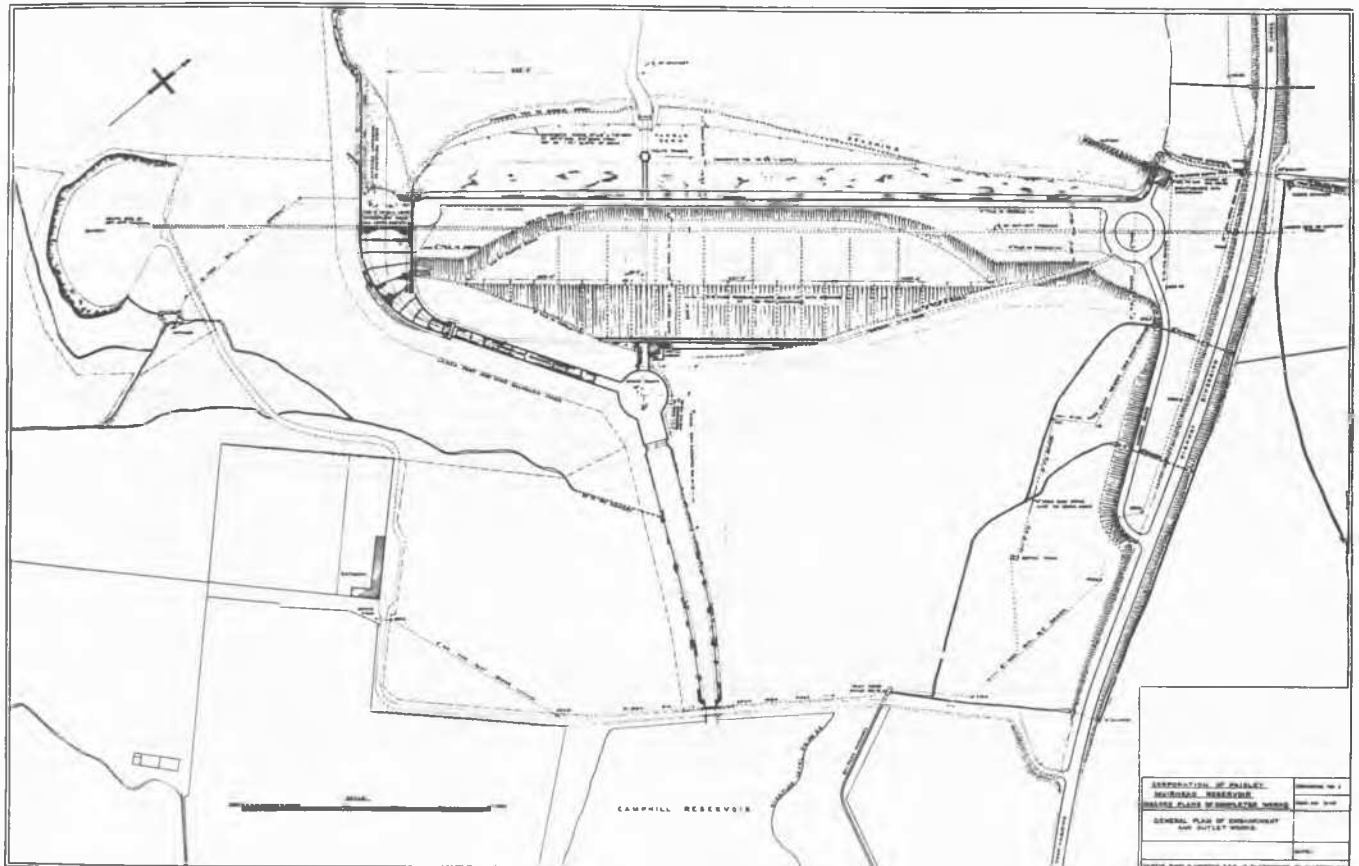
DRAWING 1

The original design of the dam was on orthodox lines. The outline in so far as it did not conform with the ultimate profile was as shown by dotted lines and omitting the upstream berm in the typical cross section in Drawing 2. Stone rubble walls formed the toes of the slopes. The upstream face was pitched with stone and the downstream slope sown with grass. Drainage was provided in the outer half of the downstream side by a 2-foot layer of quarry

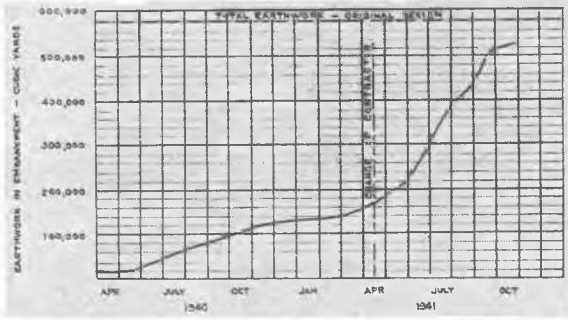
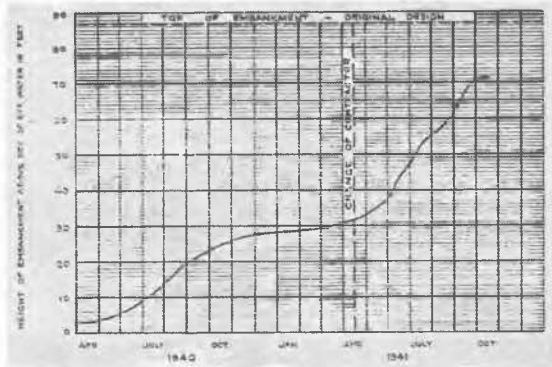
FIG.4

The rate of forming the embankment is shown in Figures 4 and 5. Operations commenced in April 1940 and the average rate of placing was about 3,300 cubic yards per week until April 1941, at which date approximately 170,000 cubic yards had been placed, or about 30 per cent. of the total anticipated quantity of 580,000 cubic yards. Wartime industrial needs made it essential to accelerate progress, and to achieve this the existing contract was terminated by agreement and a new contract was let with another firm of contractors who had more adequate resources in both labour and plant. Thereafter an average rate of about 16,000 cubic yards per week was maintained for the ensuing 5 months until mid-September 1941 when a total of approximately 500,000 cubic yards had been deposited, the maximum quantity deposited in one week reaching the peak figure of

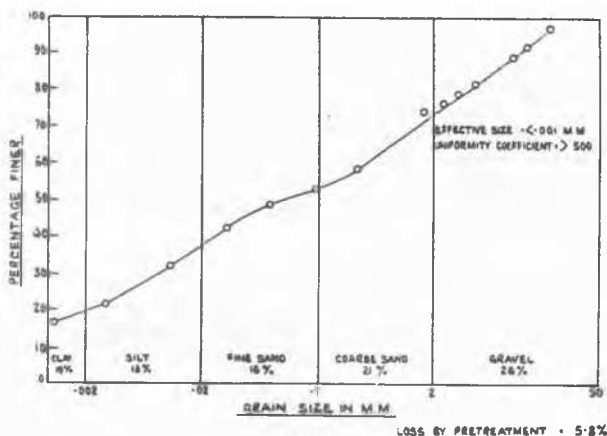
FIG.10

42.6 average and plastic limit 17.8 average. The Proctor maximum dry density was 116 lbs. per cubic foot. The mechanical analysis of the material is given in Figure 10.

Mechanical analysis of banking material

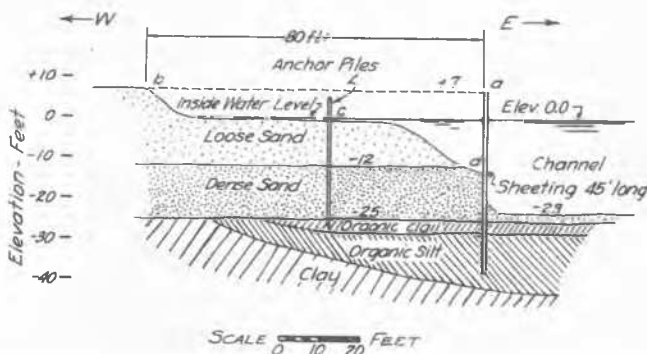
FIG. 1

Conditions prior to the slide are shown in Figure 1 which represents a cross-section through the dock wall. The outer face of the dock consisted of sheet piles 45 feet long. To the east of the sheet-pile wall was a canal with its water level at El. 0.0. The channel was maintained by dredging to El. -23. On the west side of the sheet piling the surface of the ground had a constant level at El. +7. A row of anchor piles 30 feet long was driven vertically at a distance of 40 feet from the sheet piling and was tied to it by means of steel rods at water level.

The material between El. +7 and El. -12 consisted principally of loose sand deposited by means of a hydraulic dredge. Most of this fill was pumped out of the channel during the construction of the dock. Between El. -12 and El. -25 was a natural deposit of beach sand

Conditions before slide
