ANALYTICAL STUDIES OF PANAMA CANAL SLIDES

WILSON V. BINGER

Chief, Soils and Geology Branch, Missouri River Division, Corps of Engineers,  
Department of the Army, United States of America

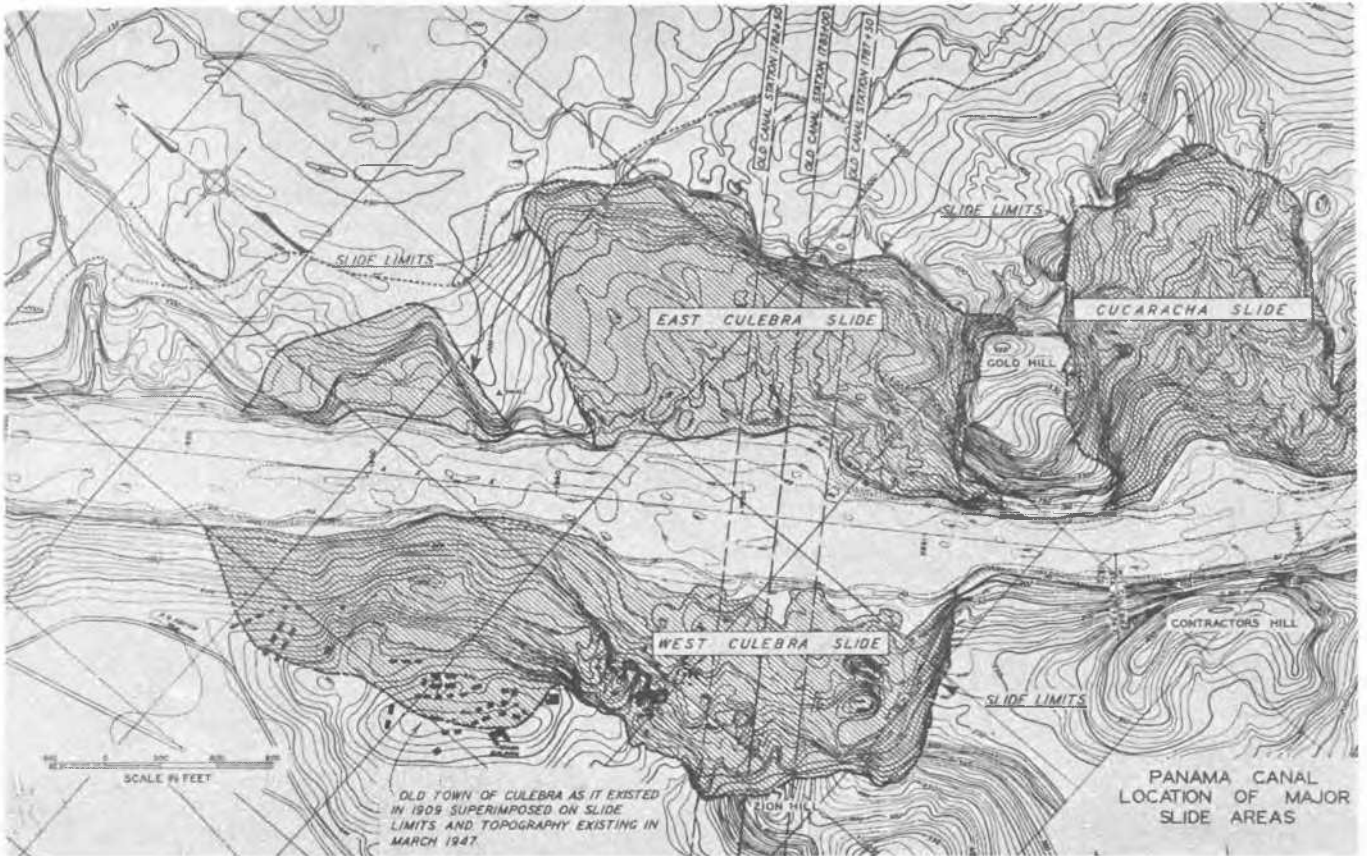
FIG.1

Of all the Panama Canal slides, the most disastrous were the great East and West Culebra Slides, the locations of which are shown on Figure 1. These two slides alone contributed more than 50,000,000 cubic yards of additional excavation to the task of building the Canal. On January 1, 1916, their areal extent was 70.5 and 60.8 acres, respectively. Figure 2 gives some indication of their destructive nature. In this paper will be described certain analyses of these two slides, the results of which were used in the design of slopes for an improved Panama Canal.

Panama Canal location of major slide areas.

For use in the analytical study, canal cross sections showing the monthly progress of excavation during the construction period were available. Three sections were selected for study at the locations shown on Figure 1. The geology, as determined from drill holes and surface reconnaissance in the area, was then plotted for each section. By the use of these cross sections, together with topographic maps of the period, it was possible to determine the ground surface as it existed at dates preceding each slide movement.
