UNDERPINNING AND UNDER-DRAINAGE TO CHECK EARTH SLIDING AND SETTLEMENTS

AT A LARGE CEMENT PLANT

Carlton S. PROCTOR

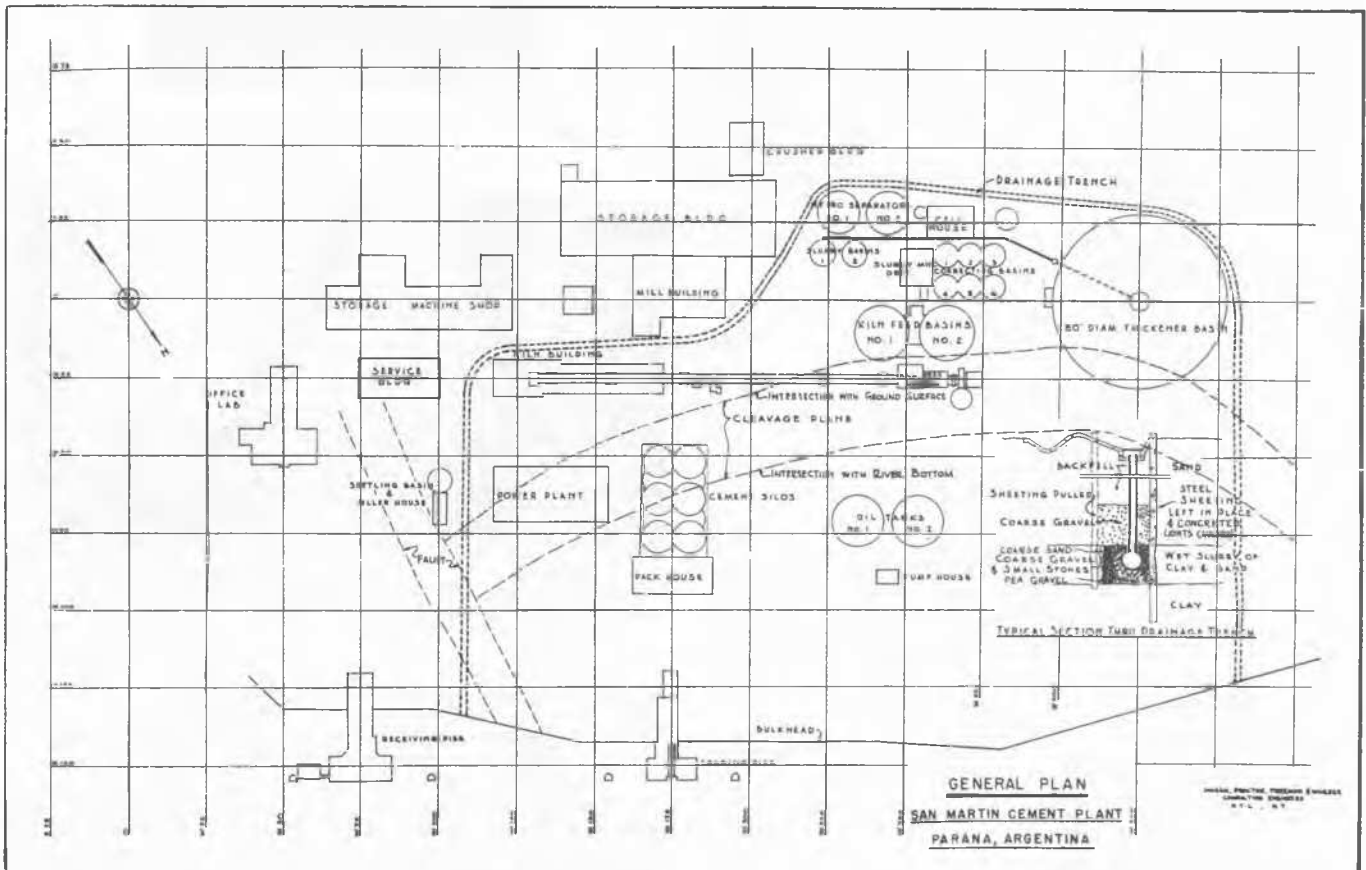
FIG.2

Hence, careful investigation of Paraná City records were made, and many of the oldest residents were interviewed, and it was discovered that about a hundred years before, when the river bank at the plant site had outlined a semi-circular cove, limestone had been quarried from the side hill by a stoping or undercutting method that had caused the overlying sandstones and clays to shear off and to fill in the cove.

The new plant grades had required up to 30 feet of fill above the top of old fill. The boundary between the original fill and the natural soil followed the approximate shape of a spheroidal surface. Therefore a condition obtained that was conducive to a rotational slide, and such a slide did occur over the entire filled area.

Fig. 2 is a plan of the plant site.

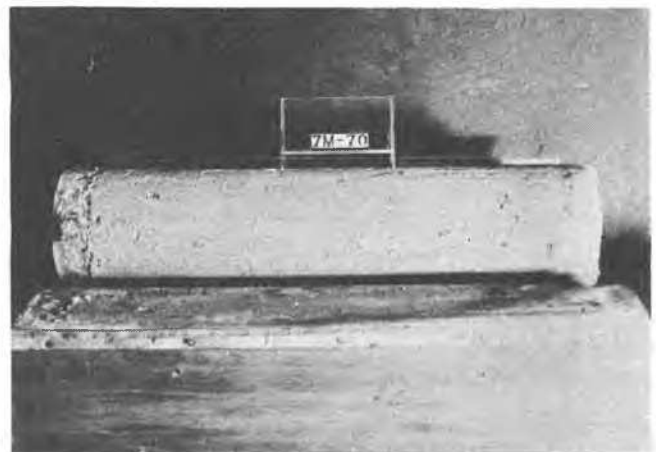
FIG.2

Dennison sample after casing was removed.
