# DKSField investigation of liquefaction-induced damage due to the 2016 Meinong earthquake in the Shi-Din area of Taiwan

**ABSTRACT:** The M 6.4 Meinong earthquake occurred at 3:57:27 a.m. local time on 6 February 2016 in Taiwan (19:57:27 on 5 February 2016 UTC). The earthquake, which took place just before New Year's Eve celebrations for the Lunar Year of the Monkey, killed at least 117 people. Liquefaction damage due to the earthquake occurred in the Shi-Din area in the Annan District of Tainan City. Damage observed in the area includes excessive soil boiling, lateral spreading of a sloped road, and tilting and settling of houses with shallow foundations. Soil profile in this zone is: the first 9m beneath the ground surface is consisted of loose sandy soils and silts with low SPT- N value, and followed by soft clayey soils and stiffer sandy layer to 20m depth. After the earthquake, houses built in continuous shallow foundation were found to experience maximum settlement 15 cm which is less than the ones built in individual shallow foundation experiencing the maximum settlement 120 cm and significant tilt. The main purpose of this paper is to document and analyze geotechnical pro

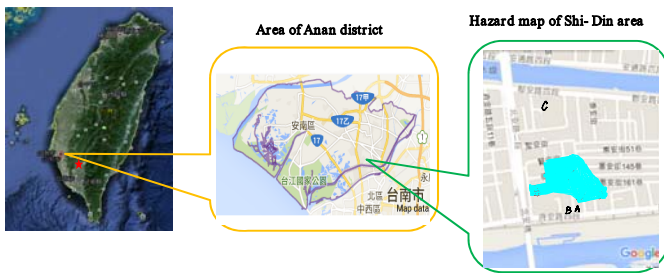
Figure 2 Location of the Shi-Din area and the hazard map (modified from Google map)

Most of the 2-to-4 story buildings in that area have shallow foundations and were built 30 to 40 years ago; these buildings experienced significant liquefaction-induced settlement. According to a borehole close by as shown in Figure 2, the upper 9 m of soil in the area consists of loose to medium density sand with a relative density of around 60% and a water table that is very close to the ground surface.

The distribution of liquefaction features, as evidenced by sand boils on the ground, is shown on the map in Figure 2. Observe that the Shi-Din area, which is about 4 km away from the present coast and surrounded by two major drainage systems on the northern and southern sides denoting the extend of a former marginally marine area, is the region that experienced significant soil liquefaction. The light blue area on the map denotes zones of significant liquefied soils found after the earthquake. Sand boils that spread out on the road are 1- 3 cm thick in general and in drains can reach thicknesses as great as 25 cm. Highlighted features marked 1 to 4 are discussed. Houses A and B and Building C, which experienced some damage are investigated and discussed in the following sections.

After detailed field investigations conducted by the author, five localities were identified (marked on the map in Figure 2). These localities, which are introduced below, are numbered in sequence from south to north and east to west. Two drainage systems go through the regions on the north and south sides, which results in substantial local concern regarding the soundness of the embankments bounding this drainage and focusing attention on assessments of these features.
