Reinforcement of Transportation Infrastructure, The Cable Car Network of La Paz (Bolivia)

Freddy Lopez

Friedr. Ischebeck GmbH, Ennepetal, Germany

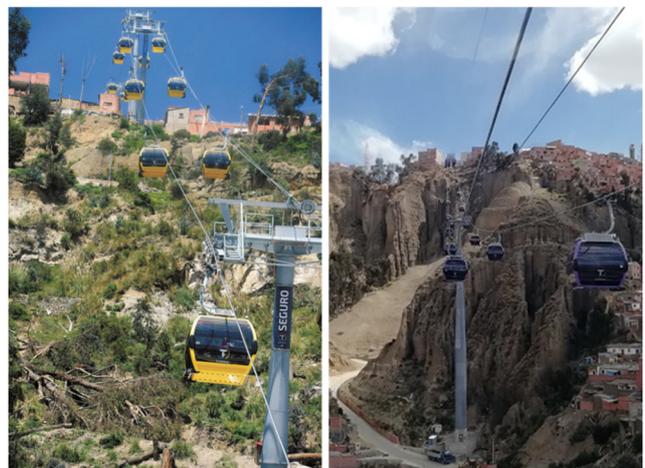
Several of the towers (pylons) in the network are located in areas, characterized by the same conditions discussed in this paper:

- On and / or nearby steep slopes
- Founded on the *La Paz-Formation*

Figure 10. Some examples of towers for the Cable Car Network (Left: Yellow Line / Right: Purple Line)

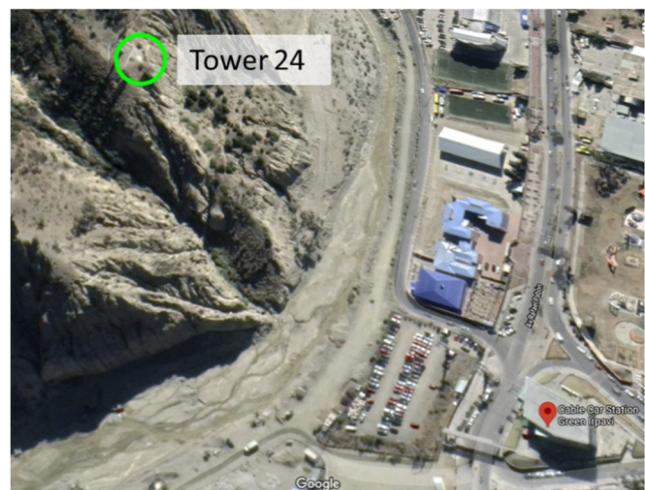
Figure 11. Plan view of the Tower 24 (Green Line)

Following the above-mentioned methodology, a slope stability analysis was conducted for the Tower 24 of the Green Line, located on a 43m-tall steep clayey cliff (Figures 11 and 12):
