Altos de la Estancia: a Large Landslide Area in Bogota, Colombia- History and Remedial Measures

Alvaro J. Gonzalez G.

Abstract

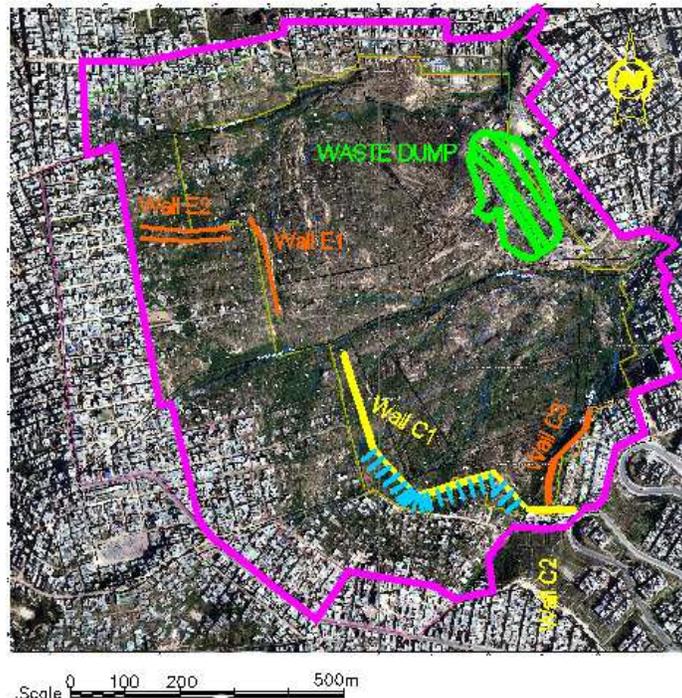
Figure 2- Altos de la Estancia - General Morphology

The landslide area is located in the mountainous poor district called Ciudad Bolivar and it has two large landslides: El Espino Landslide in the northern part and La Carbonera Landslide in the southern part, both limited by a central geological fault that runs along the Santo Domingo Creek (Figure 2)

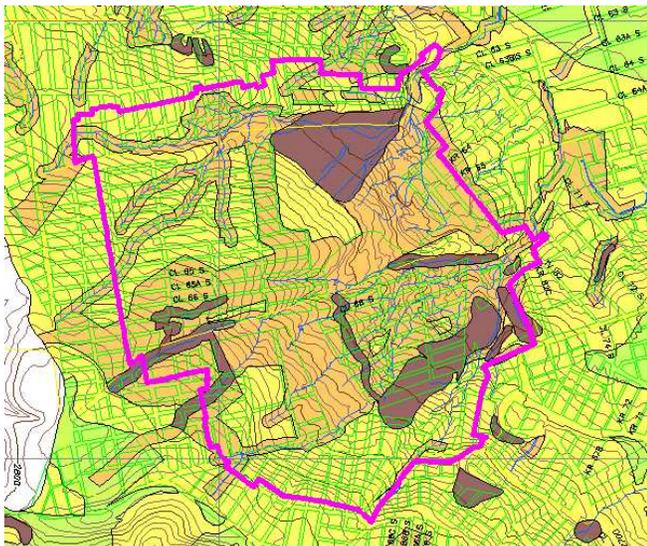
Figure 11. Altos de la Estancia Landslide Hazard Map (INGEOCIM, 1998)

Altos de la Estancia is located in an area with Landslide Hazard from Medium to Very High, according to the 1998 Bogotá Landslide Hazard map (Figures 10 and 11- INGEOCIM, 1998)

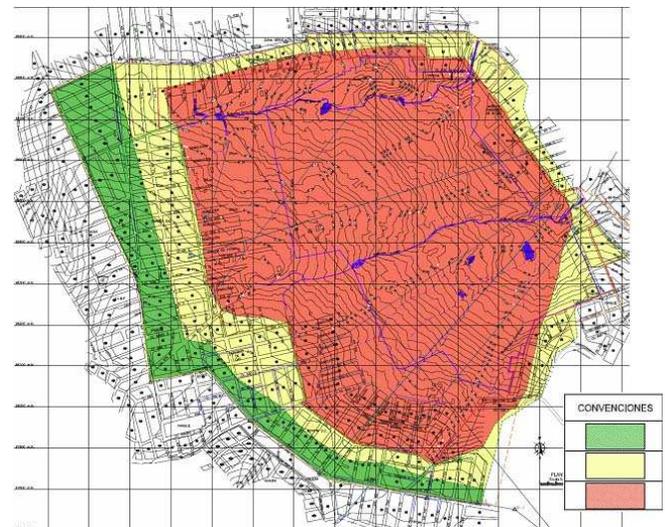
Figure 13. Altos de la Estancia Landslide Hazard Map (CONSORCIO ALTOS, 2008)

The landslide hazard maps by INGEOCIM (1998) and IGR (2004) were done with scales of probabilities of failure (the Author acted as Director of these two studies) and the CONSORCIO and CI AMBIENTAL maps were obtained with scales of factors of safety, all of them with earthquake and rainfall included. Therefore the effect of the remedial measures can be deduced by comparing these last two maps

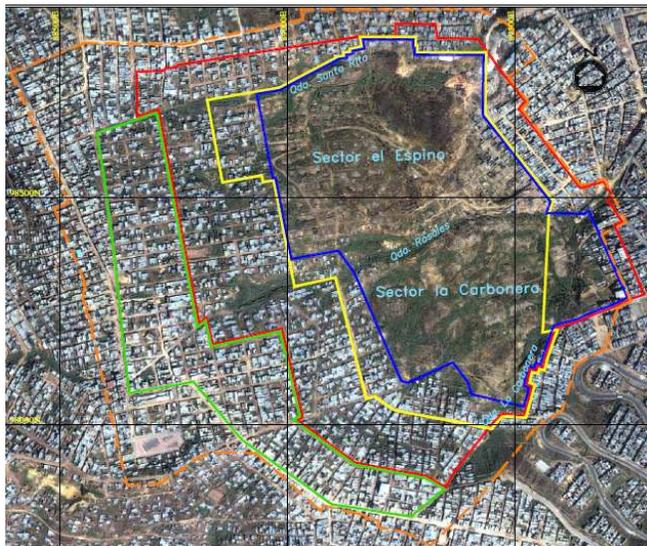
Figure 15. Altos de la Estancia –Evacuation Zoning Map (CONSORCIO ALTOS, 2008)

In this Figure 15, from 2007, the blue zone indicates the already evacuated area in that date, the yellow area the Priority 1 Evacuation Area and the red area the Priority 2 Evacuation Area, which now (2020) is almost completely evacuated. In total about 16,000 persons have been moved out of Altos de la Estancia
