The paper was published in the proceedings of the 11th International Conference on Scour and Erosion and was edited by Thor Ugelvig Petersen and Shinji Sassa. The conference was held in Copenhagen, Denmark from September 17th to September 21st 2023.

The role of gravel shoals on scour and erosion in the Yellowstone River during the 2022 flood event - initial observations

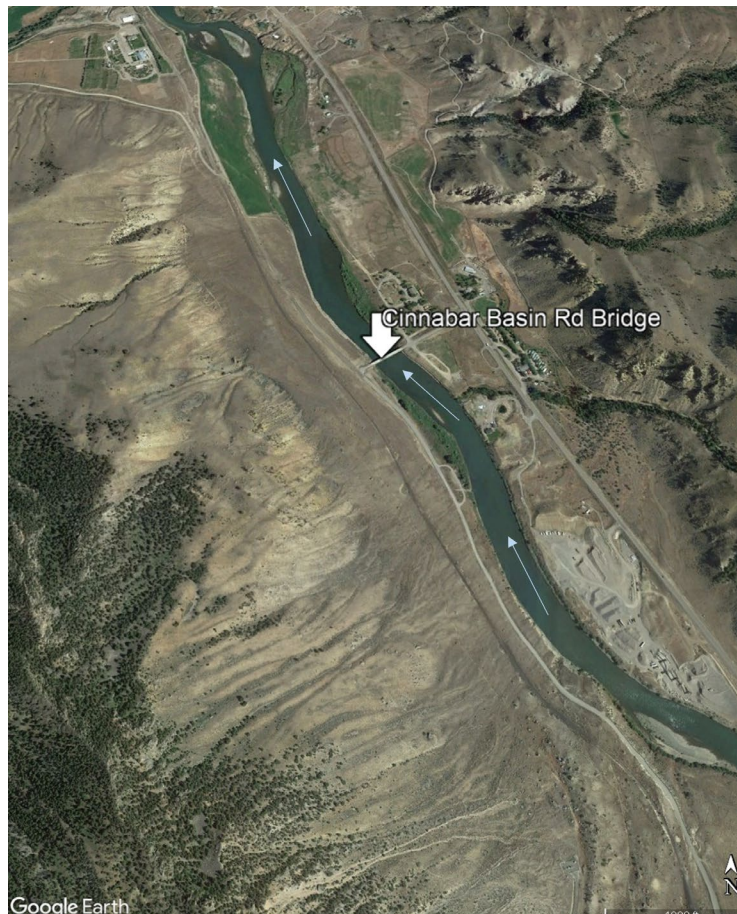
Figure 1. Google Earth Image of the Yellowstone River Cinnabar Basin Rd Bridge in Gardiner, Montana, with blue arrows indicating the flow direction from southeast to northwest.

the river cross-section in the shoal section increases flow velocities and discharge just upstream of the bridge and that increasing meandering directs peak flows towards the outer bend, i.e., the northeastern riverbank, abutment, and bridge pier upstream of the bridge. The bridge represents the transition point from a west bend meander to an east bend meander, directing peak flows just downstream of the bridge to the southwestern river bank, and possibly at an oblique angle at the bridge.

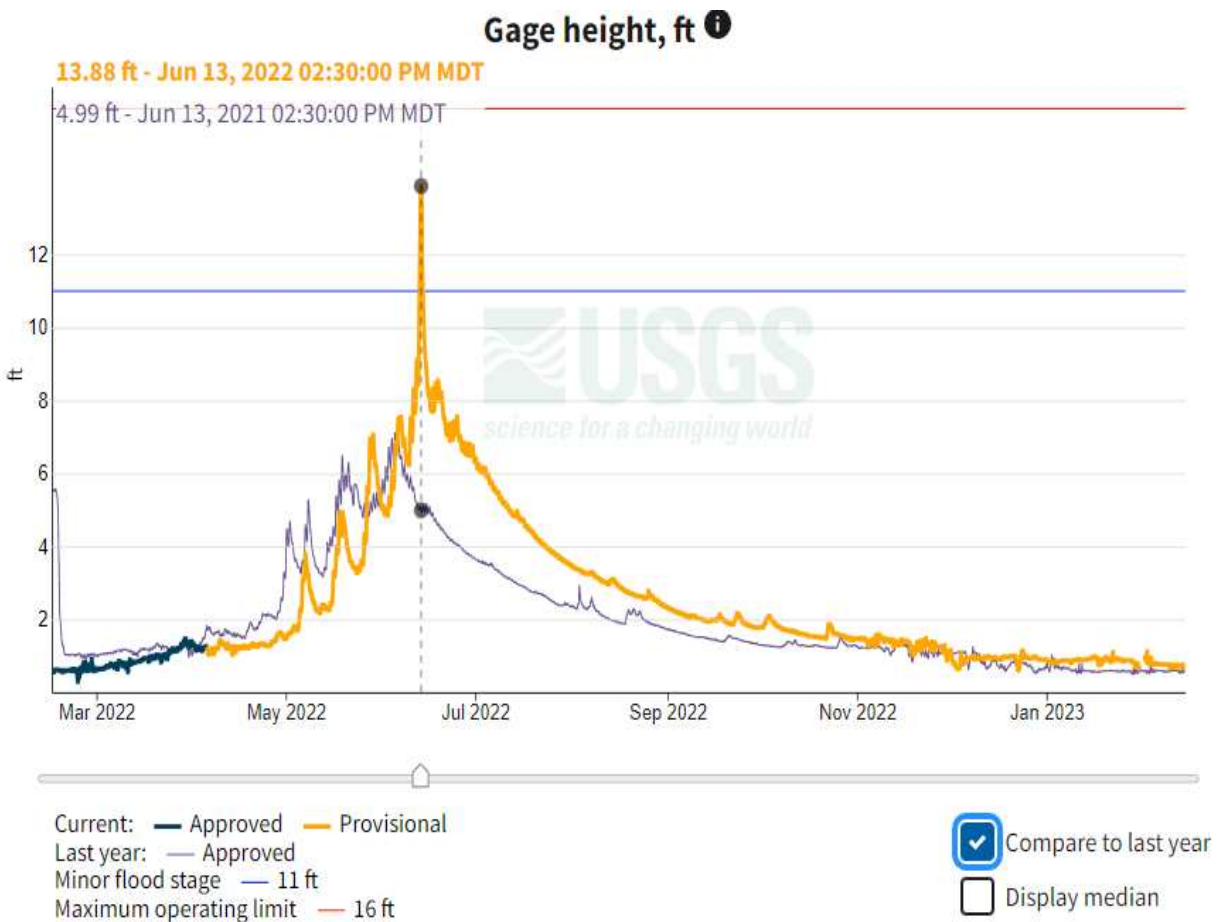
U.S. Geological Survey (USGS) gauge 06191500 is located in the direct proximity to the bridge (Fig. 2). It recorded a high water level of 4.23 m on June 13, 2022 compared to 1.52 m in the previous year. The discharge during the 2022 flood event peaked at 1339.39 m³/s.

Figure 2. USGS gage 06191500 data for Mar 2022 to Jan 2023 (orange) and the previous year (purple). <https://waterdata.usgs.gov/monitoring-location/06191500/>
