Forensic Geotechnical, Hydrological and Hydrogeological Analysis of Instability Phenomena Occurred at a Waste Management Centre

ABSTRACT

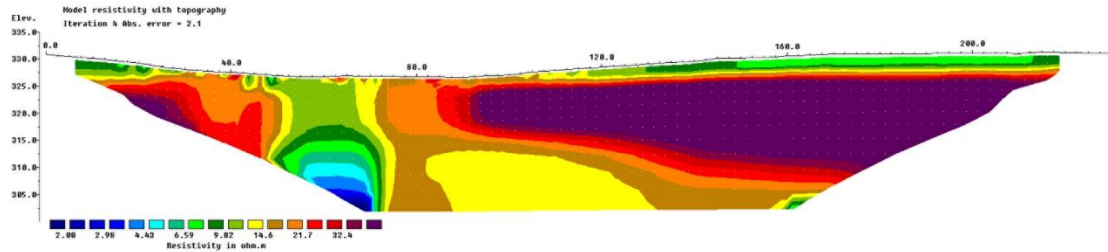
Figure 5. Inverse Model Resistivity Section

Within the site, a total of 11 electrical resistivity tomography (ERT) investigation profiles were conducted. The total profile length was approximately 2500 m. During the data acquisition phase for electric resistivity, the SYSCAL Pro Resistivity and IP device, produced by IRIS INSTRUMENTS, was used. The primary data was filtered to eliminate systematic errors using the ProSYS2 program, and subsequently the filtered data was modelled in the RES2INV program and the ERT-Lab1 program (Figure 5).

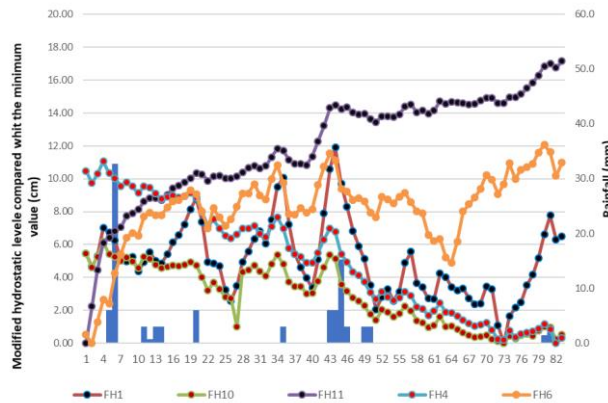
Figure 6. Groundwater monitoring data

5 hydrogeological wells were monitored during a period of 90 days (autumn - winter time). The groundwater level and temperature were monitored using automated pressure and temperature data loggers (Figure 6).

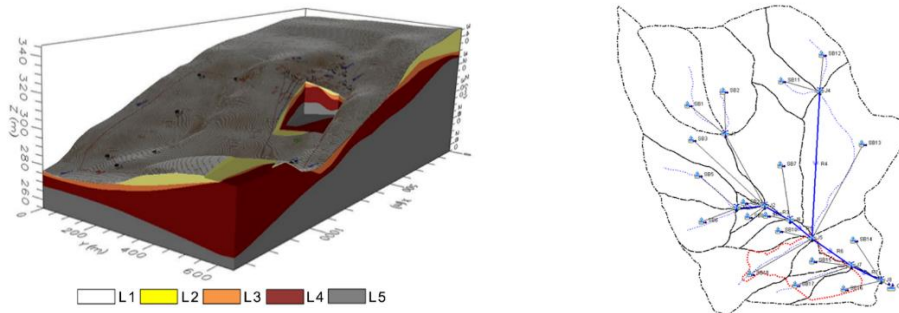
Figure 7. Geological 3D Model (left) and hydrological model scheme (right – with red line is the delineation of the WMC).

The geological model (Figure 7) has a rectangular shape, with the SW boundary set at a sufficient distance from the upstream limit of the WMC. Therefore, drainage works don't influence the boundary condition of hydraulic head imposed, as specified boundary condition within the hydrogeological model. The characteristics of the model are: (1) length $L = 1352.245$ m and width $I = 646.961$ m; (2) maximum ground elevation $Z_{max} = 350$ m. The minimum elevation of the model was set 5.70 m below the minimum elevation of the marl deposits determined by the study drillings, namely $Z_{min} = 255$ m.

Five layers were considered, from top to bottom: (1) L1-topsoil, (2) L2-silty clay, yellowish silty clay, yellowish-brown or greyish-brown, (3) L3-gravel with sand, with or without boulders in clay matrix, (4) L4-silty marl clay, yellowish-brown or greyish-brown silty clay marl and (5) L5-gray marl.

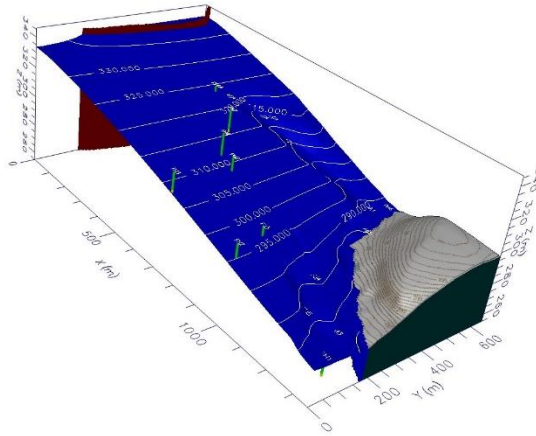
Figure 8. 3D representation of the groundwater table

Figure 8 below presents the 3D representation of the groundwater level in the area, while Figure 9 shows the groundwater after drawdown.
