# Site Investigation of Sinkhole Damage in the Armala Area, Pokhara, Nepal

R. M. Pokhrel, T. Kiyota, R. Kuwano, G. Chiaro and T. Katagiri

*Institute of Industrial Science, University of Tokyo, Japan*

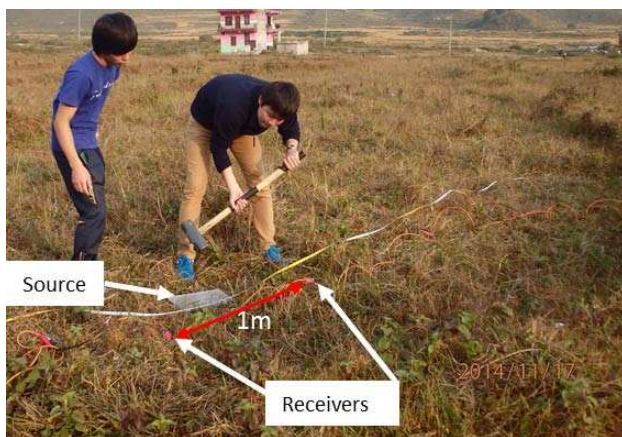
Fig. 6 Surface wave exploration method used in this investigation

As shown in Fig.2, surveys were performed along two different lines using surface wave exploration, for a total length over 250 m. The testing conditions consist of: 24 vertical-component geophones deployed with 1 m interval; and a 5 kg hammer used as a source of surface waves. Source was also moved with 1 m interval. The nearest source to receiver offset was 0.5 m. An OYO MCSEIS-SW was used for data acquisition. Fig. 6 shows typical surface wave exploration alignment used in this investigation.
