The Instability of Natural Slopes and the Reconstruction of Sabrosa Quay, in Douro River

A. Santos-Ferreira
DGRM, Lisboa, Portugal

ABSTRACT: Douro River is one of the Iberian Peninsula's largest rivers, crossing east to west Portugal's northern territory, being of the utmost importance for this region's socio-economic development. For thirty years the navigation in the Portuguese territory has been established with the construction of several dams, and fluvial quays have been built, as Sabrosa's fluvial quay, located in the right bank of Douro River. Sabrosa quay consisted of a 100 m quay wall, flanked with a gabion wall. Recently, deformations were detected at the quay's foundation ground, as well as heavy gabion corrosion. A geotechnical study of the area's natural slopes identified instability issues in some areas. This information was included in the rehabilitation design. The solution consisted, taking in account the instability mechanisms identified for the involving slopes, in the design of a new quay wall consisting in a tied-back sheet pile wall with a total quay length of 410 m, 119 ground anchors in a single row, horizontally spaced by 3 meters, was used. This solution

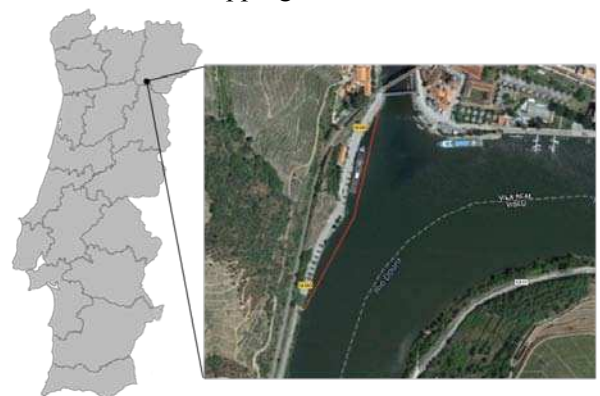
Sabrosa's fluvial quay is located in the right bank of Douro River, northern Portugal (Fig. 1). In the same figure is also presented the original quay layout and the rehabilitation proposal.

Fig. 1 Sabrosa's fluvial quay location, actual layout and proposed layout (marked in red)

This new quay will have a parallel orientation regarding the right bank of Douro River (Fig. 1).

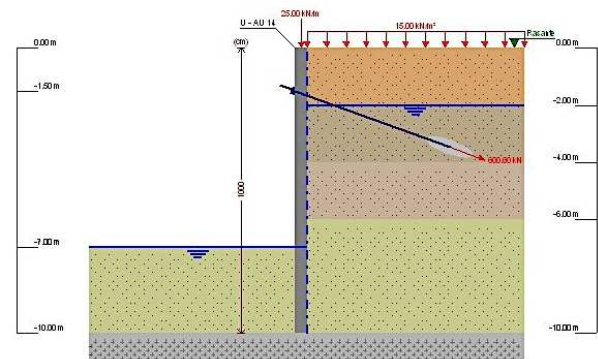
Fig. 6 – Design section for maximum water level difference for both sides of the sheet pile wall (anchor is schematic, not at scale)

As showed, two design sections were analysed; in the first one, the considered water level difference for both sides of the sheet pile wall was 6.0 m and in the second one the water level difference was 0.00 m. This analysis aimed the identification of the most unfavourable situation.

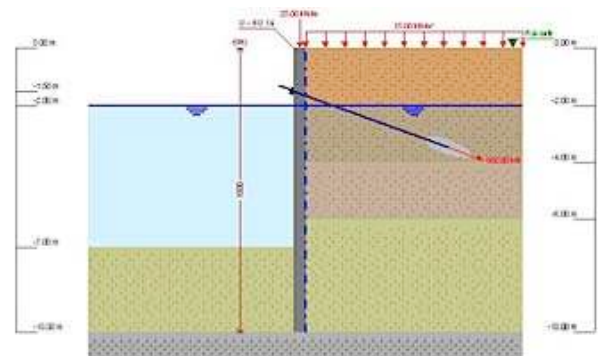
Fig. 7 –Design section for no water level difference for both sides of the sheet pile wall (anchor is schematic, not at scale)
