Investigation on Slope Failures Caused by the 2018 Northern Kyushu Torrential Rainfall, Japan

Takashi Fujishiro

Hemanta Hazarika

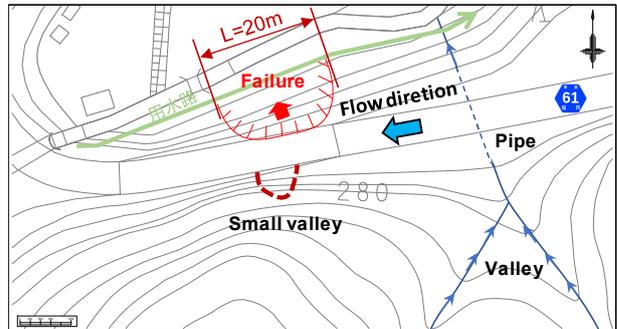
Figure 10. Topographic map around the failure slope [7]

The topography of the slope failed land is a parallel slope on the side of the ridge topography and does not show a typical water collection topography. The slope on the mountain side of the road is an untreated cut slope, and a part of the slope failed horseshoe-shaped depression (valley-like landform) is seen.

Slope failure has occurred in embankments and cliff deposits. On the left side of the landslide slope, erosion marks due to water leakage from the broken road gutter are seen.

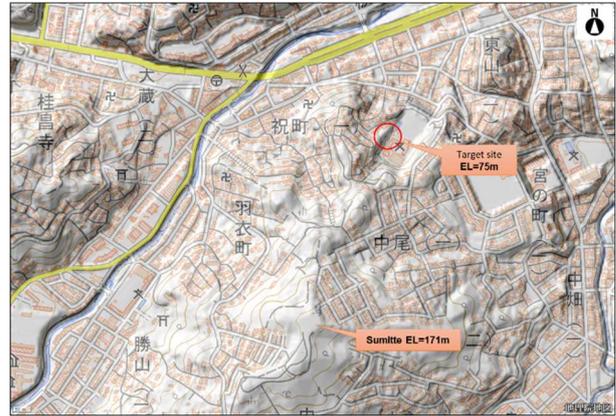
Figure 13. The topographic map around the failure slope [5]

Fig. 13 shows the topographic map around the target site, Fig. 14 shows the aerial photograph, and Fig. 15 shows the photograph and sketch of the failure slope. The failure slope is located in a low mountainous area with small undulations where residential land development has progressed, and on a straight ridge topography. In the borehole survey, fresh rock mass has not been confirmed, and there is no outcrop nearby, so the relationship between geological structure and topography and failure is unknown. Since it is located on the east side of the ridge topography and surface water is not easily collected, it is thought that the influence of surface water on the collapse is small.
