# Application of CPT to investigation of abandoned shallow coal workings, and their remediation by grouting

S. Fityus<sup>1</sup> L. Bates<sup>2</sup>

**ABSTRACT:** CPT testing was carried out before and after the grouting of abandoned shallow coal mine workings to understand the conditions of the workings and to infer the extent of underground voids that were filled with grout during their remediation. The site, with 2-3m of coal extracted by bord and pillar workings from between 10 and 13m depth, has a recorded history of widespread surface subsidence and ongoing potholing over the more than 100 year period since mining ceased. Prior to grouting, from 3 CPTs and three drilled boreholes, there was no evidence of open voids, indicating that collapse of the workings was extensive. The CPT was found to be a poor differentiator of subsurface conditions in this instance, failing to clearly differentiate intact roof from subsided roof, or between subsided roof and goaf. Despite the phreatic surface lying only 4-6m below the surface, pore water pressure data was inconsistent, fluctuating unpredictably between positive and negative values. Generally, negative pore pressures were recorde

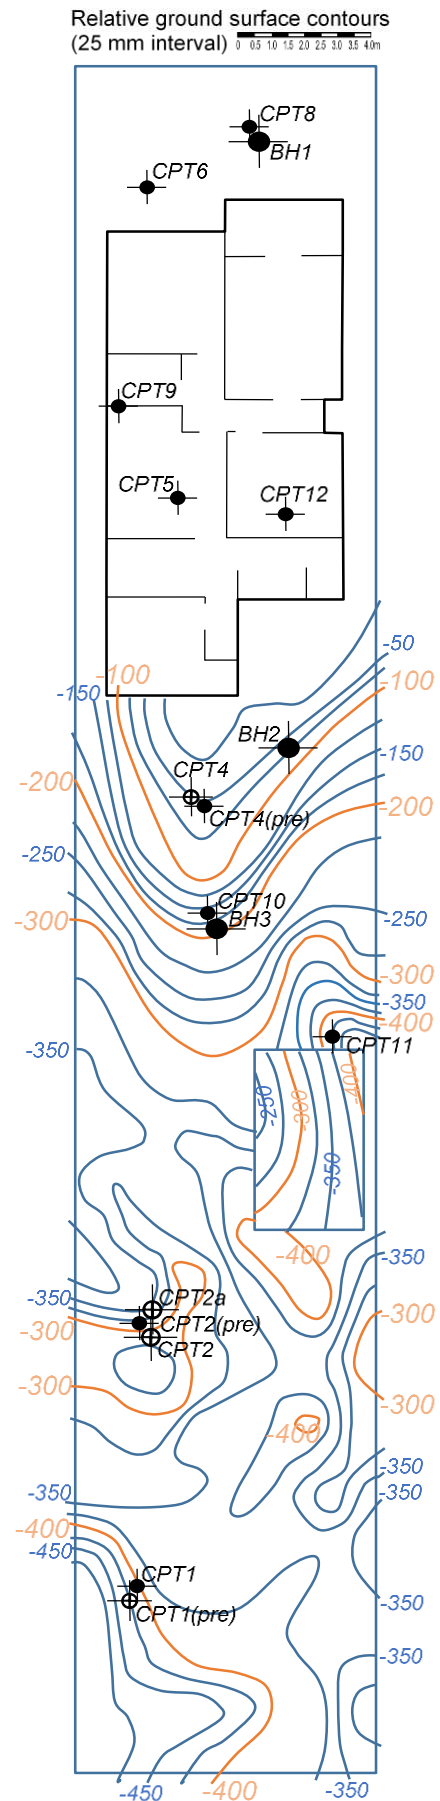
**Figure 7.** Site map showing the location of the house (prior to demolition) and the test locations. The contours show relative ground surface levels (in mm) prior to the site being regraded.

The layout of CPT tests is shown in Figure 7, relative to the position of the (former) house on the site. The positions of drilled site investigation boreholes (including BH1; see Figure 4) are also shown.
