Reconnaissance survey on earthquake-induced failures of ground composed of volcanic materials in Hokkaido, Japan, during the 2018 Hokkaido Eastern Iburi earthquake of Mw=6.6

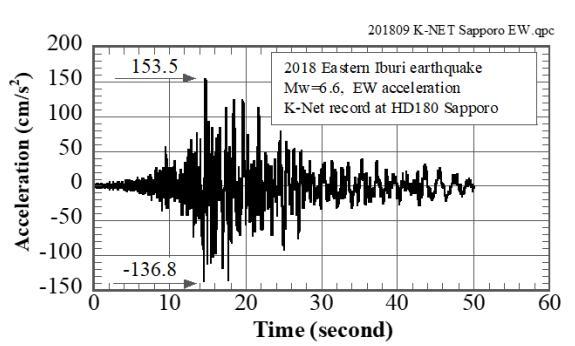
The 2018 Eastern Iburi earthquake affected Sapporo City. Fig. 4 indicates the K-Net acceleration record at HKD180 station in Sapporo City. This station rests on a very thick soft soil and the maximum acceleration in EW direction was 153.5 cm/s², whereas the maximum value in the NS direction was 142.8 cm/s². The JMA seismic intensity in Sapporo was 5+ out of the maximum value of 7. When the earthquake happened, the first author was staying in Sapporo City for business and was able to immediately commence damage reconnaissance.

Figure 4. Acceleration record at K-Net HKD180 Station in Sapporo resting on thick soft subsoil.

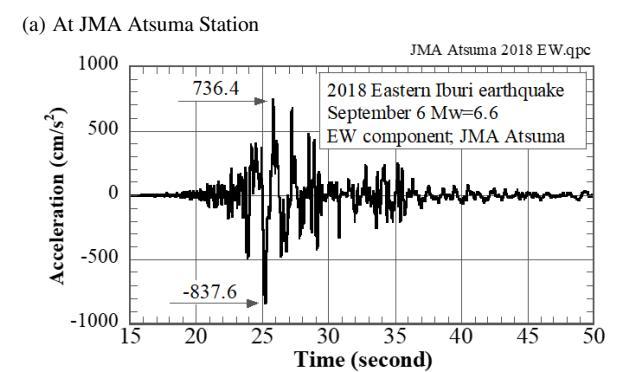
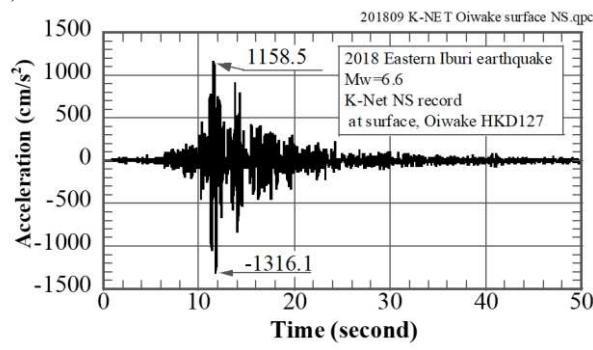
Figure 8. Acceleration records in and around Atsuma Town (out of EW and NS data, the stronger component was plotted at respective site).

where g stands for the gravity acceleration. This formula suggests PGAs in Fig. 8 to be equivalent to K=0.32 and 0.37. For this range of seismic coefficient, $c_u=15.3 \text{ kN/m}^2$ gives the factor of safety less than unity, being consistent with the observed slope failure. Note further that $c_u=5.8 \text{ kN/m}^2$ was obtained from H/L of failed slopes without considering the seismic inertial force. Therefore, the plot for this c_u value is reasonable only for K=0 which is indicated by a bigger triangle (∇) in the figure. Then, the factor of safety=0.53 at K=0 is not unrealistic for the seismically failed slopes.

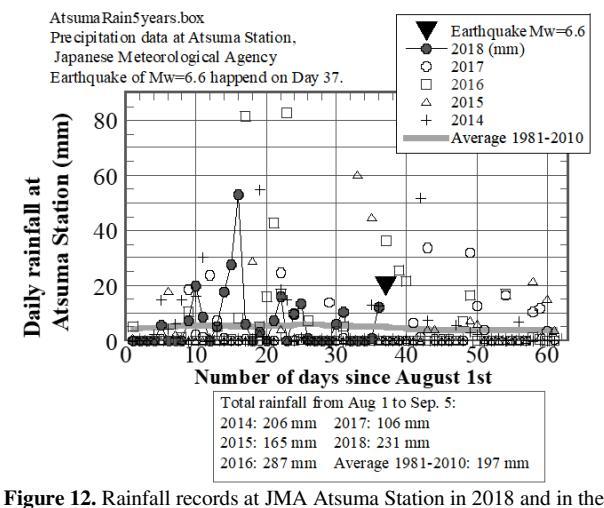
the shear strength of the soil, making sliding easy above it. Fig. 11 shows the appearance of one of the head scarps where ground water was still coming out two days after the disaster. This water probably corresponds to the perched water (Table 1) that was produced by antecedent rainfalls (Fig. 12).

It is possible that the antecedent rainfall affected the slope instability. In this perspective, Fig. 12 presents the JMA rainfall record in Atsuma. The earthquake happened on the 37th day in this diagram. In 2018, the significant rainfall was recorded in mid August due to a typhoon. Afterwards, several precipitation events occurred. It appears that the amount of rainfall in 2018 did not signifi

Figure 12. Rainfall records at JMA Atsuma Station in 2018 and in the past years.

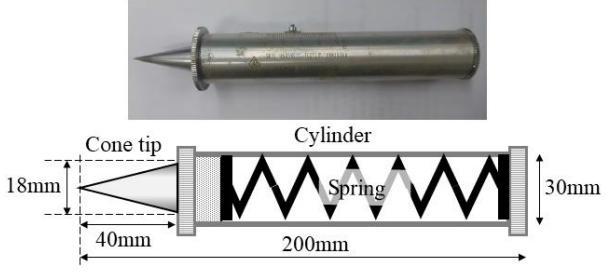
Figure 15. Schematic illustration of Yamanaka Soil Hardness Tester (Cone tip angle = 25.33 deg.; drawn after JGS Soil Testing Standard).

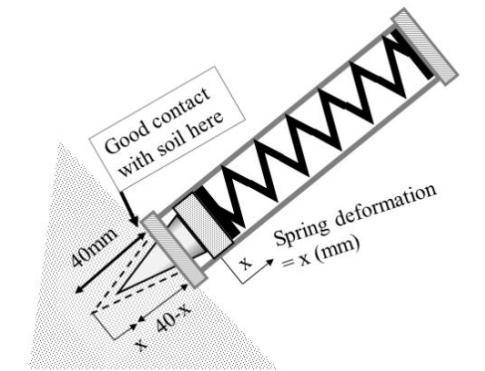
Figure 16. Use of Yamanaka Soil Hardness Tester at surface of slope

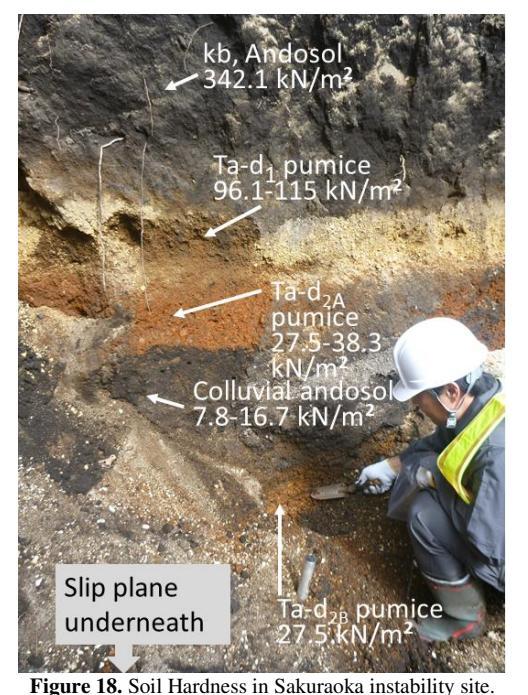
Soil hardness was measured in several failed slopes. At each point of measurement, data was taken 3 times and the mean value was kept in record. First set of data was obtained in Sakuraoka District. Fig. 17 clearly shows layers of volcanic materials parallel to the slope surface. The depth of the slide was approximately 2m here. Fig. 18 illustrates the distribution of P value in the lower part of the side wall. Generally, the P value decreases as going downwards possibly because of inundation in perched ground water. In particular, the lower part of the Tarumae-d₂ pumice layer exhibits very low strength. Under this layer, a slip plane was encountered above the upper face of the underlying Tarumae loam layer (Ta-Lm) in which the P value was 79.5 kN/m² (Fig. 19). Thus, slip happened at the interface between the overlying weaker and underlying stiffer layers.

Figure 19. Yamanaka Soil Hardness Test immediately below the slip plane in Sakuraoka instability site.

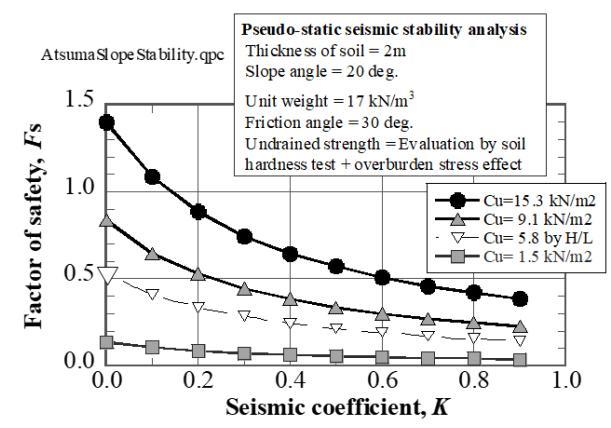
Fig. 25 illustrates the calculated factor of safety that varies with the value of seismic coefficient. The smaller values of c_u =1.5 and 9.1 kN/m² failed to give factor of safety greater than unity even under static conditions. c_u =5.8 kN/m² as assessed by *H/L* gave very small factor of safety as well. This is probably because the assessed strength corresponds to the state of flow which occurs after large distortion of soil. In other words, this strength corresponds to the residual strength after the peak strength has been achieved and softening has occurred.

In contrast, the preset study with $c_u=15.3$ kN/m² is able to demonstrate a possibly realistic factor of safety, which is greater than unity under static condition and becomes less than unity under some value of seismic coefficient, *K*. Although it is difficult to determine a particular value of *K* that is relevant to the measured maximum acceleration (*PGA*) in Fig. 8, an empirical formula on the basis of seismic damage case histories of harbor strucutres may be useful [13];

Figure 25. Seismic factor of safety varying with pseudo-static seismic coefficient.
