Remedial measures to facilitate the construction of stable bridge approach fills: A case study

V. Diyaljee

ABSTRACT: The proposed construction of a north-south log haul road from Secondary Road (SR 686) to North of the Little Cadotte River was to form part of the roadway infrastructure requirements for the proposed Daishowa Pulp Mill in Peace River, Alberta. This paper deals primarily with stability issues associated with the Cadotte River crossing. After the construction of 5 m of the proposed 20 m high bridge approach fill in November 1988 deep seated movements were noted at a depth of 22 m below the original ground from monitoring of slope indicators on the north approach. Remedial measures consisting of wick drains, stone columns, flatter approach fill head and sideslopes, and interceptor drains were then implemented. However, as a result of the movements that were taking place at depth it was decided to abandon the proposed 3-span bridge and construct a one-span Bailey bridge. This paper addresses the geotechnical investigation, evaluation and assessment of the bridge approach fills and the remedial measures implemented to minimize the movements.

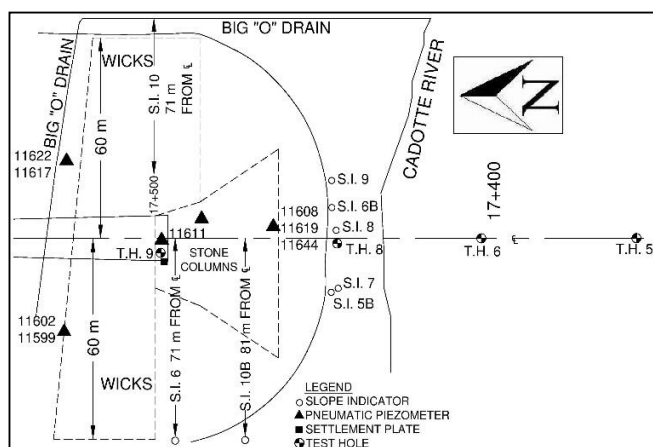
Figure 2. Testhole, Instrumentation & Trench Drain Location

For the bridge approach fills and foundation assessment four (4) testholes were drilled. These holes are referenced as TH 5, 6, 8, and 9 and located as shown in Figure 2. Testhole drilling was undertaken using an auger rig with capabilities of coring using a

Prior to the placement of the bridge approach fills slope indicators and pneumatic piezometers were installed to aid in the monitoring of fill construction. Piezometers were installed at locations shown in Figure 2 to a maximum depth of 9 m below existing ground. No deeper installation was undertaken at that time since it was not perceived that movements, if they were to occur, would be deep seated. Slope indicators were, however, installed to a depth of 26 m although the first installation (SI 2) on the south side was terminated around 13 m since very hard ground was encountered. The decision to install the inclinometers to 26 m was based on the observation of the variability of the clay shale with depth from the testhole logs.

Trench (French) drains with Big-O drainage pipe were installed as shown in Figure 2. During excavation of these trench drains seepage zones were observed along the walls of the trenches from gravel and sand layers. The majority of flow, however, was associated with a lower gravel layer which appeared to be co-incident with the base of the beaver ponds.
