Site investigation, monitoring and stability analysis of a built-up slope involved by gas pipeline explosion

ABSTRACT: The paper describes the results of site investigations, monitoring and stability analyses of a built-up slope located near Pineto (Italy). In March 2015 the explosion of a gas pipeline in the upper portion of the slope caused extensive damage to existing buildings and lifelines. Soon after the event, a site investigation and monitoring program was planned. The site investigation included 3 boreholes (25-30 m depth) and 3 flat dilatometer tests DMT (15 to 30 m depth) carried out inside the boreholes by use of the "torpedo" system. The boreholes were instrumented for inclinometer and piezometer measurements. A detailed topographic survey was carried out to reconstruct the ground profile. Hydrological data were analysed for possible critical rainfall events. The slope is formed by OC clay, covered with an upper, 10-14 m thick clayey-sandy silt colluvial layer. The stability of the slope was analysed both in pre- and in post-explosion conditions. The pre-explosion conditions were back-analysed assuming different levels of the groundwater table (at the time of the expl

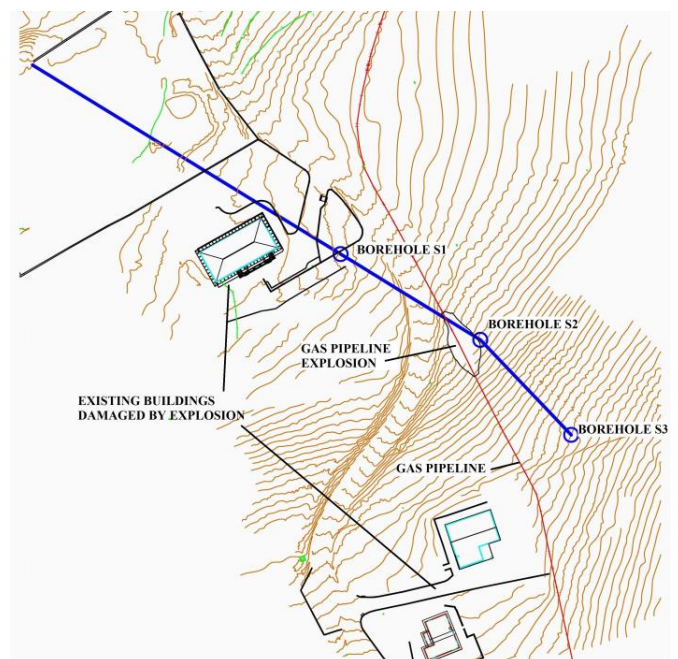
A site investigation and monitoring program was planned soon after the pipeline explosion (Figure 5).

Figure 5. Plan layout of boreholes and DMT tests.
