# Case study importance in geotechnical engineering - educational approach

A.Popa, V. Farcas & N. Ilies

## 1 INSTABILITY CAUSES FOR SHEET PILE WALL IN CLUJ NAPOCA – BAUMAX PLATFORM

## 2 VERIFICATION OF THE STABILITY FOR A SHEET PILE WALL (TANGENT PILES) ON KAUF LAND -ZALAU

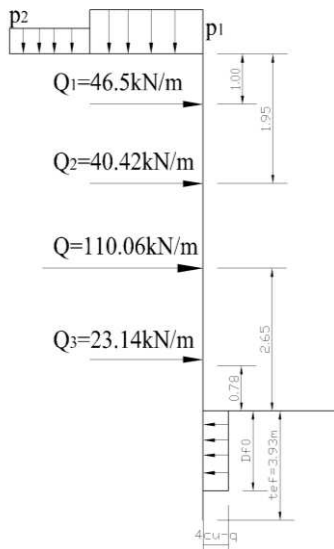
In case A,  $t=7.43\text{m} > t_{ef}=5.29\text{m}$  and in case B,  $t=3.10\text{m} < t_{ef}=5.29\text{m}$ . For more than 2 m earth cut height and 2 m width situation, because that lateral support is missing rotation movement get started which lead to redistribution of reaction diagram on the wall. Diagram of resistive efforts became from a rectangular one, a triangular one on the fixed support length, Figure 4. It resulted overturning of the wall until the remobilization of the entire passive resistance of the ground in front of the wall.
