# **Proposal of Japanese Geotechnical Society for More Reliable Installation of Prefabricated Piles**

**Ikuo Towhata<sup>1</sup> and Hiroshi Furuya<sup>2</sup>**

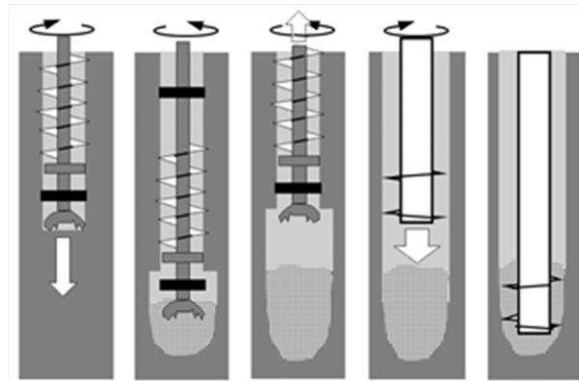
**Figure 2. Construction sequence of prefabricated pile foundation (Drawn after JSCA)**

The depth of the bearing layer is an essential information for successful installation of prefabricated piles because, different from driven piles, it is difficult to directly confirm the existence of firm layer during pile construction (Fig. 2). Moreover, if the bearing layer is found deeper than the estimation during pile installation, additional pile has to be manufactured and connected to existing piles, which creates additional time and cost. Hence, care must be taken in advance of the depth of the bearing layer which may be different from pile to pile. This is particularly so near the hill slope where the soil profile is highly variable. In spite of these situations, the present practice does not pay sufficient attention to the importance of soil profile information. Efforts are needed to improve this unsatisfactory situation.

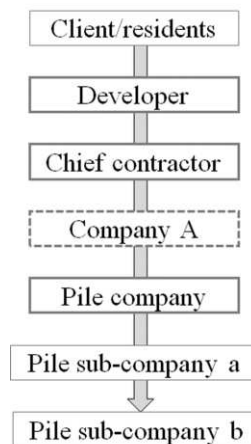
**Figure 3. Multi-storied subcontract structure of project**

The committee proposed measures to avoid repetition of the same problem in future. First, it was pointed out that the multi-storeyed structure of construction industry (Fig. 3) makes unclear the responsibility. The chief contractor should take the due responsibility of the entire construction procedure, including foundation. However, it was stressed that safety of buildings and abuse of data should be separately discussed. No final conclusion was reached on the situation of piles under the condominium building.

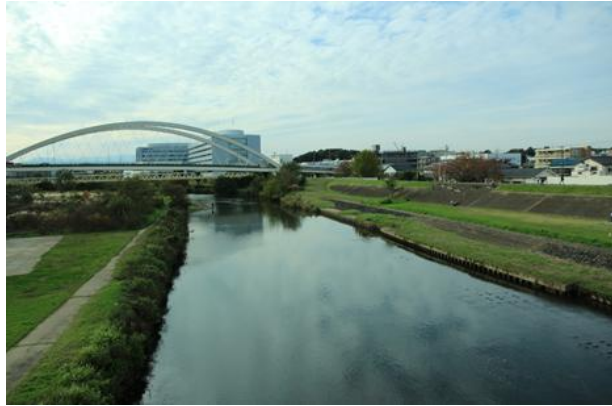
The site is situated in a shallow valley near a hilly terrain (Fig. 4). The valley is filled with very soft alluvial soil that was deposited by a river (Fig. 5). Because of the ancient erosion procedure, the bearing layer, which continues to the nearby hill slope, is not horizontal. Its depth varies from place to place by the order of meters (Fig. 6). The data in this figure was obtained from a public data base but no bore hole data within the condominium site is released to the public.

**Figure 5. River whose soft sediments deposited in and filled the local valley**
