# Forensic Investigation of the Failure of a Marginally Stable Hill Slope

Priyanka Talukdar<sup>1</sup>, Ruplekha Bora<sup>2</sup> and Arindam Dey<sup>3</sup>

This paper presents the forensic study of the failure of an existing naturally stable stratified hill-slope, destabilized by seepage and sequential anthropogenic construction activities. The slope, located in the Umrangso region in the Dima Hasao district in the state of Assam, India, was initially in a stable state before any human intervention. However, the site had been chosen to establish various industrial manufacturing units which resulted in a massive mass movement of the slope where deformations were observed nearly approaching the toe of the slope with the progressive stages of construction. Concrete retaining walls constructed to arrest the mass movement did not serve the purpose of protecting the slope, rather added more weight leading to further destabilization of the slope. A forensic geotechnical investigation has been carried with the aid of field and laboratory investigations and subsequently aided by the development of a finite-element based numerical model. Field visits indicated multiple reasons related t

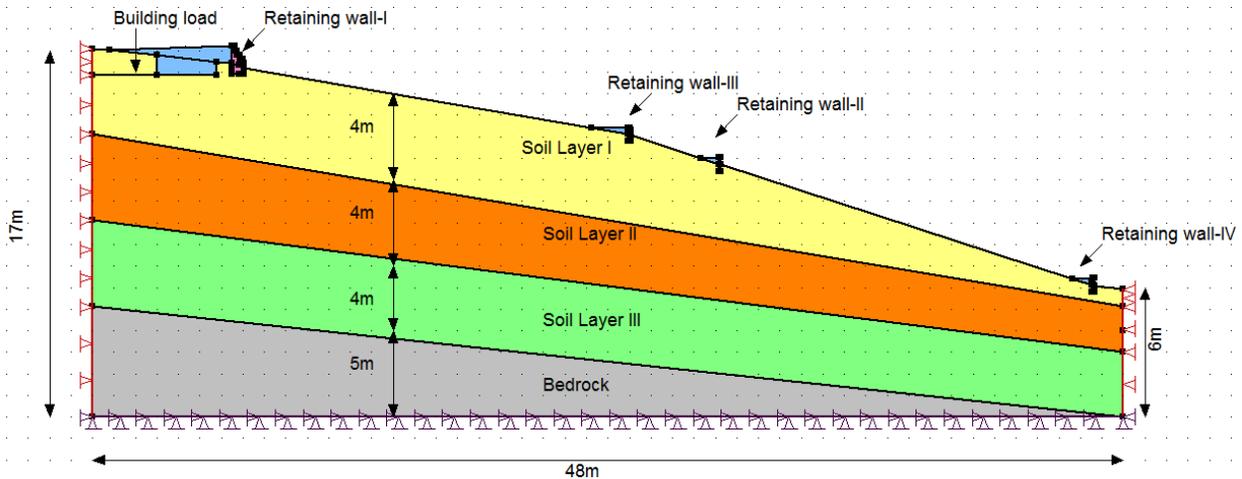
**Figure 7. Model slope for the present study**

Finite element modeling of the slope had been carried out to simulate the real field scenario, as closely as possible, to comprehend the failure triggering mechanisms. The critical slope geometry had been modeled in Geostudio 2007. A scaled-down model has been used wherein the actual horizontal field dimensions have been downscaled by 5, while the vertical dimensions are kept the same as that of the field scenario. Such scaling helps to generate the model stresses and strains at par with that developed in the field while the extent of the deformations in the horizontal directions as obtained from the simulation needs to be multiplied by 5 for obtaining the field extents. The entire soil depth had been classified into four layers among which the top three layers consists of soil varying in stiffness and the bottommost layer consists of impenetrable bedrock. The model of the slope for the present study along with its relevant dimensions is presented in Fig.7.

Figures 14 and 15 exhibit the deformation characteristics observed for the two most critical stages of construction (Stage 3 and Stage 6, respectively) with the identified slope geometry, soil stratification and the location of the phreatic surface and its intersection region in the slope. Supplement to Fig. 7, it can be observed from the deformation contours of Fig. 14 that a shallow slope movement with significant deformation extent has taken place at Stage 3 itself, when the building has been constructed. The deformation reached a depth of 4m below the ground surface and laterally extended up to 200 m from the building location towards the downhill of the slope. In order to arrest the movement originated due to the building construction, R1 was constructed with a foundation embedment depth of around 1 m from the ground surface.
