# Geotechnical perspectives of Failure cases in Head walls of Hume pipe culverts and their Forensic Investigations

Amit Srivastava<sup>1</sup> and Dharmendra Kumar Srivastava<sup>2</sup>

The present study discuss and highlights the geotechnical aspects of failure cases observed in the head wall of Hume pipe culverts constructed at various locations on a bypass as apart work of ‘Four Laning & strengthening of a national highway in Haryana state’. Systematic Forensic investigation of the observed cracks developed in a head wall of Hume pipe culvert suggested construction as well as design deficiencies. From geotechnical perspectives, various aspects of failure, such as, suitability of soil as foundation material, inadequate compaction of the foundation soil, consolidation process and amount of settlement etc. were studied. Observed performance and development of crack at the location of stress concentration in the head wall were also verified through numerical analysis using finite element based numerical tool PLAXIS 2D. Upon investigation, it has been found that inadequate compaction of soil below headwall foundation was the primary reason for excessive settlement and development

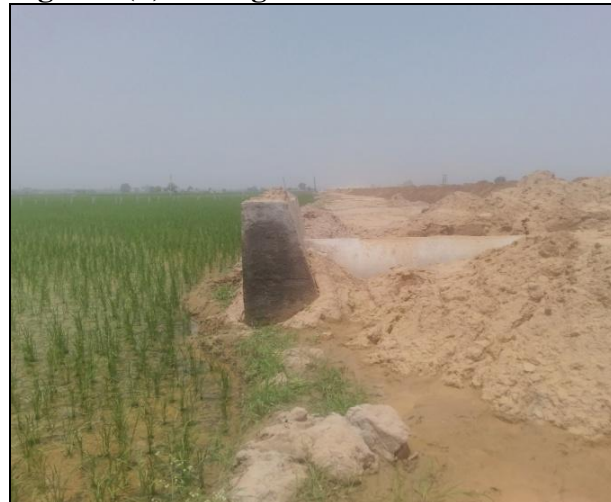
**Figure 4(d) Casting of head wall**

Construction of HPC follows the sequence of activities like preparation of bed of foundation soil, such as, leveling and compaction of bed. Compactions are done either with roller or manual. After bed compaction, the foundation concrete (PCC, M-10 grade) of nearly 100mm are placed to support the Hume pipe. Hume Pipes are laid and jointed with each other so that there is no leakage take place (Fig 4). After laying and jointing the pipes, headwalls are constructed on both ends of culvert, serving as a retaining wall as protection against the scouring or undermining of fill or a flow diverting device

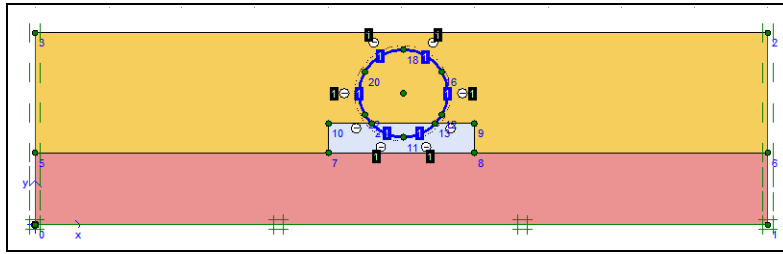
**Figure 6(a) Finite Element model for the numerical analysis of Head Wall**

Fig 6 shows the step followed in the numerical analysis of the Hume pipe culvert. From results of the analysis, it can be noted that both compressive and tensile stresses are developed in the head wall. Blue shade shows tensile stresses developed and red shades indicates development of compressive stresses in the Head wall. It can be noted that the tensile stresses developed in the head wall is at the location of the crown of Hume pipe where the crack was developed. As we know that concrete cannot take tension, development of tensile stress ( $53 \text{ kN/m}^2$ ) has caused severe cracks in the head wall. Based on the study, provision of reinforcement can be suggested at the location of tensile stresses development in the head wall.
