Rawene Reserve landslips emergency response and stabilisation

Simon Farquhar

Tonkin and Taylor Ltd, New Zealand, sfarquhar@tonkintaylor.co.nz

KEYWORDS: landslide, ground stabilisation, debris flow, anchored palisade wall, strainmeter

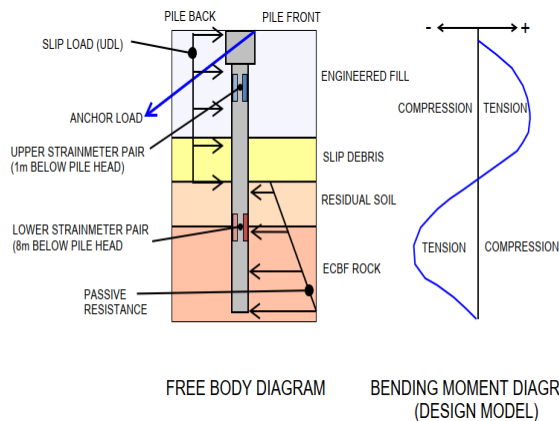
Figure 7. Free body diagram and bending moment diagram showing idealised loading and design actions.

The design of the palisade wall was undertaken following the method described in Poulos (1995). The approach involves three main steps: (1) determining the shear force needed to increase the factor of safety of the slope to the target value; (2) evaluating the shear force that each pile can provide to resist sliding (3) selecting the number and type of piles and the most suitable location in the slope.

The design was controlled by the short term (undrained) loading case. Placement of the fill prior to the construction of the palisade wall was also limited. Settlement of the landslide debris and alluvium was considered, however, the majority of the settlement was expected to occur during construction, and prior to final surfacing (asphalt) being constructed on the carpark. The design was undertaken using a limit equilibrium analysis (Geostudio Slope/W) to determine the stabilisation load required to reach the desired factor of safety for stability of 1.5. The stabilisation load, at a factor of safety of 1.5 was then modelled as a uniformly distributed load (UDL – refer to Figure 7) over the length of pile in the area of predicted movement to design the pile and anchors. The retaining wall design was undertaken using WALLAP.

The strainmeters typically show for the upper pairs (located 1 m below the top of the pile) a positive bending moment of approximately 175 kNm is measured (25% of the calculated design action). For the lower pair of strainmeters (located 8 m below the top of the pile) a negative bending moment of 415 kNm is measured (30% of the calculated design action). The ULS design load for the wall was determined using limit equilibrium analysis targeting a factor of safety of 1.5. For large failure surface areas this can result in very high stabilisation forces being required. The monitoring indicated that the actual (working) loads in the piles are significantly smaller than the design loads. Additional strainmeter pairs would have helped to confirm the full bending moment profile along the length of the piles. However, this would have added significant cost to the project.
