Transpennine Route Upgrade: Geotechnical engineering solutions to replace failed structures caused by peat and dissolution hazards

For the Transpennine Route Upgrade East (TRUe), SYSTRA and the TRUe Alliance delivered three new flood balancing structures as a replacement to a failed culvert on the Normanton and Colton Junction Line. Geotechnical research into the cause of the culvert failure and geological investigations into this region of North Yorkshire, identified that dissolution of gypsiferous material and the presence of peat deposits had been causing the rail embankment (through which the culvert was constructed) to displace.

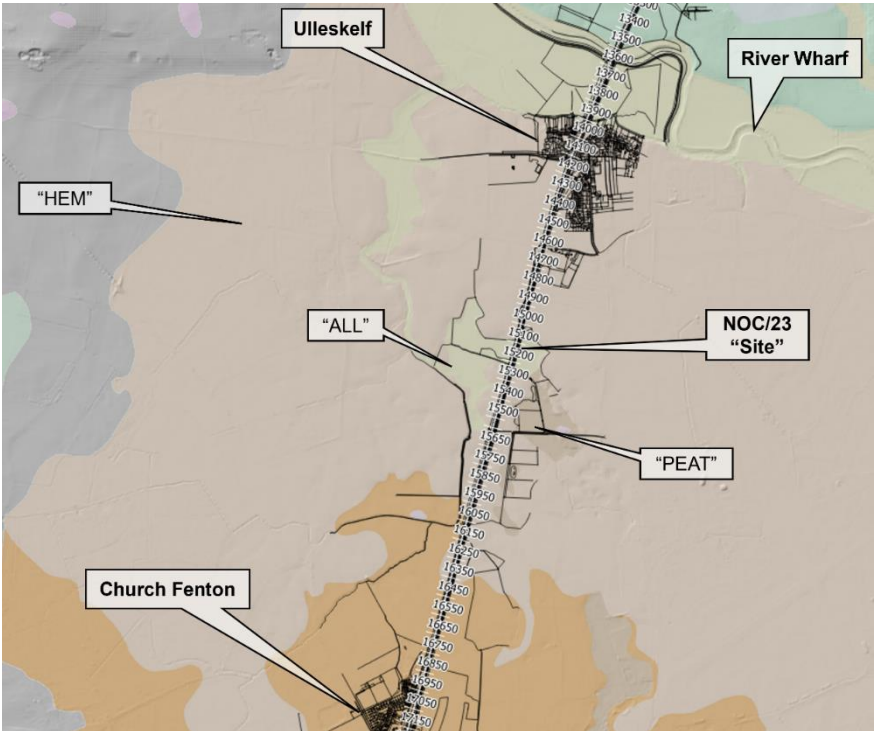
Figure 1: Site Location, with Superficial Geology (as mapped by the BGS 1:50,000 WMS Layer)

The existing NOC/23 flood alleviation structure is located within a region of North Yorkshire referred to as Ulleskelf Mires. These mires are an area of elevated flooding risk, with natural grassland and woodland flooding seasonally. The Mires can be identified from aerial imagery and are visible on Figure 1 aligning with the BGS mapped extent of Alluvium and Peat.

The revised 1:10,000 Scale BGS map SE53NW, compiled by Cooper (2000) shows large areas of Alluvium and Peats (see Figure 1) that are likely gypsum subsidence features. The Department of the Environment gypsum subsidence study (Thompson et al. 1996) maps subsidence features from air photographs, illustrating sinkholes in the area north of Church Fenton. Based upon the Environment Agency Open-Source LiDAR datasets, mapping provided at Figure 2 shows the region of NOC/23 to be generally flat, however shows a depression, likely attributed to subsidence (orange), at NOC/23 and Ulleskelf Mires. Cooper (1986) identifies a similar pattern of hollows in subsidence surface patterns as a result of confirmed dissolution locations at Ripon. They are interpreted as amalgamated hollows, whereby subsidence occurs as a result of the first hollow collapsing the underlying cave,
