Geotechnical risk assessment on Albanian historical bridges

M. Gega

Polis University, Department of Architecture and Civil Engineering, Tirana

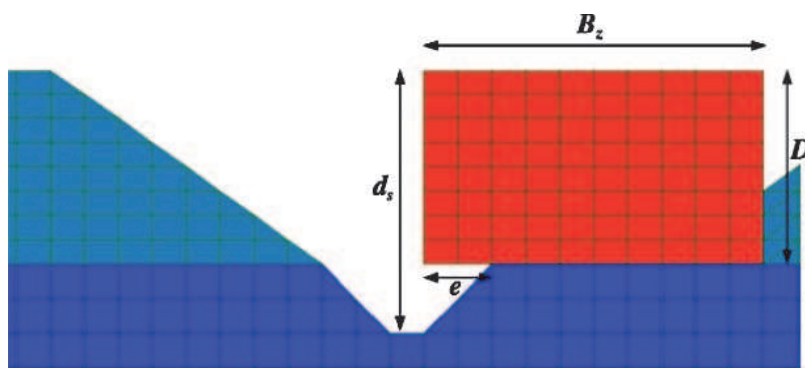
Fig. 3: Dimensionless scour depth d_s/D and lateral erosion e/B_z (Zampieri 2017)

When ratio of the (d_s/D) is lower than 1, scouring does not influence structural behaviour of stone arch bridges. While in case of lateral erosion under pier foundation cracking phenomena is observed at bridges arch (Zampieri 2017). From the current state the damages are only affecting the foundations of the bridge and have not showed any arch crack to the stone structure. So according to its initial purpose wood pile foundations has resisted very well to local scour but also have prevented lateral erosion and possible bridge settlements that can lead to the loss of equilibrium and structural damages. From the geological conditions Kollorcka bridge foundations are placed on the second layer of cohesive cemented siltstones. Different studies have stated different results about scour in cohesive soils when comparing it to non-cohesive soils, when soil properties testing are placed on the same pier condition and river flows (Sonia Devi 2017). Because of the lack of a general equation that include the required parameters for understanding the scour mechanism in cohesive soils we cannot judge if in our case the presence of cohesive soil decreases or increases the scour dimensions in our flow and pier conditions. The wood pile foundations have played an important role in the bridge resistance to harmful natural conditions such as temperature changes, hydrological, hydrogeological and potentially geological too. All this conditions change have resulted in the exposition of Kollorcka bridge wood piles.

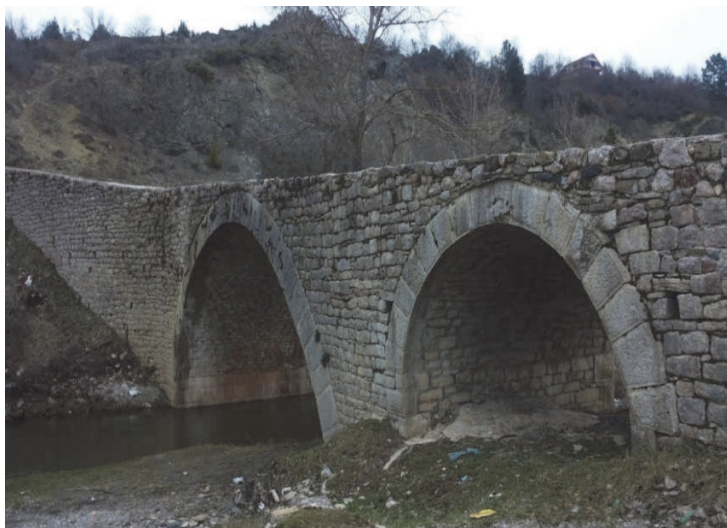
Fig. 5: Shen Prodhomi Brige (IMK)

Meanwhile human activity in Shen Prodhomi XVII century stone bridge placed in Korca Albania, has complicated its serviceability and caused excessive dynamic load from a variety of transportation services contrary to its initial purpose. Materials aging and temperature changes set Shen Prodhomi in high sustainability risks.

The foundations of Shen Prodhomi Bridge are placed on terrigenous sedimentary rock. As conglomerates they have very good resisting parameters 1-1.5 MPa. Also the presence of the retaining wall sets Shen Prodhomi foundations in good conditions. Human activity with the usage of heavy transportation vehicles have caused cracks in the arches of the bridge. Hydrological conditions and humidity has taken further the initial cracks. Also potential earthquake set Shen Prodhomi Bridge in difficult situations due to stone material fatigue from excessive dynamic load.

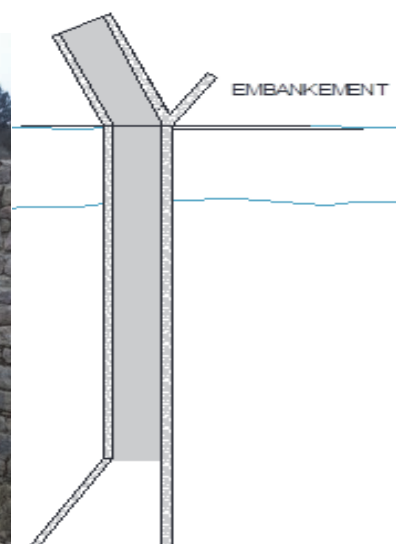
Fig. 6: Brige Plan

Shen Prodhomi XVII century bridge has a 51.70 m longitude and a 4.60m width. It is composed of 1 bigger arch with 11.00 m spacing and a smaller one of 4 m spacing. In the river shore the brigde route has a 22° turn (IMK). In order to prevent

the foundation damage in the other side a retaining wall is constructed. As shown in the bridge plan in the part where maximum spring flow occurs it hits the retaining wall. As shown in fig. 7 the wall is considerably damaged up to 50 %. This leads to monitoring requirement on deteriorating factors affecting this retaining wall. Mainly the presence of erosion has created a dynamic load on the retaining wall structure by eroding underwater parts of the mortar and the wall stone in the same time. This wall requires immediate interventions as it also serves as a protection for the foundations of the Shen Prodhomi bridge.

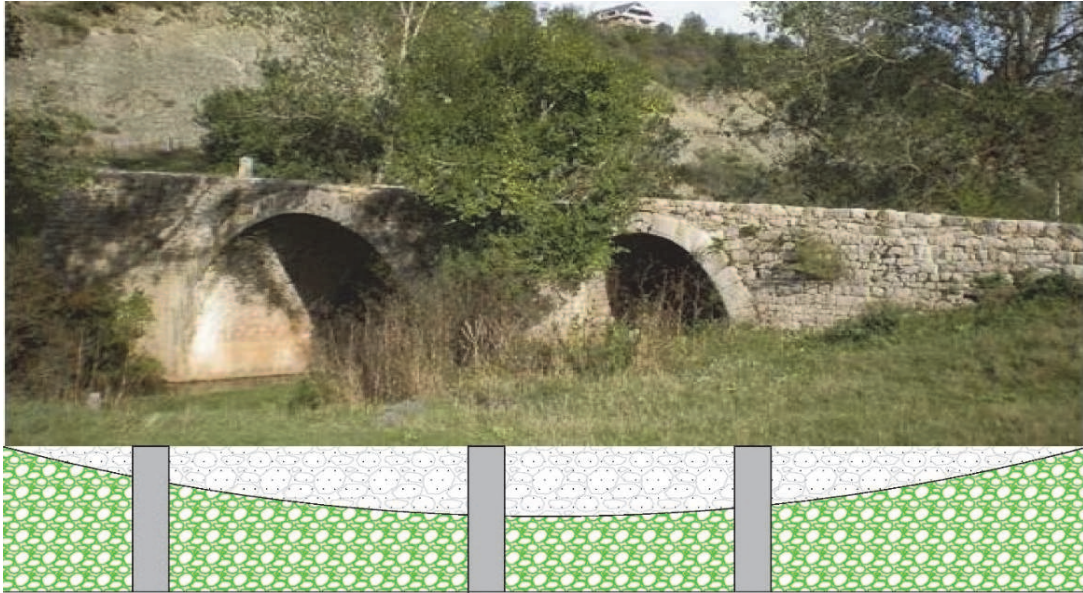
Fig. 8:Shen Prodhomi geological profile

Grey basal conglomerate are the first layer noticed in the terrigenous sedimentary rock. The fragmented material is mainly composed of ophiolite, limestone and silicates material varying from a few cm up to 50cm with irregular sorting. They have low clay-sand cementation with ophiolites Robertson et al (2012) compound mainly.

It is placed under the terrigenous sedimentary rock layer with compatibility. In the carbonate rock layer is found the combination of limestone conglomerate, fragmented limestone rich in ophiolite material, limestone-marl sequences and marl with reddish carbonate-clay cementation dating back to Barremian - Aptian age.
