# Geotechnical interventions to mitigate the geomorphological risk of the access road to Ribeira Quente parish - Azores archipelago

L. Moniz\*, P. Amaral, A.M. Malheiro, F. Marques, A. Santos  
*Laboratório Regional de Engenharia Civil, Ponta Delgada, Portugal*

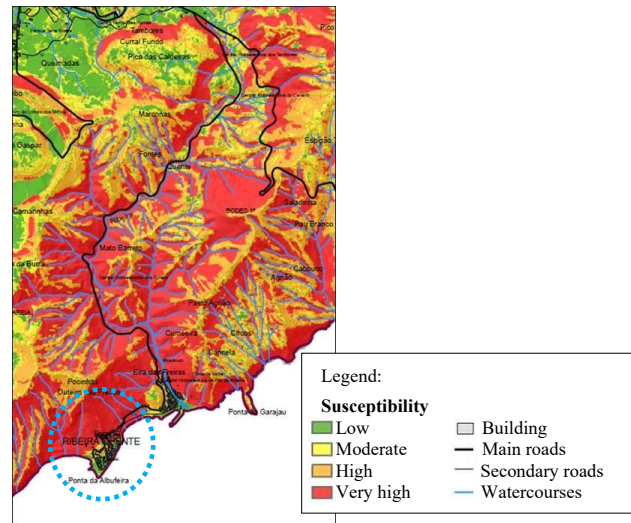
Considering the susceptibility of this location to the occurrence of slope movements, Marques (2013), based on the work carried out by Marques et al (2009), produced a map of susceptibility and propagation of slope movements for the municipality of Povoação, including the Ribeira Quente parish (Figure 1).

From this map, it can be seen that this road is very vulnerable to geomorphological instability processes. Based on this information, which justifies the phenomena that have occurred in this location, it became imperative to implement actions to minimise some of the most serious situations, intending to improve safety conditions for passers-by. It is important to emphasise that these measures do not

Figure 1. Map of susceptibility and propagation of occurrence of slope movements for the Ribeira Quente valley, outlined in blue (adapted from Marques, 2013).

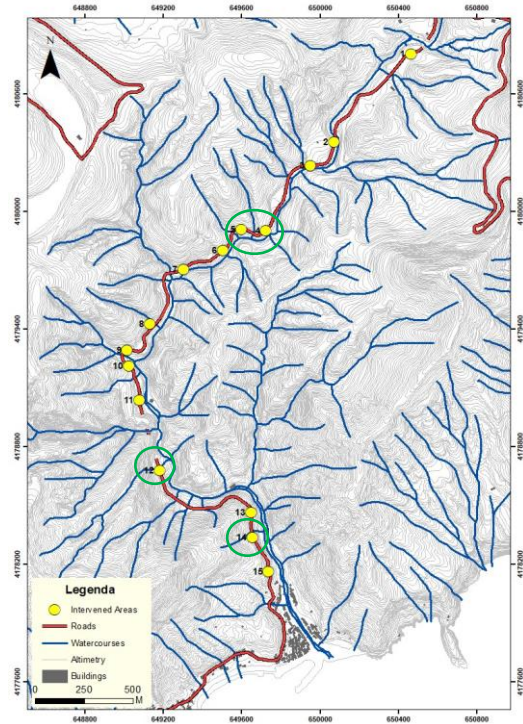
In recent years, 15 sites along the E.R. 2-2<sup>a</sup> (Figure 2), which had been identified as critical, have been intervened. The risk mitigation measures to be implemented are: (1) re-profiling the slope, (2) a retaining wall with a ditch at the end, (3) construction of a semi-tunnel, (4) removal of rock blocks and (5) metal nets with nails and sometimes with shotcrete. This paper will present only 4 of the 15 sites intervened, corresponding to sites 4, 5, 12 and 14 (Figure 2), taking into account their representativeness in the overall context of the interventions.

Figure 2. Location of the sections of the intervened areas. In green circles, the indication of the four sites presented in this work.
