# Collapse of the historical archive of the city of Cologne due to underground construction – Damage analysis and conclusions for quality assurance and risk management in geotechnical engineering

Christian Moormann

*University of Stuttgart, Institute for Geotechnical Engineering, Stuttgart, Germany MGC  
Moormann Geotechnik Consult, Stuttgart & Cologne, Germany*

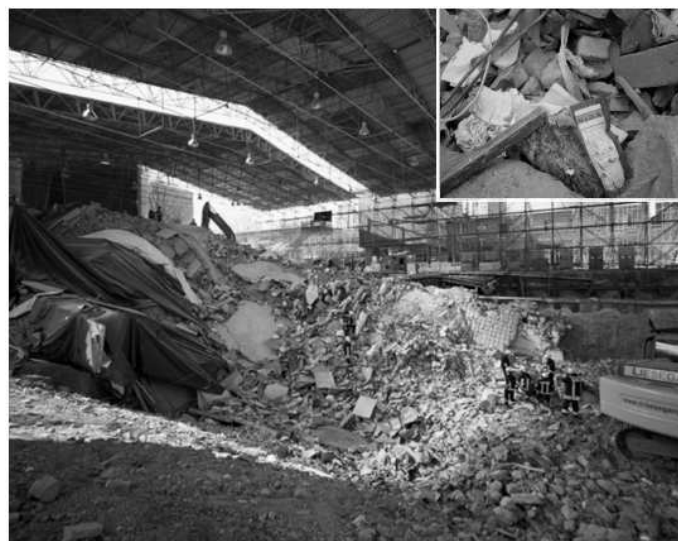
Figure 5. Salvaging the archives from the rubble of the collapsed Historical Archive at Waidmarkt, looking west with the eastern diaphragm wall of the 'GWB' pit.

In an initial salvage phase, the fire brigade and the Governmental disaster relief organization carefully removed the huge cone of rubble and debris under the protection of a temporary lightweight hall erected over the excavation pit (Fig. 5) and handed over the archive material that came to light to archivists and many volunteers.

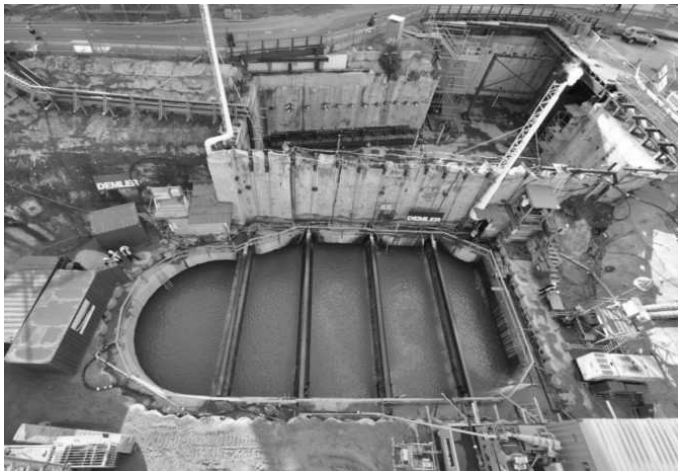
Figure 6. Salvage pit (in the foreground) in front of the eastern diaphragm wall of the 'GWB' pit.

Based on a conceptual study, the excavation pit was constructed in the form shown in Figures 6 and 7 with ground plan dimensions of around 16.5 m by max. 30 m and a rounded section ('apse') in the south, as a particularly large amount of archival material was suspected here. The excavation pit thus enclosed significant areas of the explored excavation funnel. The construction pit was secured on three sides by a secant bored pile wall (pile diameter  $D = 1.2$  m, pile length 29.5 m) and braced against the eastern diaphragm wall by a circumferential reinforced concrete beam with three tubular steel struts and a reinforced concrete strut which were pre-stressed by hydraulic presses.

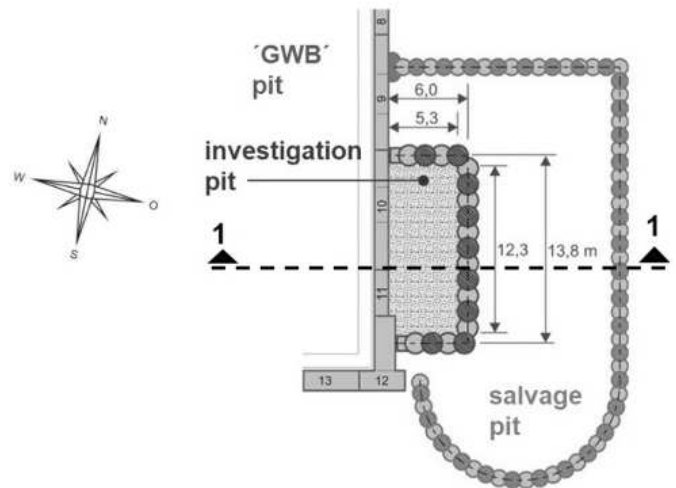
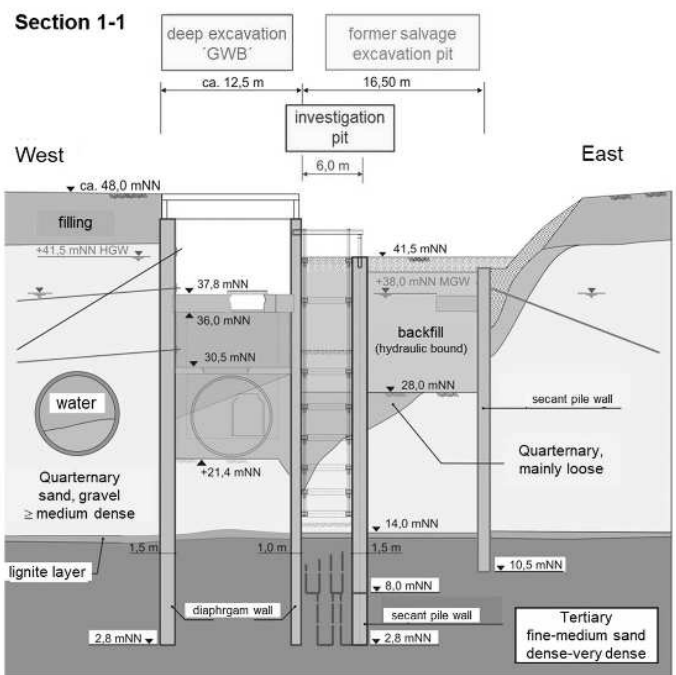
Figure 7. Salvage pit and inspection pit to the east of the 'GWB' pit: a) ground plan, b) cross-section 1-1.

The investigation pit enclosure was constructed on three sides as a secant bored pile wall with large diameter bored piles ( $D = 1.50$  m) (Figs. 7 and 10). The pile base level was initially planned uniformly at 2.8 m a.s.l., corresponding to the depth of the diaphragm wall of the 'GWB' pit. The planned pile length was therefore almost 40 m. The piles had to be executed fully cased while maintaining a water load inside the casing to be controlled depending on the quaternary groundwater level and a sufficient advanced penetration of the casing below borehole level in order to minimise construction-related loosening, particularly with regard to the sensible evidence situation.

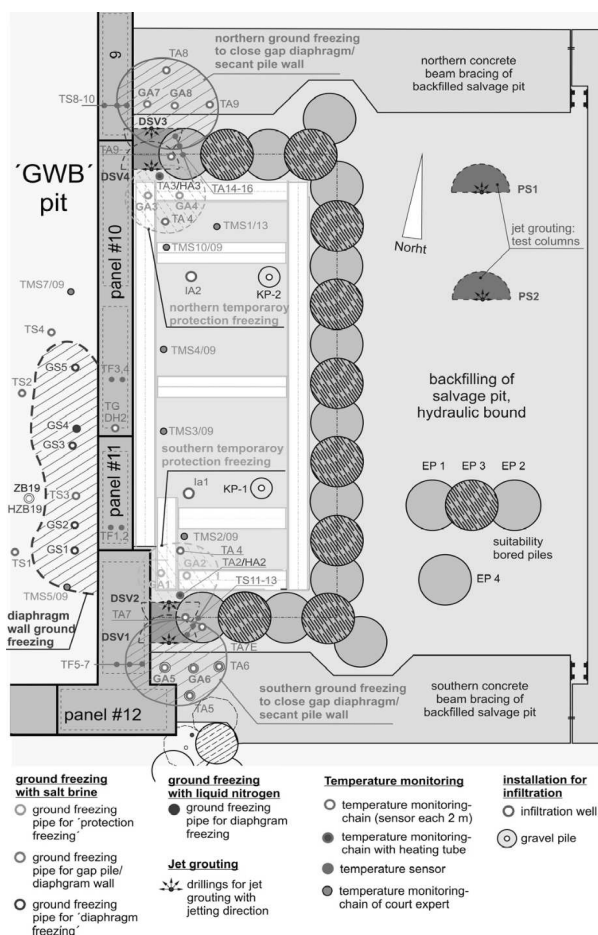
Figure 10. Ground plan of the investigation pit with secant bored pile wall and connecting construction to the diaphragm wall of the 'GWB' pit plus ground freezing for the diaphragm wall.

wall of the 'GWB' pit with jet grouting as the main element (Fig. 10). As a preliminary step, a temporary 'protection freezing' was realised inside the inspection pit. Under its protection, it was possible to grout the soil body, which would later be in contact with the free groundwater in the connection area, using the jet grouting method without having to worry about any impact on the soil situation inside the inspection pit. As a fall-back level and to seal the gap below the excavation level, a further ground freezing, the so-called 'connection freezing', was realized on the outer side of the gap and operated for the construction period. The shielding and connection freezing were both carried out using the salt brine freezing method.

Four brine freezing pipes (GS1 to GS3 and GS5) and a nitrogen lance (GS4) were installed for the diaphragm wall freezing (Fig. 10), whereby the latter could be used to generate increased heat extraction locally and in defined depth sections that could be varied by moving the feed pipes if the exploration work required this, for example when faults were encountered, which was almost always the case during the execution. The freezing area extended from approx. +28 m a.s.l., i.e. the surface of the debris cone reaching just below the lower concrete slab bracing, to the surface of the lignite at approx. 14.0 m a.s.l., so that this frozen soil body had a height of approx. 14 m.

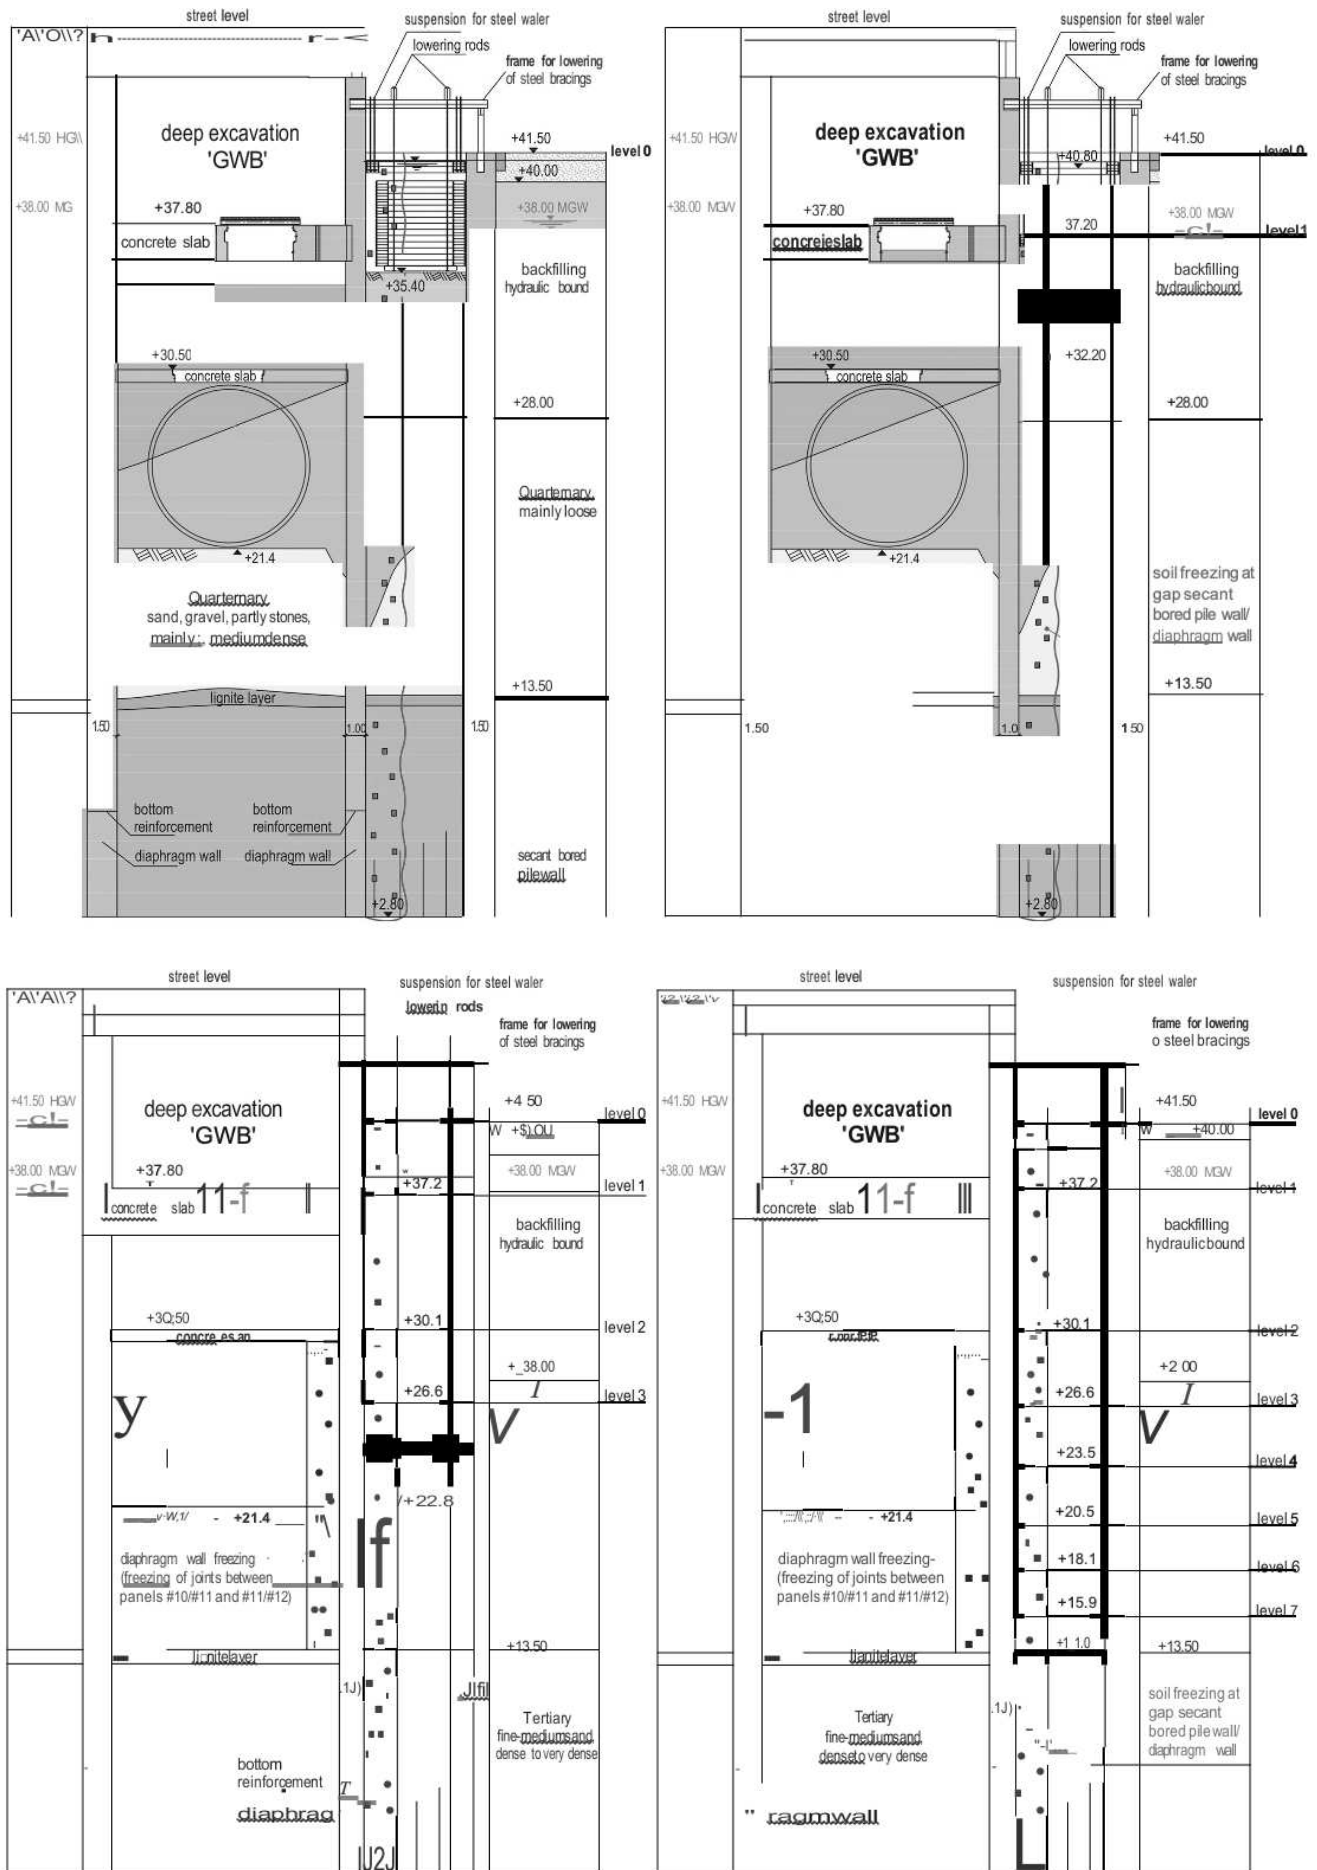
The investigation pit was braced by steel bracing frames in a total of eight levels (Figs. 10 and 11). This bracing solution ensured that the eastern diaphragm wall of the 'GWB' pit was supported almost over its entire surface, thus ensuring that the earth pressure effects on the diaphragm wall from the east remained as unchanged as possible and were distributed almost evenly, so that overall the boundary conditions of the stable initial situation of the 'GWB' pit were not significantly changed and at the same time the diaphragm wall could be safely supported even in the event of larger defects. Due to the cramped conditions in the investigation pit and the fact that the bracing had to be installed under water, a concept was developed in which the pre-assembled steel frames for all eight bracing levels were lifted into the investigation pit after an initial excavation phase (35.4 m a.s.l.) and then lowered as a 'package' following the excavation using hydraulic devices, whereby the topmost frames were successively fixed in place (Fig. 11). The dead weight of the prefabricated, horizontally telescopic frames made of sectional steel was between 17.5 t and 27.5 t per bracing layer.

Figure 11. Construction sequence of the inspection pit (west-east section, selected stages).
