# Embankment stabilisation on Van Reenen's Pass, Kwa-Zulu Natal

**ABSTRACT:** The National Route 3 highway is the main artery between the hubs of Johannesburg and Durban. This route passes through the Van Reenen's Pass on the border of Free State and Kwa-Zulu Natal, an area which has historically been noted for slope instability, and with little alternatives for diverting traffic. One such area of historic slope instability below the roadway showed clear signs of settlement and cracking in the 2021-22 period. This paper discusses the investigation, design, and construction of a piled solution intended to protect the roadway from progressive slip caused by the downslope instability. Special attention is paid to the underground morphology, subsurface water regime, and strength of fill, colluvium and weathered rock layers which lie at the root of the instability.

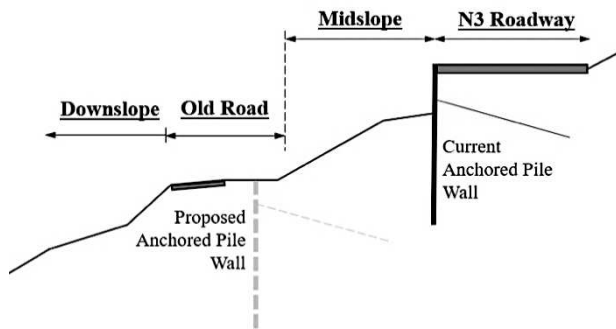
The current N3 route was built in the 1970s as a multiple carriage roadway, replacing the earlier single lane roadway that had been in use for much of the early 20<sup>th</sup> century. Different generations of infrastructure development therefore lie on variable mountainous topography that have been shaped through the ages. These factors contribute to the complexity of understanding and working on this site, as records are not available prior to the 1970s. A cross section of the site is presented in Figure 1. Of note in this section is

the current N3 roadway, as well as the old roadway below it.

Figure 1. Named areas of site, in section.

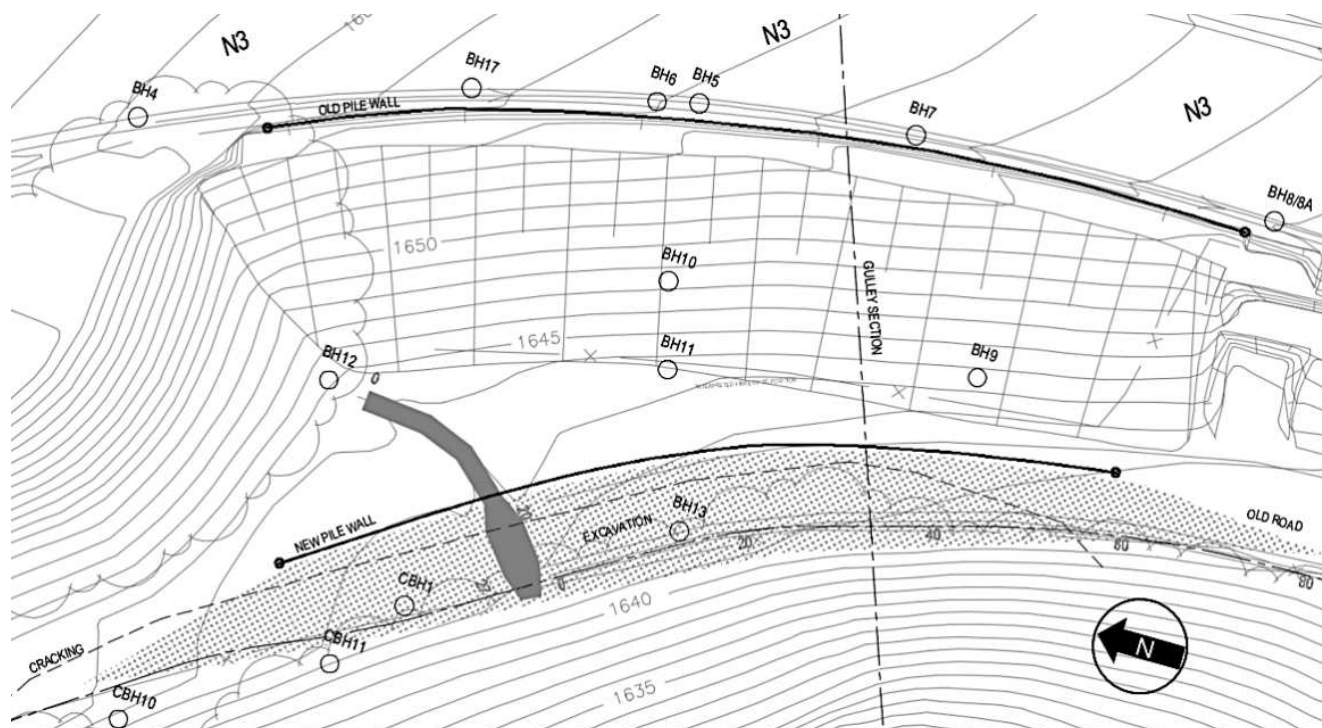
Figure 3. Site layout

A total of nine boreholes were drilled to complement the historical borehole data from the 1993 investigation. The boreholes in the 2023 investigation were primarily focused on establishing ground conditions on the downslope area, as this area had not been investigated during the previous investigations. Figure 3 presents a general site layout with boreholes.

Boreholes confirmed the presence of a deep fill and colluvium (~20 m to very soft rock) on the old road towards the north of the site. However, the deep fill and colluvium layers in the downslope were not as extensive across the downslope area as initially anticipated. Both boreholes on the northern and southern ends of the downslope area found much shallower depths to bedrock (10 m - north, 3 m - south).
