# Investigation on the damages induced by slope movements on historic buildings: the case of San Nicolò di Capodimonte church in Liguria

L. Cambiaggi

R. Berardi

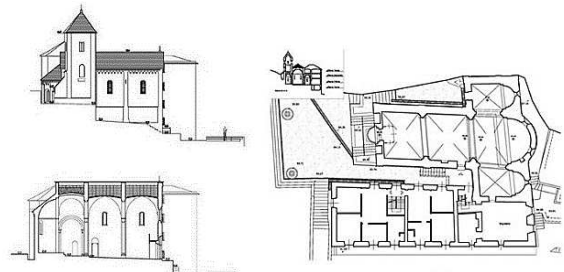
Figure 1: Plant and section of San Nicolò

The church, whose construction probably dates back to the eleventh century (Cavaciocchi et al., 2009), is a construction of limited dimensions and has a single nave with a transept and apses (Figure 1). On the upstream side there is the bell tower, while on the sea side, in the transept area, the church is connected to the rectory and to a small building called “Casa dei Pescatori” (Fishermen’s House), which has been a shelter for local fishermen in the past. S. Nicolò is located in an area classified with a high level of landslide susceptibility and in a position close to a large active landslide. The area in which the complex is located is limited by two natural streams along which the water flows and the groundwater is canalized.

The presence of a very clear crack pattern has placed the attention on the church, bound by the Superintendency, which has planned some structural monitoring in recent years.

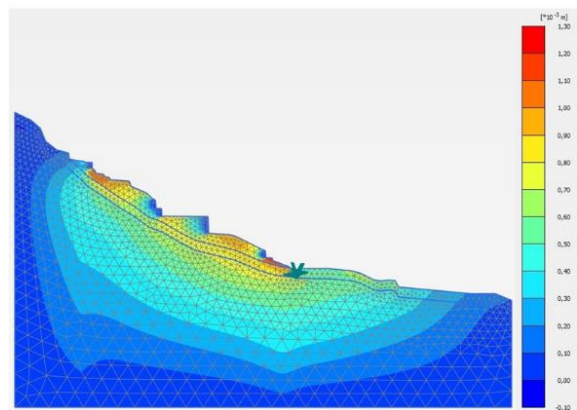
In preliminary analyses the different soil types have been modelled with the elastic-perfectly plastic Mohr-Coulomb model; then, more accurate FEM analyses have been performed adopting the HSM model (Hardening Soil Model), a non-linear isotropic hardening model used to better simulate the real behaviour of soils. The aim was to investigate the settlement profiles in each section, under different groundwater levels, both in free-field conditions and by introducing the presence of superstructures. For example, the trend of horizontal displacements in section E is shown in Figure 4 that illustrates how the maximum displacements due to groundwater oscillations are concentrated precisely in the San Nicolò complex area.

Figure 4: Horizontal displacements due to groundwater oscillations

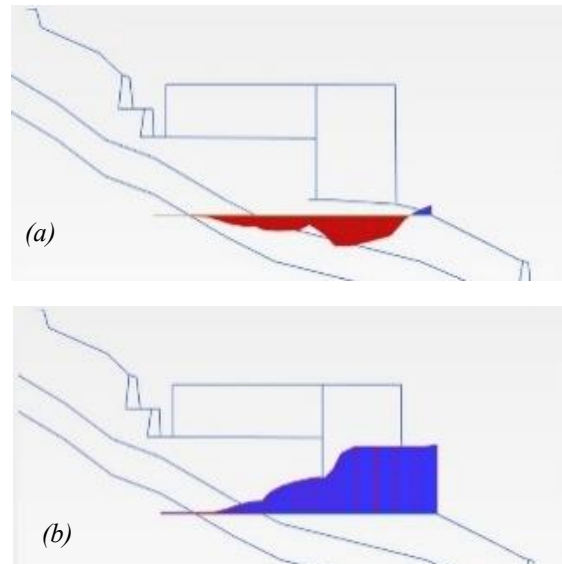
The maximum displacements are concentrated under the Fishermen's House (as shown in Figure 5 and 6-a) which influences the performance of the S. Nicolò church to which it is connected.

Figure 5: Settlements (a) and horizontal displacements (b) at foundation level

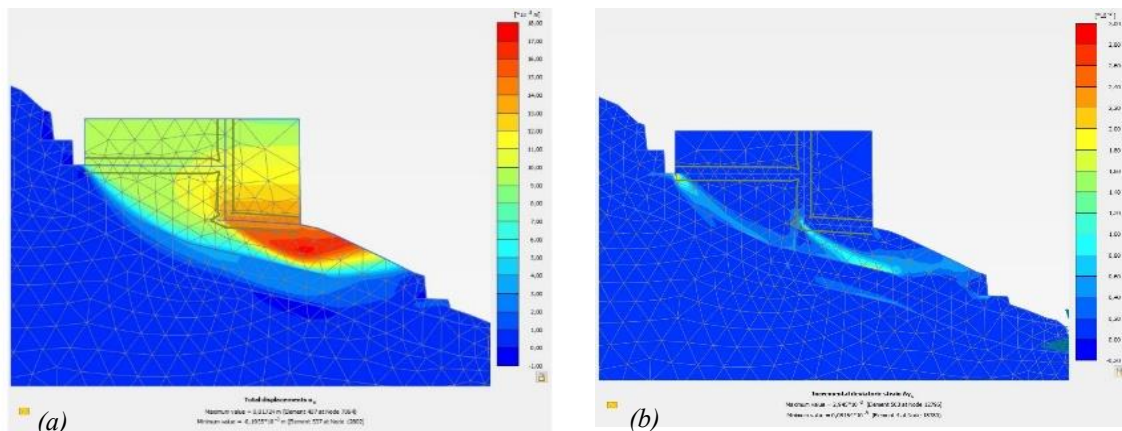
concentration tend to be joined in a single potential failure surface (Figure 6-b).

Finally, the numerical analyses have provided results in good agreement with actual evidences observed in the area, also referring to other sections under examination. For example, the reliability of the analyses have been proved by the observation of local phenomena of instability that actually occurred the blanket in the recent past,

Figure 6: FEM analyses results: Horizontal displacement (a) and shear strain concentration (b)

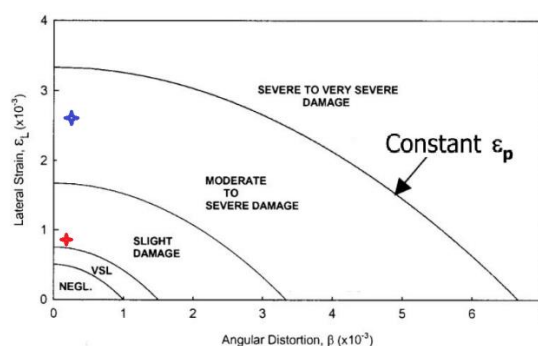
The values of horizontal deformation and angular distortion were used to estimate the degree of damage according to the approaches suggested by Son and Cording (2005) and Schuster et al. (2009), particularly committed to deep excavations (Figure 9). According to the Son and Cording's approach the damage is slight (for the church) to medium (for the Fishermen's House). A similar result is obtained with the approach proposed by Schuster et al., being the Damage Potential Index DPI equal to 16 (slight damage) and 52 (moderate damage) respectively for the church and the Fishermen's House.

These results correspond to the actual survey of the cracks, which appear more serious in the basement of the Fishermen's House, compared to those of the church that, although relevant, have a generally lower opening.

Figure 9: Abacus for the evaluation of the level of damage (adapted from Son and Cording, 2005)
