# The Älvkarleby Test Embankment Dam

**ABSTRACT:** The Älvkarleby test embankment dam was constructed as a large-scale physical model to investigate damage detection, mechanical behaviour and internal erosion of embankment dams under controlled conditions. Designed in accordance with Swedish dam safety guidelines, the 4 m-high dam incorporated intentional defects and was instrumented with a comprehensive suite of geotechnical and geophysical monitoring systems. The project aimed to evaluate the performance of these monitoring techniques, assess the dam's response to initial impoundment and cyclic reservoir level fluctuations, and examine the effectiveness of remedial grouting. The results demonstrated that traditional sensors effectively captured pore-pressure and deformation trends, while advanced monitoring methods, such as 3D electrical resistivity tomography and distributed acoustic sensing, provided valuable insights into subsurface anomalies. The dismantling of the dam confirmed several of the monitoring-based observations, including the development of a preferential seepage path near the base of the core. The study highlighted the importance of integrating multiple monitori

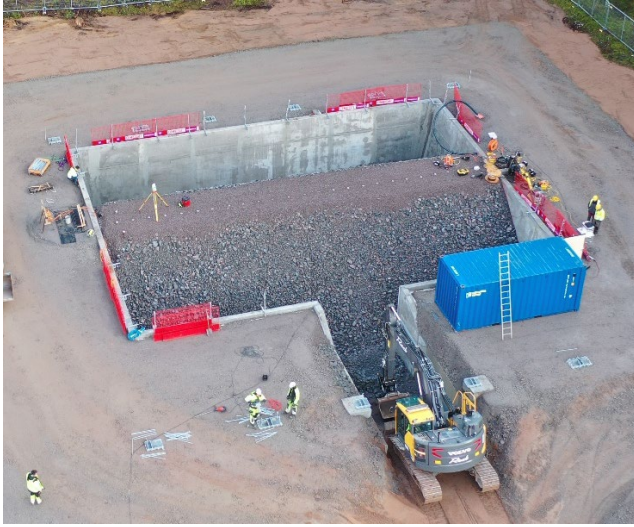
Figure 1. Overview of the concrete containment box and test embankment dam prior to the installation of an uninsulated tent.

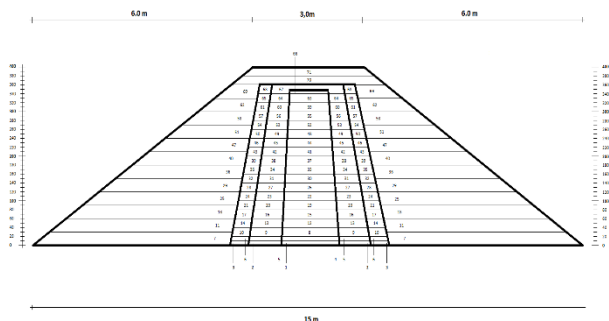
Figure 2. Cross section of the embankment dam.

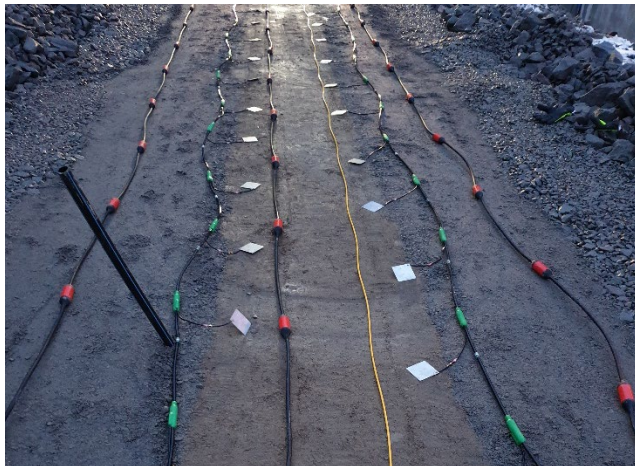
Figure 4. Fibre optic cable (yellow), ERT cables (green/silver) and hydrophone cables (red) at the crest of the core soil before being covered with fine filter and shell fill.
