GEOTECHNICAL PROPERTIES OF LANDSLIDE DAMS INDUCED BY THE IWATE-MIYAGI NAIRIKI EARTHQUAKE IN 2008

ABSTRACT

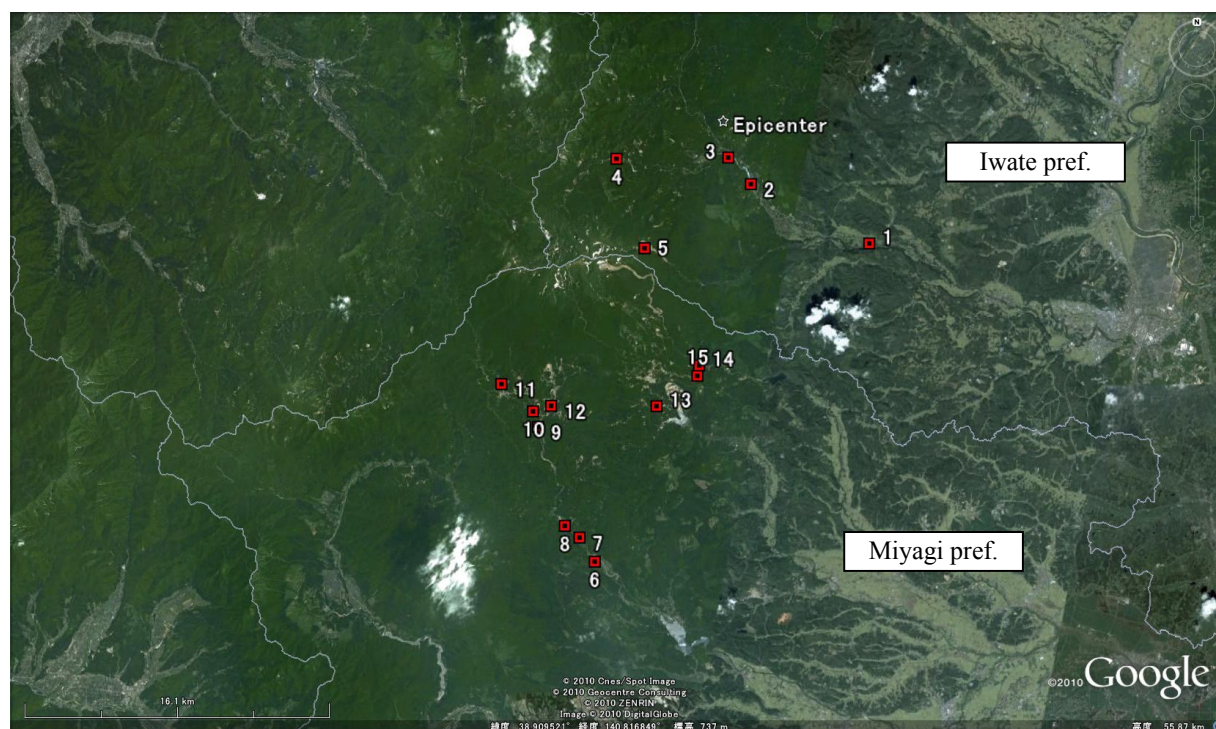
Figure 1. Major landslide dams (MLIT, 2008) in Iwate and Miyagi prefectures

Figure 1 shows the locations of major 15 landslide dams in Iwate and Miyagi Prefectures (MLIT, 2008). More than 50 landslide dams including small ones were observed in the damaged area. The locations are identified with field reconnaissance, aerial survey with helicopter, aerial photos (GSI, 2008; TCA, 2008) and reports of Prefectures (Miyagi, Iwate and Akita Prefectures, 2008). The surface soil in the area consists mainly of volcanic and pyroclastic sediments such as andesite, pumice tuff and welded tuff due to past eruptions of the Kurikoma Volcano on the border between Iwate and Miyagi Prefectures. Most natural slope failures occurred on these volcanic sediments. The failure patterns of the natural slope failures are classified to surface failure of weathered rock, rock falls along columnar joint and landslide along potential bedding plane. The epicenter of the earthquake also is shown in Figure 1. Most major landslide dams are located in southern area from the epicenter. It is possible that this tendency is due to the geological conditions and the directivity of earthquake source fault. Some source inversion analyses (e.g. NIED, 2008) shows that the fault slip propagated toward south from the hypocenter and the asperity is located on the border between Iwate and Miyagi Prefectures. Moreover, some slope failures are located at the usual landslide landforms. Multifaceted and detailed investigations are necessary to identify the real damage factor for each site in the future.

corresponds to the location in Figure 1. At Ichinonobara (No. 2), large amount of collapsed soil dammed up the Iwai River (Photo 1). The collapsed slope was gentler than other most natural slope failures which caused landslide dams, and the potential slide is possible to be triggered by this earthquake. As the Iwai River had no artificial dam with a large capacity at the downstream side of the Ichinonobara quake lake, the countermeasure works against the erosion of landslide dam was started immediately after the main shock. A temporal drain on the left bank was expected to avoid the overtopping on the landslide dam (Photo 1). The volume of collapsed soil at Ubusume (No. 5) was the largest one which made a quake lake. The length of landslide dam was about 260 m along the Ubusume River (Photo 1).

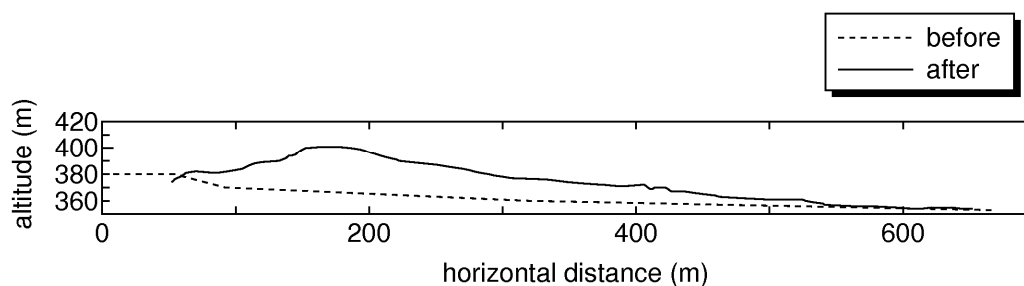
Figure 3. Sectional view along the old river channel (red line in Figure 2)

Figure 2 shows the topographical map before and after the earthquake. The topography before the earthquake is 1:25,000 topographical map by Geographical Survey Institute (GSI). The topography after the earthquake was obtained by aerial laser profiler conducted by MLIT. The slope failure occurred from near the top of the mountain at the left bank. Figure 3 shows the cross section of the landslide dam along the river which is obtained by comparing the topography before and after the earthquake in Figure 2. The collapsed soil of about 810,000 m³ flowed down the left bank slope and deposited on the downstream along the river. The bottom length and the maximum height of landslide dam are about 540 m long and 30 m high.

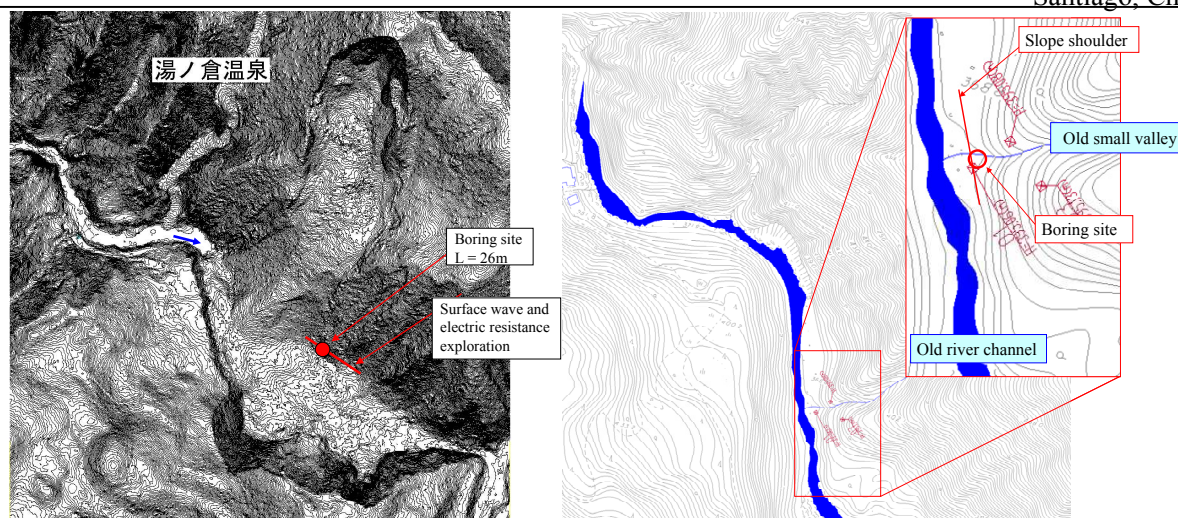
Figure 5. Locations of boring and surface wave exploration at Yunokura

Figure 5 shows the locations of boring and surface wave exploration in October 2009. The testing site is located on the left bank and is near above the old river channel. Figure 6 shows the depth distributions of the N values by SPT, the rock core ratio and elastic wave velocities. The rock core ratio is defined as a ratio of rock core length cut out from a boulder for the unit core with one meter long. The thickness of the collapsed soil at the site is about 22 m which is smaller than the maximum height of the landslide dam in Figure 3. The maximum diameter of cut-out boulder is about 60 cm and the nature is tuff, not welded tuff

The surface soil with the depth of about 2 m might be disturbed by the restoration works; therefore the N values and elastic wave velocities are very low. The N values until 8 m deep are from 10 to 20 which are smaller than the deeper part. In addition, the elastic wave velocities until 10 m deep are smaller than the

deeper part. Although the N values become large at some depths due to rock hitting in the depth of more than 8 m, the N values of the fill among the boulders are less than 20. It is possible that the fill among the boulders is not compacted despite the depth. The depth distribution of the rock core ratio agrees with that of N values. The landslide dam induced by rock slope failure consists of not only rock gravels or boulders but sand or silt. The shallow part to the depth of about 8 m contains mainly soils with lower N values and lower elastic wave velocities.
