## **DAMAGES OBSERVED IN THE 2010 CONCEPCIÓN EARTHQUAKE RELATED TO SOIL PHENOMENA**

**Felipe Villalobos<sup>1</sup>, Efraín Ovando<sup>2</sup>, Manuel Mendoza<sup>3</sup> and Paulo Oróstegui<sup>4</sup>**

### **ABSTRACT**

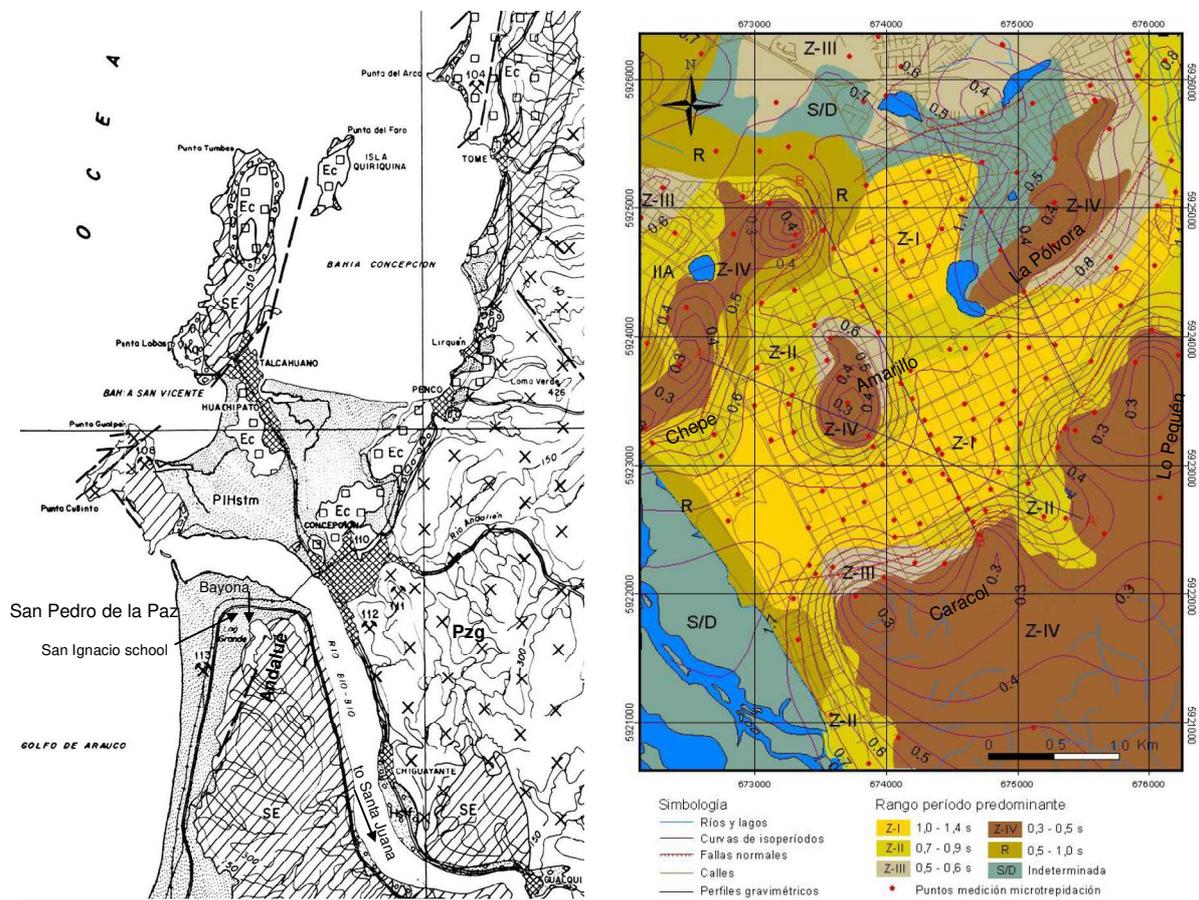
Transport of river sediments and material sliding and rolling from hills and mountains have deposited material within basins originally submerged under the sea. Figure 1a shows the legend PIHstm (dots symbol) representing widespread sediments of marine terraces. There is also presence of sediments of fluvial terraces, in Chiguyante for example. Bío Bío River, one of the longest and largest of the country, has been continuously depositing basaltic sand carried from the Andes around the mouth area before and after the retreat of the sea. The Bío Bío sand is in general clean, *i.e.* without fines content and uniformly distributed, although it can be found mixed with silts deposited by the Andalién River or with soils

Figure 1b shows the results of a work carried out by Ramírez and Vivallos (2009), where lines of equal soil period of fundamental vibration are traced. The gravimetric information was calibrated with results from a borehole, in the centre of Concepción, of 133 m depth which touched the basal rock. An interesting aspect of this work is that periods of the soil can be related to the ground type or condition. For example, periods between 0.3 and 0.5 s correspond to rocky hills and periods between 0.7 and 1.4 s correspond to sandy and silty deposits, where a particular value is a function of the material density or compactness. This information is very useful for instance to understand site effects phenomena like amplification or attenuation. Figure 1b also shows some lagoons and parts of the Bío Bío and Andalién Rivers. Around these water bodies soils are generally poor because of saturated, loose, soft or organic deposits forming swamps. It is important to point out that the Bío Bío River flowed as a delta towards the bays of Concepción and San Vicente as well as towards the current direction, *i.e.* Arauco Gulf, leaving several lagoons and wetlands which were part of old arms of the delta.

Figure 1: a) Geological map of Concepción (Gajardo, 1981) and b) seismic zonification of Concepción (Ramírez and Vivallos, 2009)

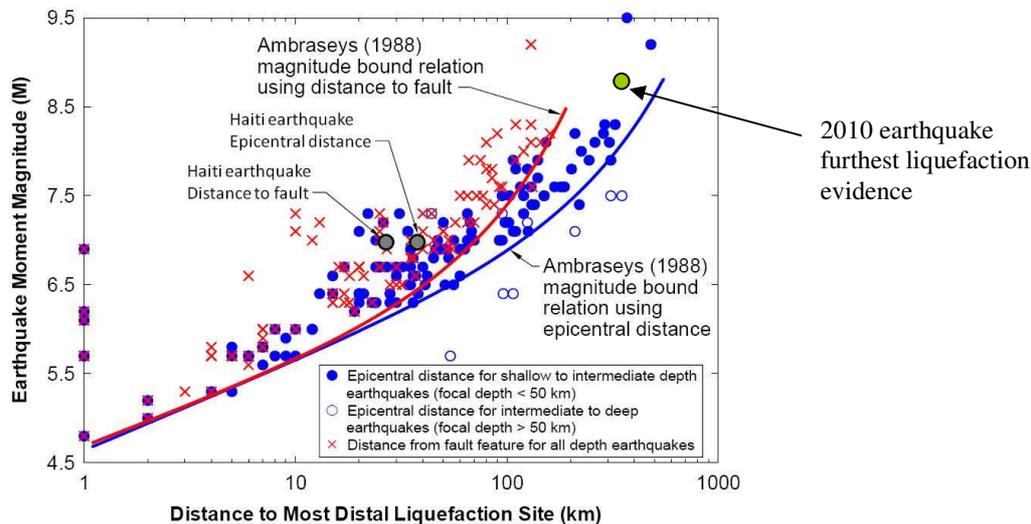
soil shear resistance. As a consequence the soil stiffness strongly decreases. The soil failure due to liquefactions induces large displacements and structures resting on a liquefied soil can suffer considerable damage. The authors observed evidence of this phenomenon in the form of, among others, cracks expelling saturated fine material where excess pore pressure was dissipated. The furthest sites where liquefaction was observed were in the motorway Ruta 5 Sur leaving Santiago, around 350 km from the epicentre. This distance is within the range proposed by Ambraseys (1988), as a function of the earthquake magnitude, for most distant sites where liquefaction has occurred worldwide (Figure 4).

Figure 4: Maximum distances for occurrence of liquefaction as a function of earthquake magnitude (Ambraseys, 1988)
