The Effect of mixed foundations on the response of some buildings to excavation

J.N. Shirlaw

ABSTRACT: Many of the older parts of Singapore are built over deep deposits of near normally consolidated marine clay. Up to the 1930s buildings were typically founded on footings supported on a dense mass of bakau piles. The bakau piles were typically 3 m to 6 m in length. The typical terraced shophouses of Singapore, built on such foundations, settle with the ground surface. Conservation of large areas of Chinatown and Little India has involved the renovation of many of these shophouses. To meet modern design codes, renovated buildings often have an interior or extension that are founded on deep piles taken to competent bearing strata, while the conserved façade remains on the old, shallow foundations. The paper records examples of buildings on mixed foundations that suffered damage during excavation for the North East subway line in Singapore. The settlements, modes of deformation and final result of excavation near these structures are presented.

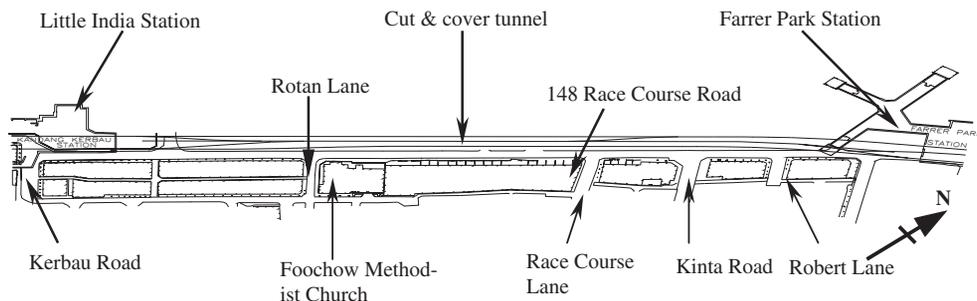
Figure 1. Race Course Road area, showing the location of the Foochow Methodist Church and number 148, Race Course Road.

The maximum settlement of No. 148 due to excavation was 107 mm. This settlement was measured on the corner of the building facing the excavation and adjacent to Race Course Lane (see Figure 1). The opposite side of the building was held up due to the rough interface with number 146. Although the settlement on this side of the building was not measured, it can be assumed that there was little or no settlement, due to the support of the adjacent, piled building. As
